May 1, 2015

00406-01910 Version 2

## Safety Recall: Front Passenger's Airbag Inflator May Produce Excessive Pressure After Long-Term Exposure To High Absolute Humidity

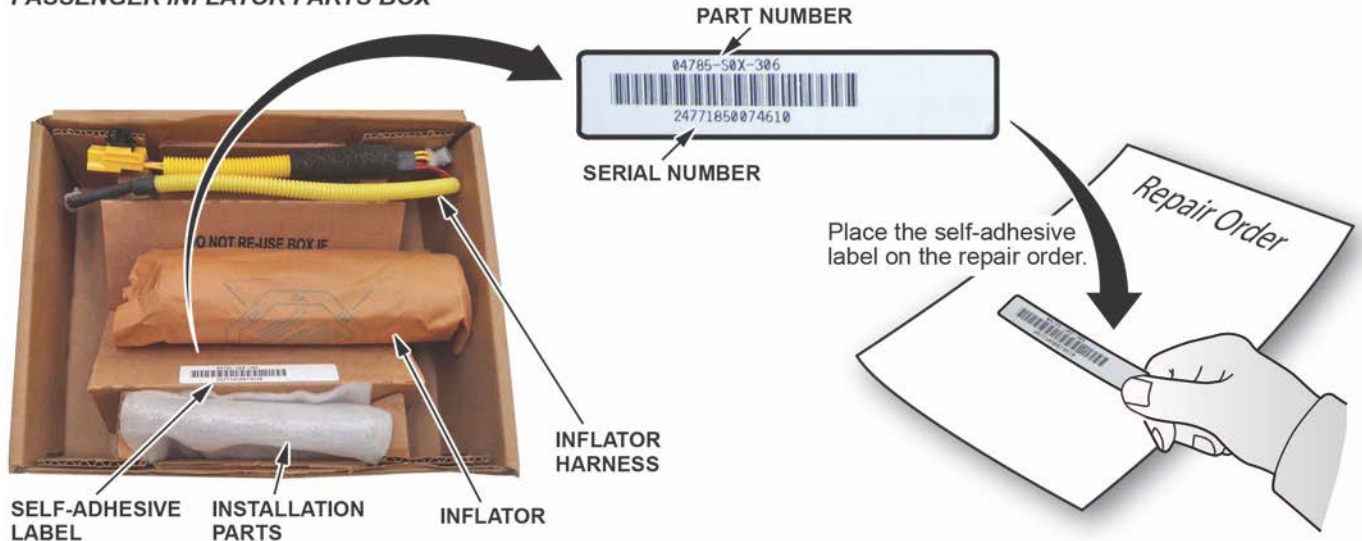
### PASSENGER INFLATOR PARTS BOX

- The replacement part number is printed on the top part of the label and the serial number is printed on the bottom. **Make sure you attach the label to the R.O. and give it to the warranty clerk.**
- There may also be a colored sticker located in the kit, ignore it because it is not used.
- Not all inflator kits have a label included. In those cases, write the serial number and part number from the side of the inflator box on the R.O. The part number always starts with 047.

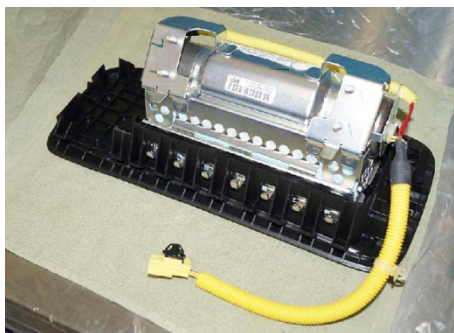
2. Remove the front passenger's airbag.
3. Place the airbag face-down on a clean shop towel as shown.

- The orientation of the airbag is critical because if the inflator is installed incorrectly, the harness will be too short when you reinstall the airbag.
- The brackets between the various models are similar but may differ from the example shown.

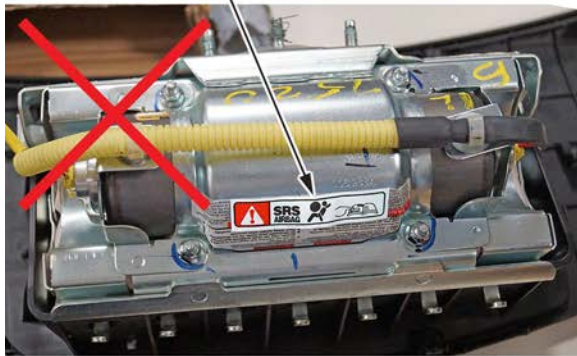
NON-STANDARD SAFETY LABEL

- If there is nothing unusual about the airbag or the inflator, go to step 5.
- If there are any unusual markings, like an incorrect label or a model year written in marker, the airbag and inflator may not be the correct airbag and/or inflator for the vehicle or it may be a counterfeit part. For more information about counterfeit airbags, you can refer to [safercar.gov](http://safercar.gov), enter keywords **MANAGING COUNTERFEIT**, and select **Recommended Dealer Guidance for Managing Counterfeit Air Bags** from the list. **If you suspect that the airbag or inflator is counterfeit, do not continue this procedure.** Contact your DPSM for assistance.

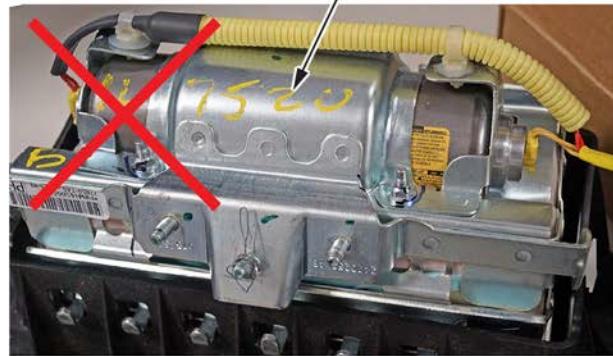
GREASE PENCIL OR PAINT MARKINGS

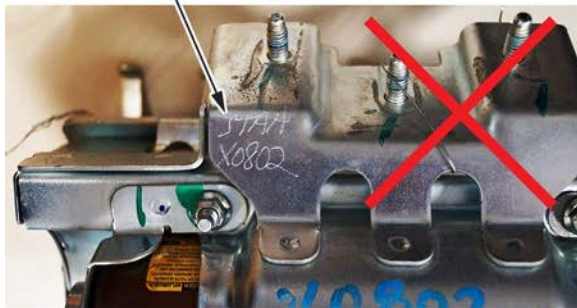
HAND ENGRAVING

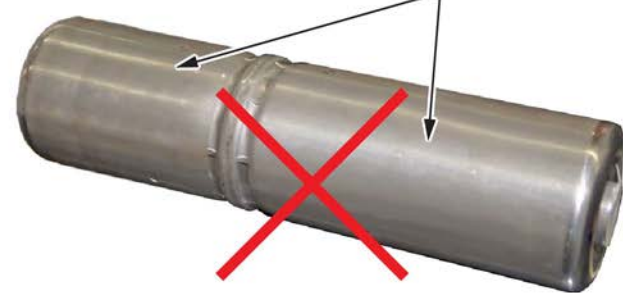
NO LABELS ON INFLATOR

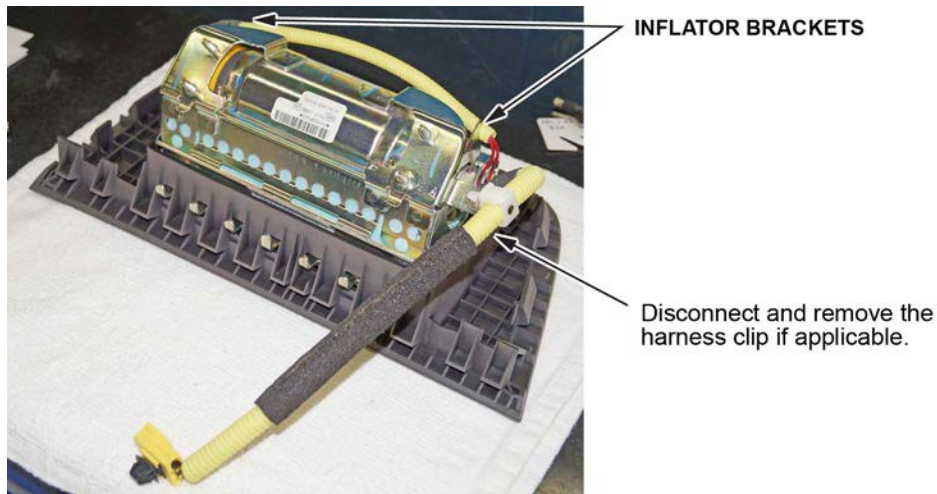
5. Remove the harness from both ends of the inflator bracket.

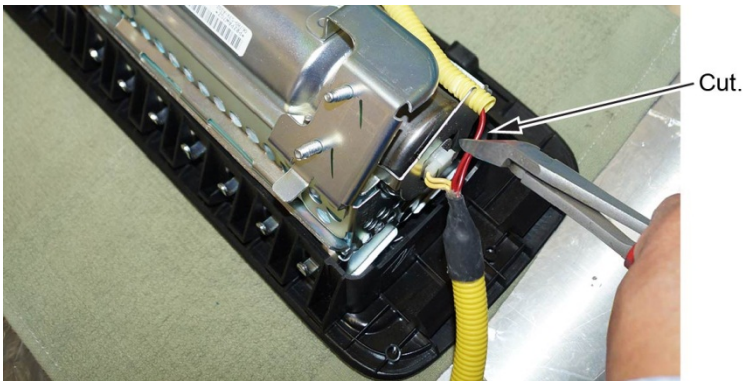
NOTE: You must cut and short the wires as indicated to prevent accidental deployment.

- Cut the red wires as shown.

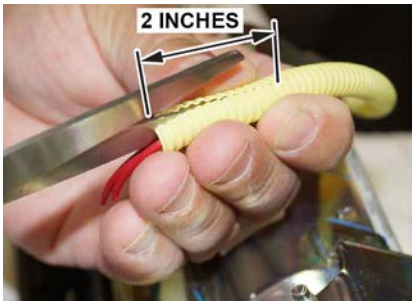
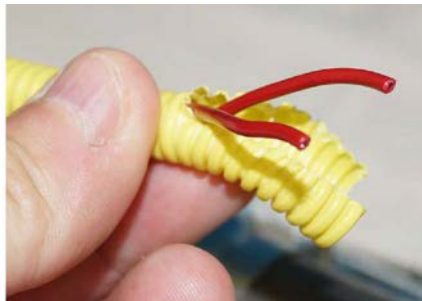
- Cut about 2 inches of the corrugated tube, then pull out the two red wires.

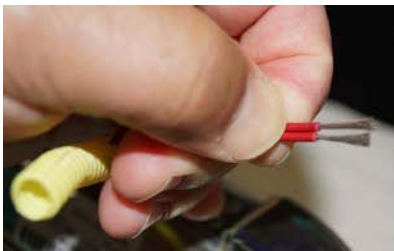
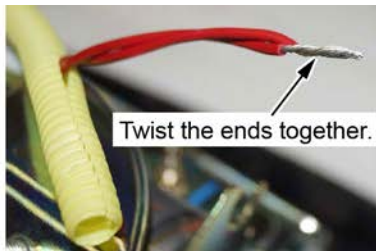
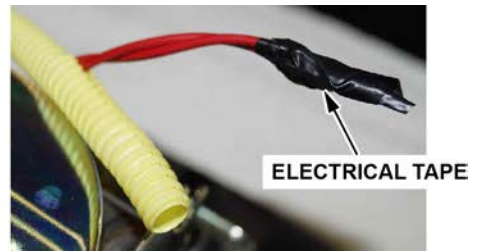
- Strip away about 1 inch of the wire insulation, then twist the wires together.

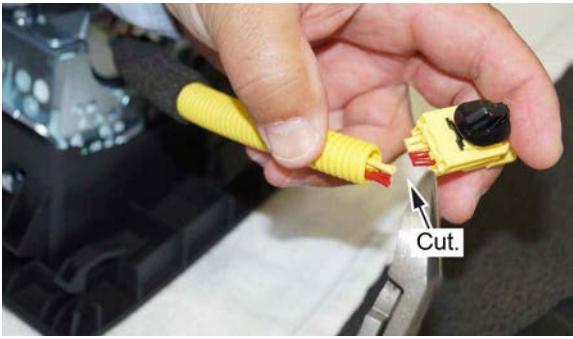
You must cut and short the wires as indicated to prevent accidental deployment.

- Cut all four wires to remove the connector.

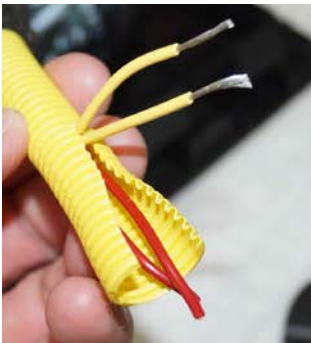
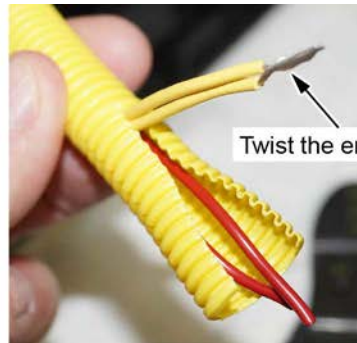
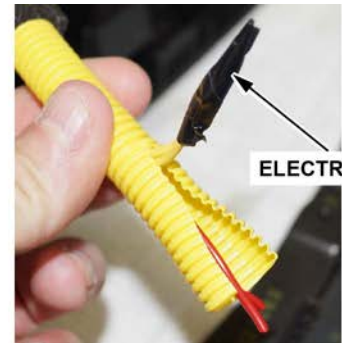
- Strip away about an inch of the wire insulation, then twist the wires together.

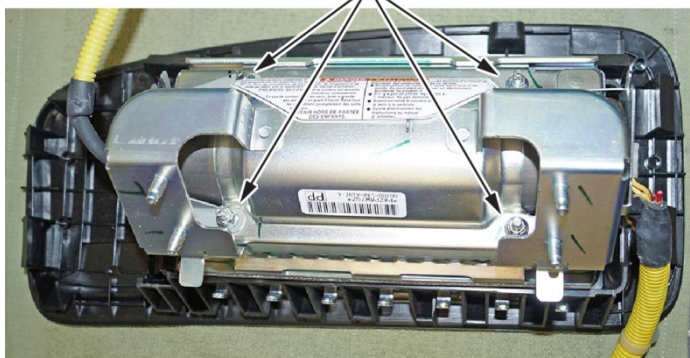
**INFLATOR NUTS**

8. Remove the four inflator nuts.

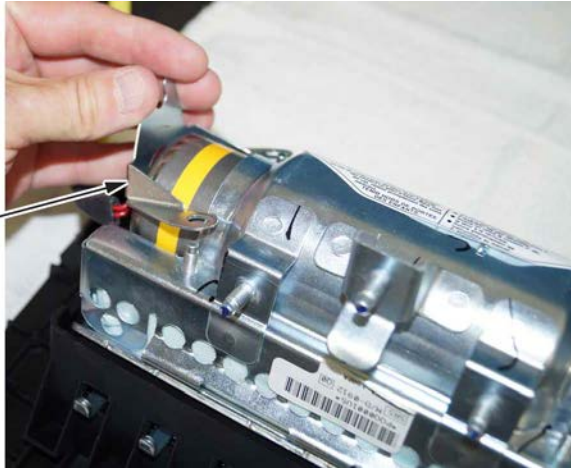
INFLATOR BRACKET

9. Remove the inflator bracket.

NOTE: You can only remove one of the brackets, as the other is welded to the airbag housing.

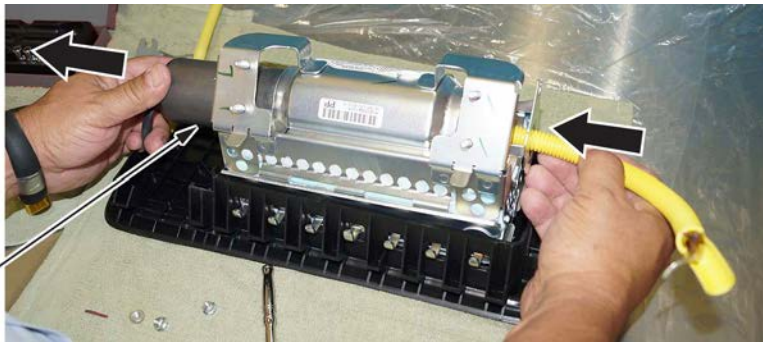
10. Remove the inflator by pushing it out.

INFLATOR  
Do not reuse.

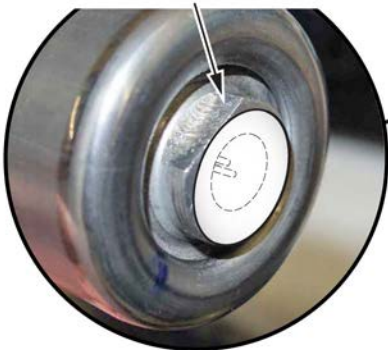
- One connector looks like a "D" whereas the other connector is a circle. Make sure you insert the "D" shaped terminal into the airbag first.

NOTE: There is a yellow band marking on the circle side.

D-SHAPED TERMINAL  
A white sticker covers the terminal.

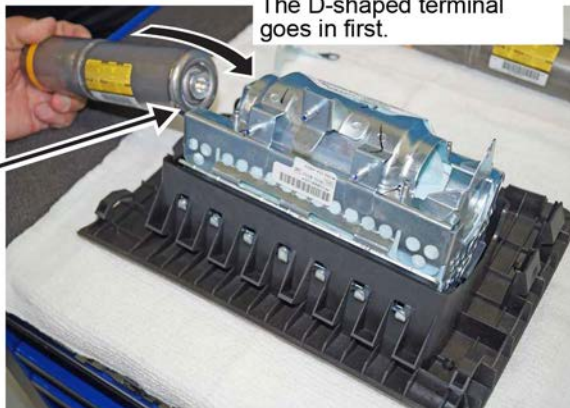
The D-shaped terminal  
goes in first.

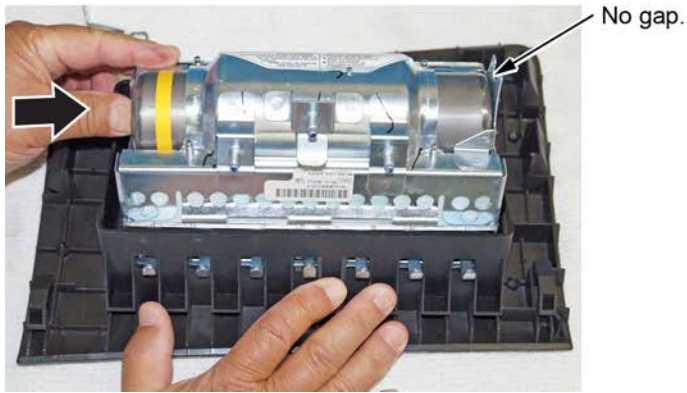
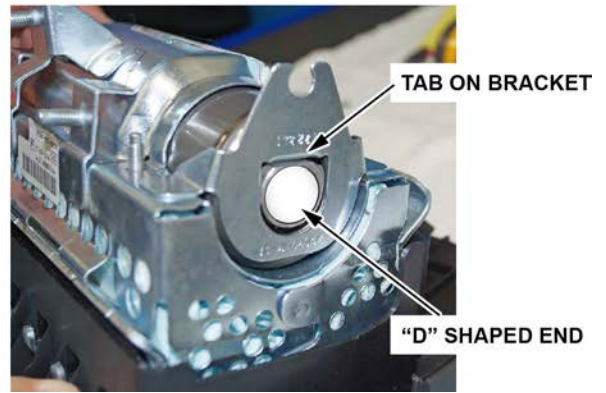
- Slide the inflator in until the “D” aligns with the tab on the inflator bracket. There should be no space or gap between the inflator and bracket.

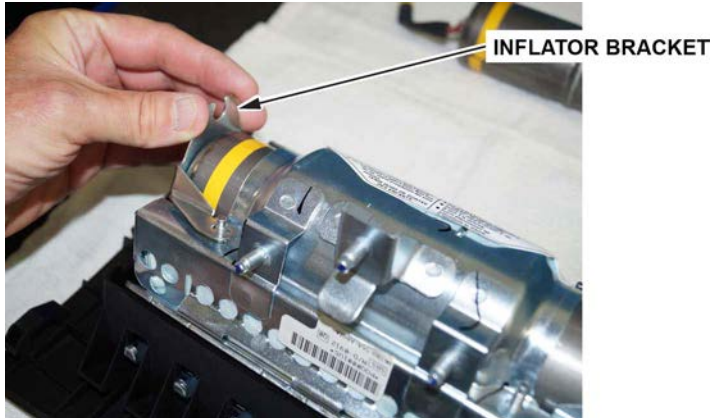
- Reinstall the inflator bracket. There should be no space or gap between the bracket and inflator.

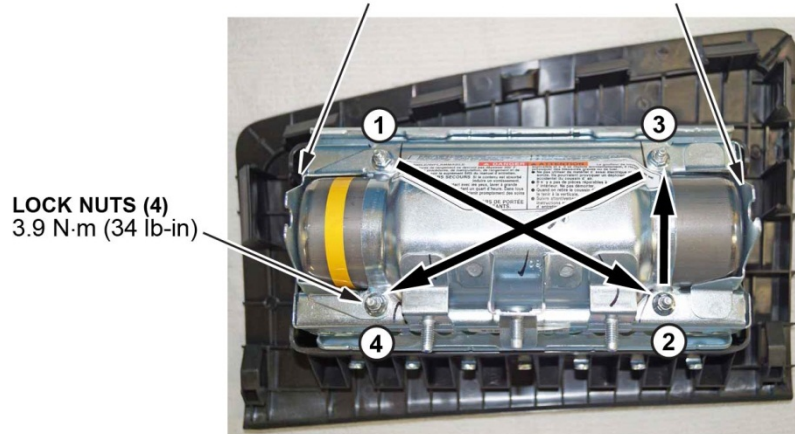
- Install the new 5 mm locknuts and torque them in sequence to **3.9 N•m (34 lb-in)**.  
Be sure there are no gaps between the inflator ends and the inflator brackets.

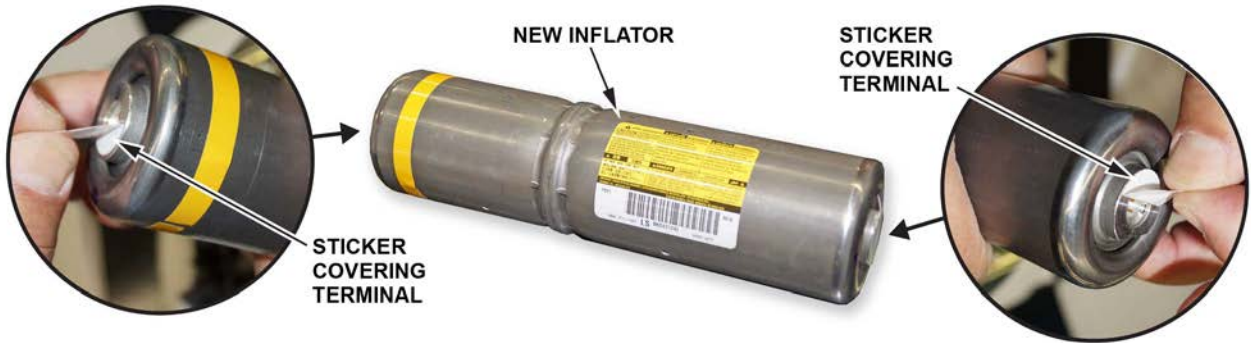
12. Remove the stickers covering the terminals on both sides of the new inflator.

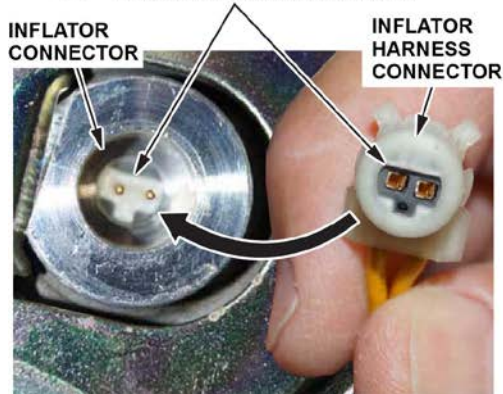
- Connect the two connectors. Align the "T" shape in the inflator harness connector with the T-shaped inflator connector, then press the connector into place.

① Match up the "T" shape as shown. The connectors are directional.

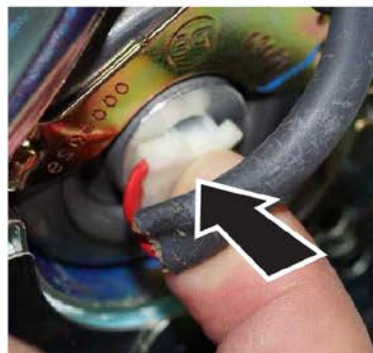
② Press the connector into place until it clicks.

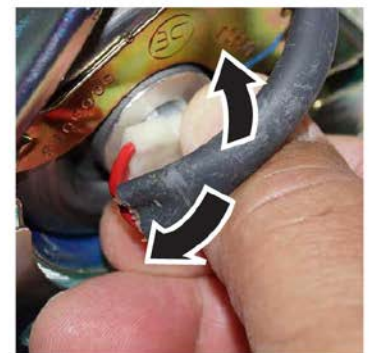
③ Wiggle the connector to make sure it's secure.

- After you hear each connector click, wiggle it to make sure it is secure.  
NOTE: If the connector is not properly aligned, it will come out.

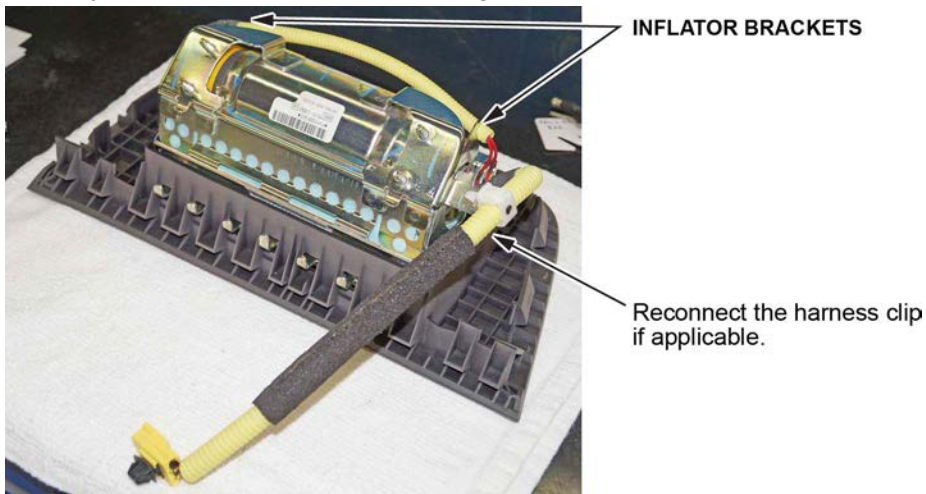
14. Connect the harness to the inflator brackets.

- Insert the side without the shrink-wrap tubing first. Insert the harness at the third “valley” in the corrugated tube.
- Insert the side of the harness with the shrink-wrap tubing into the inflator bracket. Make sure the harness is securely inserted and that it does not sag.
