April 14, 2015

46169-01677

## Safety Recall: Replacement Driver's Airbag Inflator Can Be Over-Pressurized

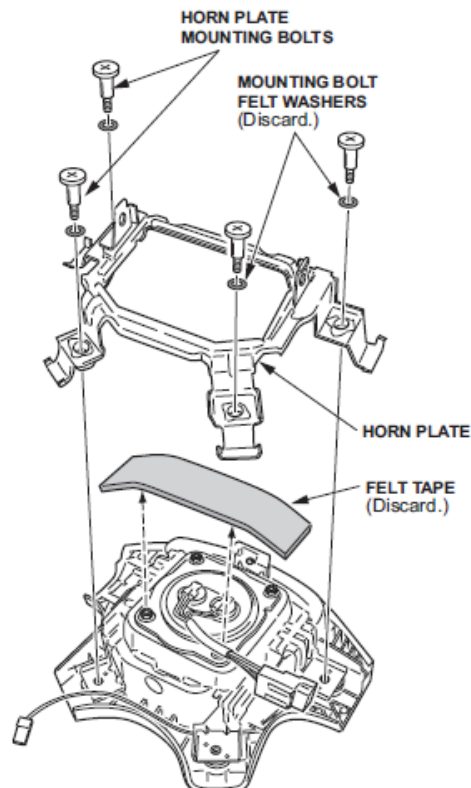
5. Remove the four horn plate mounting bolts, the mounting bolt felt washers, and the horn plate. The felt washers will not be reused.
