ATB 01724-01729 Version 2

## Recall: Driver's Airbag Inflator May Produce Excessive Pressure After Long-Term Exposure to High Absolute Humidity

Supersedes 15-022, dated March 20, 2015, to include parts and warranty information, and repair procedures

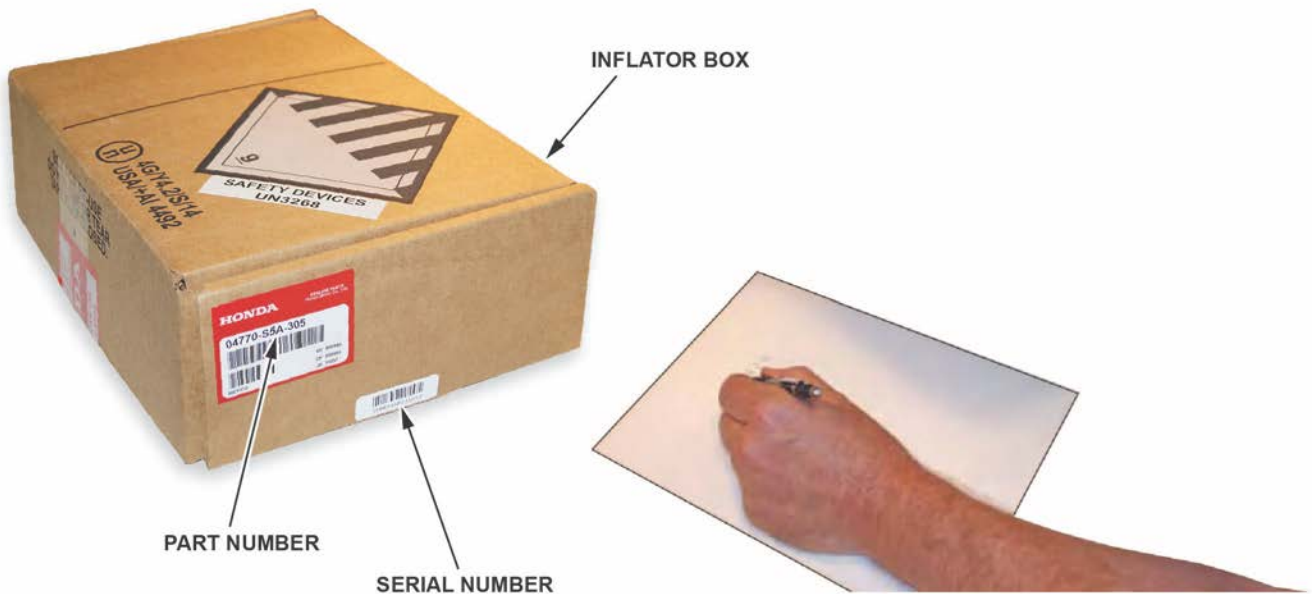
1. Remove the driver's airbag.
  2. Write down the serial number and part number located on the right side of the new inflator's box on the RO. For the warranty claim to be paid, your warranty clerk must enter the serial number in the Diagnostic Trouble Codes field on the warranty claim.

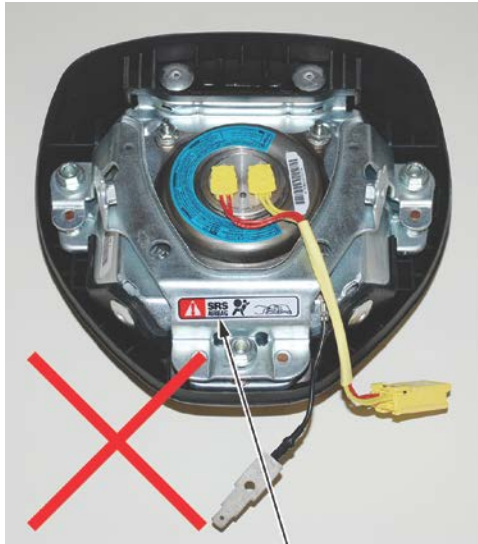
NON-STANDARD  
SAFETY LABEL

4. Visually inspect the airbag and the inflator for any unusual writing or markings.
  - If there is nothing unusual about the airbag or the inflator, go to step 5.
  - If there are any unusual markings, like an incorrect label or a model year written in marker, the airbag and inflator may not be the correct airbag and/or inflator for the vehicle or it may be a counterfeit part. For more information about counterfeit airbags, you can refer to [safercar.gov](http://safercar.gov), enter keywords **MANAGING COUNTERFEIT**, and select **Recommended Dealer Guidance for Managing Counterfeit Air Bags** from the list. **If you suspect that the airbag or inflator is counterfeit, do not continue this procedure.** Contact your DPSM for assistance.

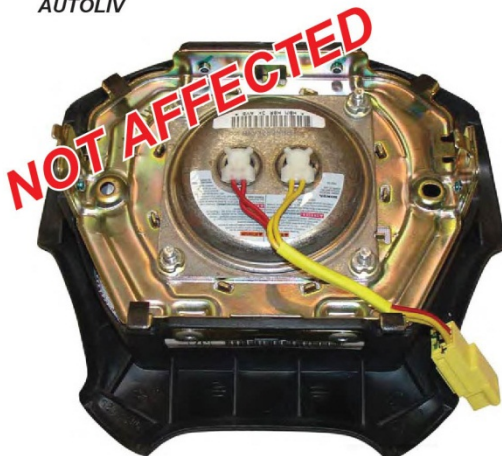
AUTOLIV

5. **Civic only** - Determine if the airbag is made by Autoliv or Takata by comparing the inflators to those in the images below.

NOTE: The Autoliv serial number label is different from the Takata label; the Autoliv has 11 characters, the Takata has 9.

- If the airbag is made by Autoliv, the airbag is OK. Reinstall the airbag using new Torx bolts. Torque the bolts to **9.8 N·m (7.2 lb-ft)**. If you already received a replacement inflator, return the unopened kit to American Honda.
- If the airbag is made by Takata, go to step 6.

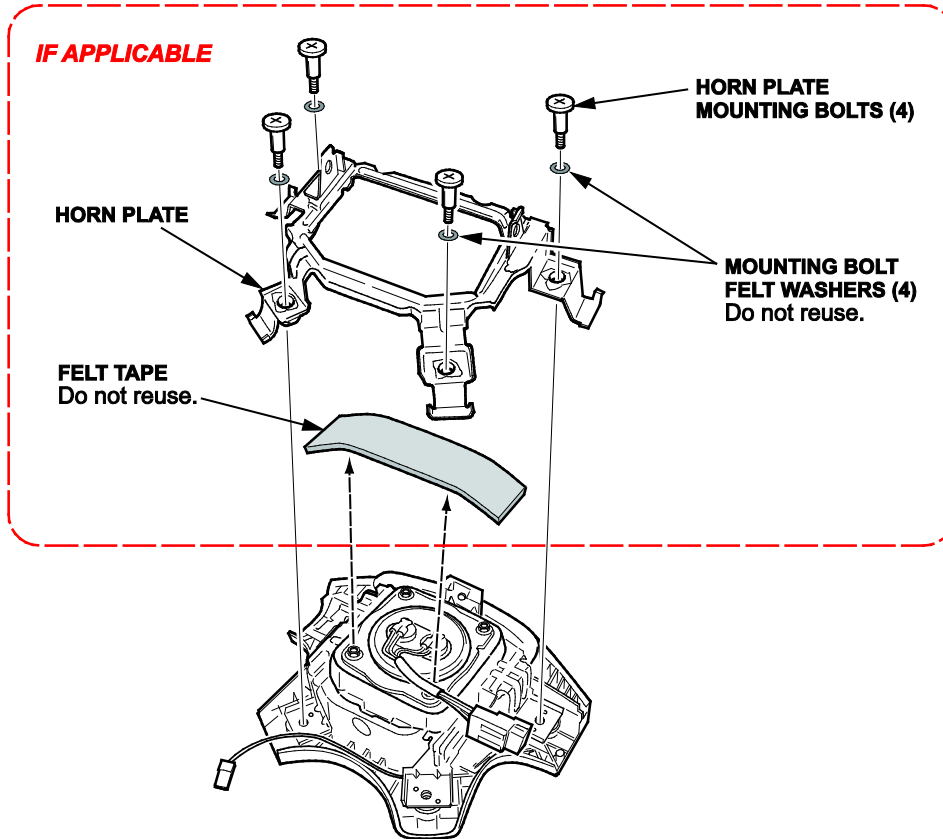
6. If there is no horn plate installed, go to step 7. If there is a horn plate installed, remove the four horn plate mounting bolts, the mounting bolt felt washers, the horn plate, and remove the felt tape covering the lower two inflator locknuts. The felt washers and felt tape will not be reused.

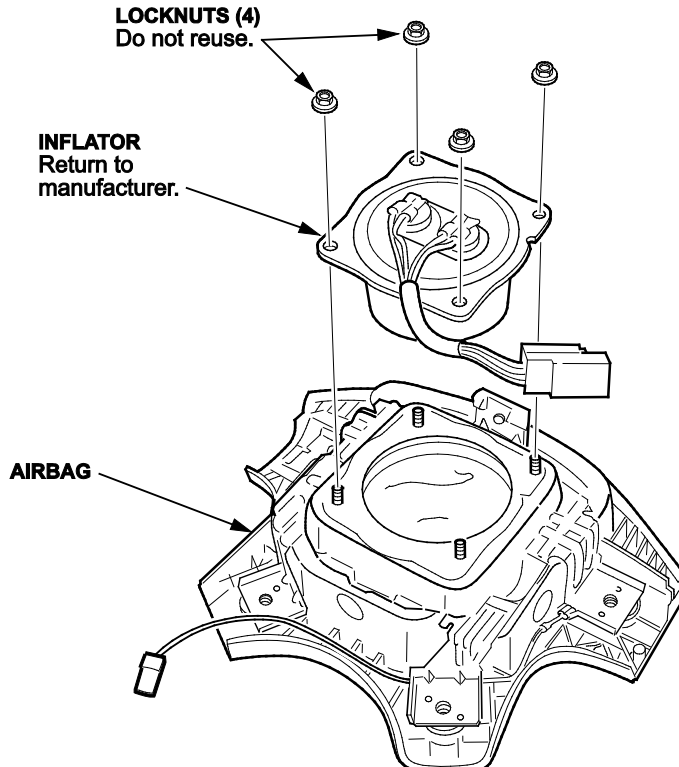
7. Using needle-nose vise grips or a 3/8 in. 6-point socket, remove the four locknuts from the inflator. The locknuts will not be reused.

NOTE: Do not remove the inflator from the airbag until you complete step 8.

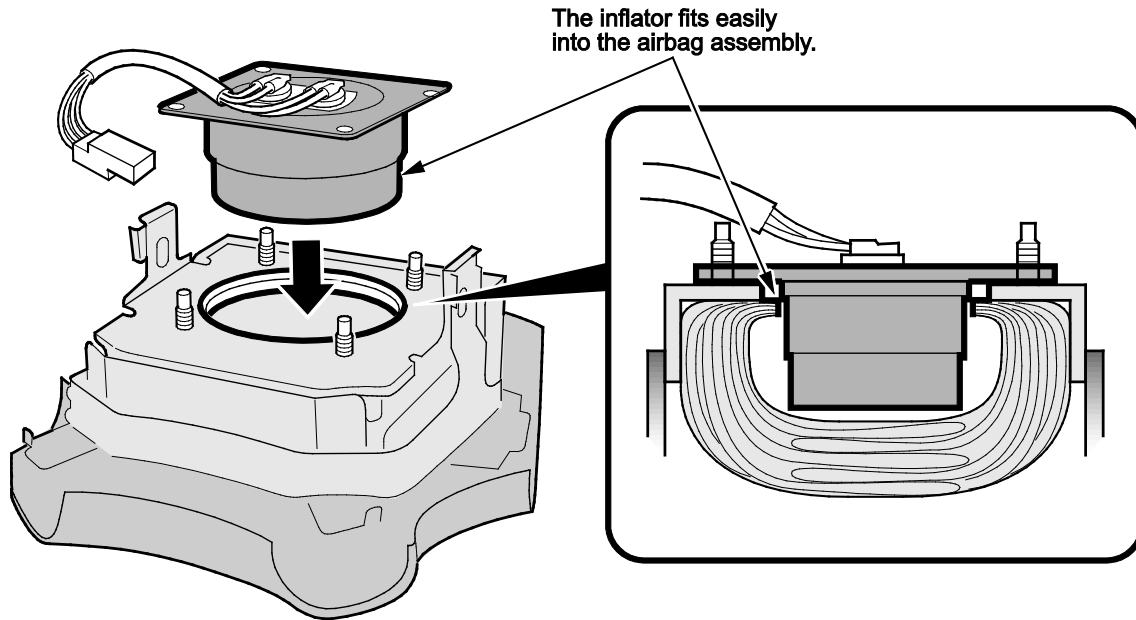
10. Install the new inflator in the airbag.

NOTE: There may be some minor surface rust or corrosion on the new inflator; this is OK.

11. Install and torque the new locknuts to **3.9 N·m (2.8 lb-ft, 34 lb-in)**.
12. If applicable, cover the lower two inflator locknuts with new felt tape.
13. If applicable, reinstall the horn plate with new felt washers on its mounting bolts. Torque the mounting bolts to **3.4 N·m (2.5 lb-ft, 30 lb-in)**, then make sure the horn plate moves freely.
14. Reinstall the driver's airbag using new Torx bolts and torque the bolts to **9.8 N·m (7.2 lb-ft)**.
15. Give your warranty clerk the inflator serial number and part number you wrote down in step 2. For the warranty claim to be paid, your warranty clerk must enter the serial number in the Diagnostic Trouble Codes field on the warranty claim.
