**NABI: BRT: Adjustable Pedal Assembly and Air Vent Clearance
Inspection**

Issue: Inspection for clearance between accelerator pedal and air vent nozzle.

Reason: Air vent nozzle should not interfere with the pedal assembly in any position

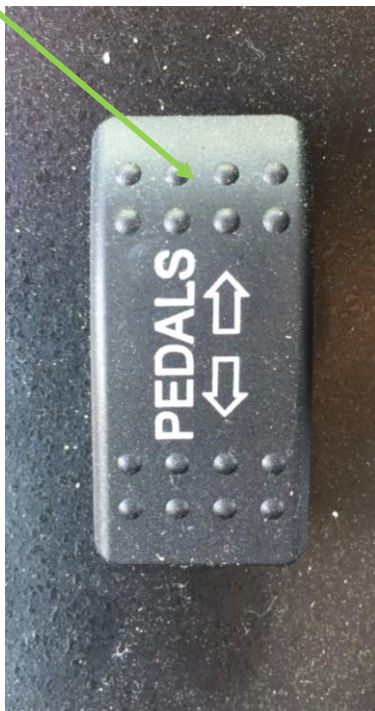
Use control button on dash to move pedal assembly all the way forward.

1. Park bus on a flat surface and apply the parking brake.
2. By using the control button on the dash, move pedal assembly all the way forward.

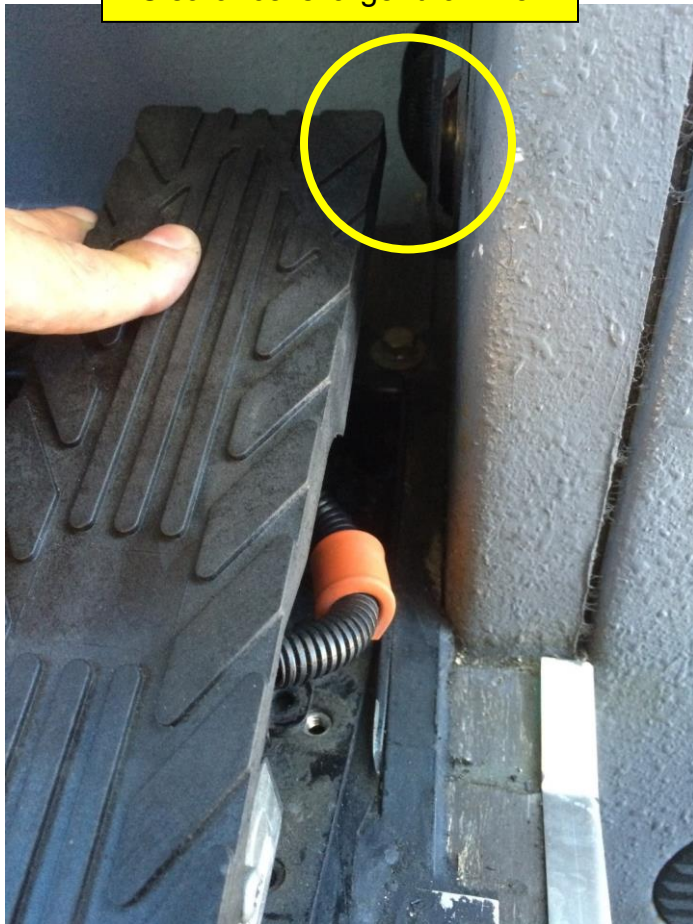
Clearance is larger than $1/8$ "

4. Push the accelerator pedal all the way down and check for clearance between the pedal and the air vent. Mark the appropriate column beside the inspected bus number on the attached matrix whether the clearance is $1/8$ " or larger or the clearance is smaller than $1/8$ ". Send the completed inspection matrix back to the following person:

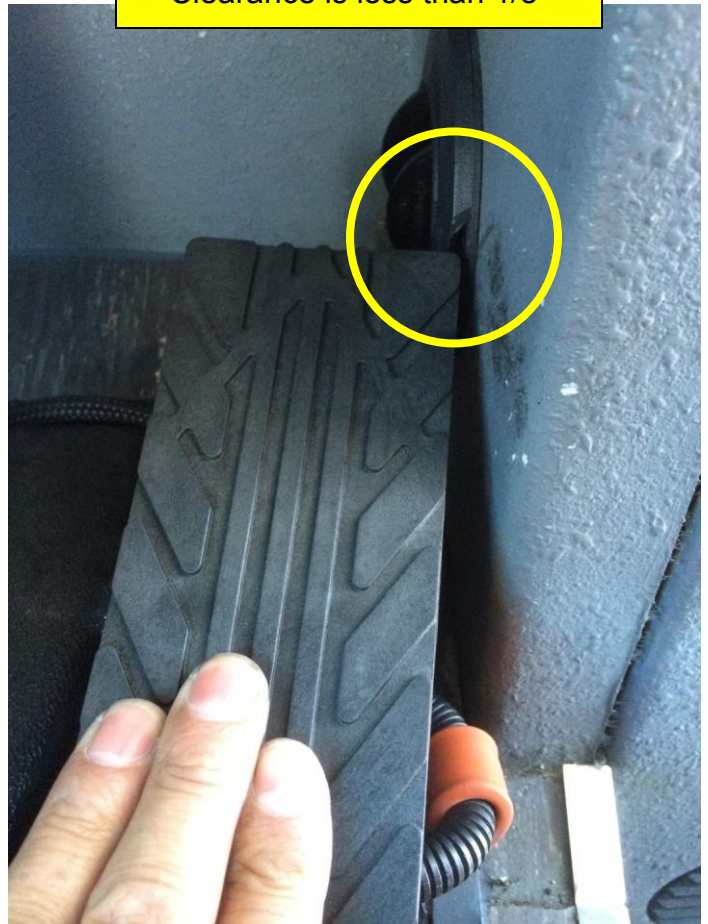
Clearance is less than $1/8$ "
