NJT – Emergency Exit Plaque Relocation

Property and TopBus Number:
NABI 305000 – 1601 - 1639

Issue: Customer requested relocation of window emergency exit instruction placard.

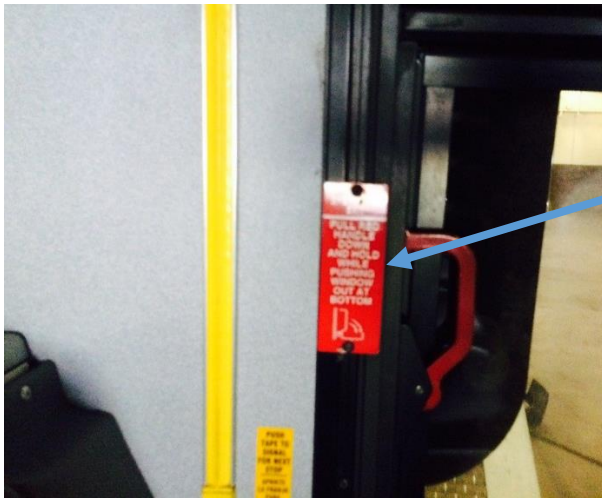
1. Park the bus on level surface and apply parking brake. Turn engine off.
2. Locate the rear street side emergency exit plaque that is mounted to the window frame (see below).

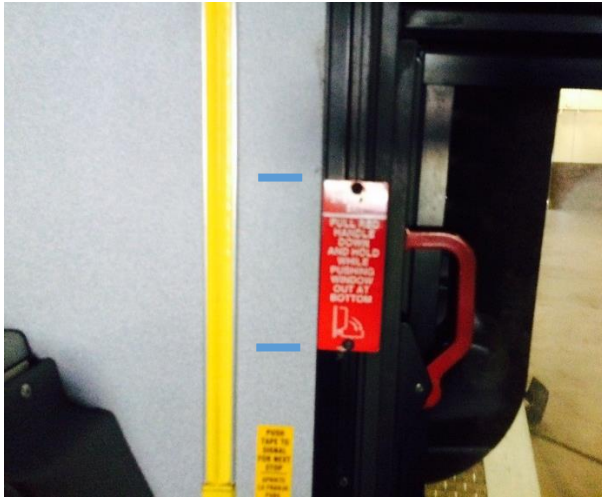
3. Mark on the wall adjacent to the window frame where the plate will be relocated using the same positioning that it is currently in & centered between touch tape & window frame (see below).

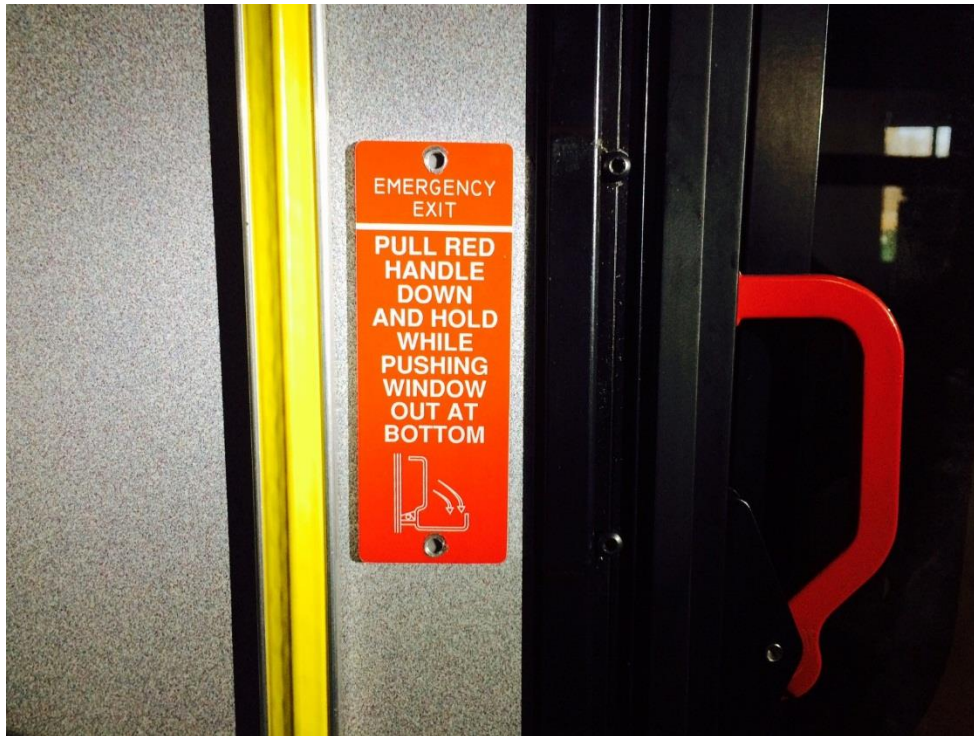
4. Remove the plaque from the window frame & reinstall the existing screws back to the window frame.
5. Clean the wall & the back of the plaque with alcohol.
6. Apply approximately 6" of VHB tape to the backside of the plaque.
7. Place plaque to the location marked in step 3 & press firmly for 1 minute.
8. See below for final installation.
