**NABI: MATA - Underseat Heater Gasket Replacement**

**Property and TopBus Number:**  
WMATA 325000 & 325500 – 8001 thru 8105.

**Issue:** Under seat heater gasket

**Solution:** Replace foam gasket with bulb seal gasket

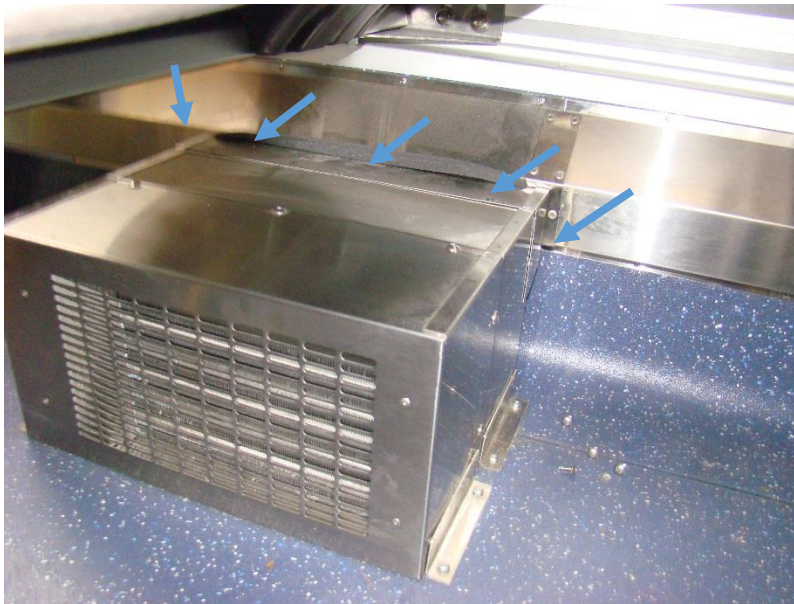
3. Remove the five screws that fasten the duct bracket of the under seat heater (see below).

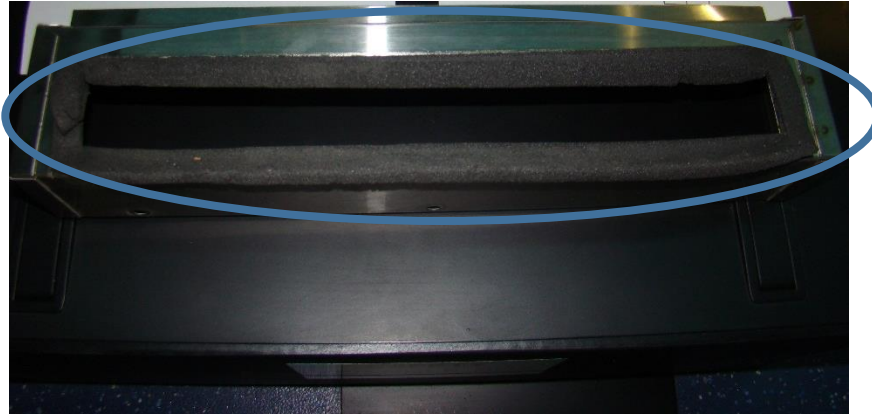
4. Remove existing foam seal using a scraper and discard foam seal (see below).

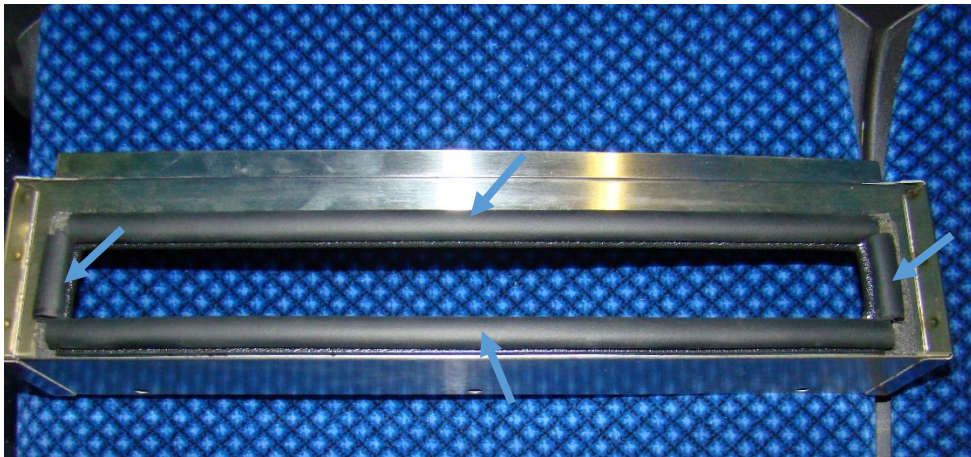
5. Install McMaster Carr PN: 1120A223 seal to the duct bracket as shown below (see below).

6. Reinstall the bracket to its original position and tighten the hardware securely.
7. Repeat process for the street side under seat heater.
8. Clean up any debris caused by performing this retrofit.
9. Record bus number, mileage and date of completion; return form to Field Service Manager
