DART Coolant Valve Replacement

Property name and Top bus number: DART 304500 – 306500 – 313000 – 314000 - 323000

Issue: Cummins coolant valve leaking at coolant filter

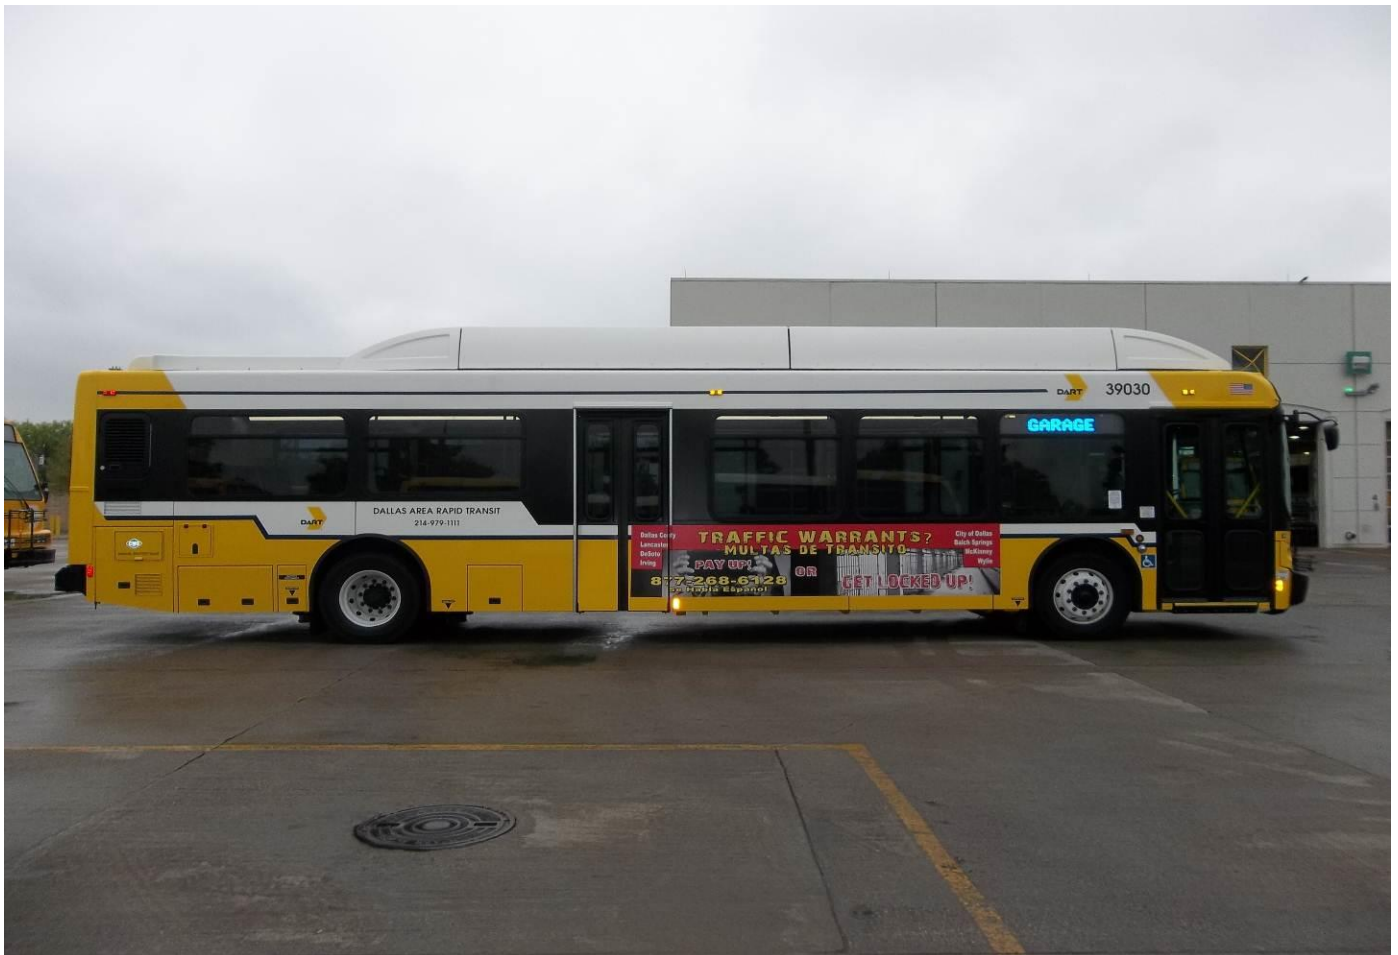
Reason/ cause: Original Cummins coolant valve located at the coolant filter on the engine may develop leaks after a period of time.

Solution: Replace coolant valve at coolant filter.

1. **Park the bus and apply the parking brake.**
2. **Turn off main battery disconnect switch(es)**
3. **In the rear of the bus on the left side of the engine you will see the coolant filter.**

4. **Pinch off water lines to the filter head with 2 pairs of hose clamp pliers.**
5. **Remove hose clamps and pull hoses of existing valve.**
6. **Remove the 4 bolts from the top of the water filter head and remove.**

7. **Put the filter head in a vice.**
8. **Remove the water valve.**
9. **Apply pipe sealer to valve pipe threads and hose barb pipe threads.**
10. **Install new style water valve and hose barb.**

11. **Install filter head and tighten to 212 inch LBS.**
12. **Install new hose clamps on lines and put lines on the valve.**
13. **Tighten hose clamps until snug.**
