## INSTRUCTION TO SERVICE

**ITS: 6019**

<b>SECTION:</b>	294 Power Cables
<b>WRITTEN BY:</b>	K. Baziuk
<b>SUBJECT:</b>	Inspect and Repair HV Wiring Connections.

## PROCEDURE: Inspect and Repair.

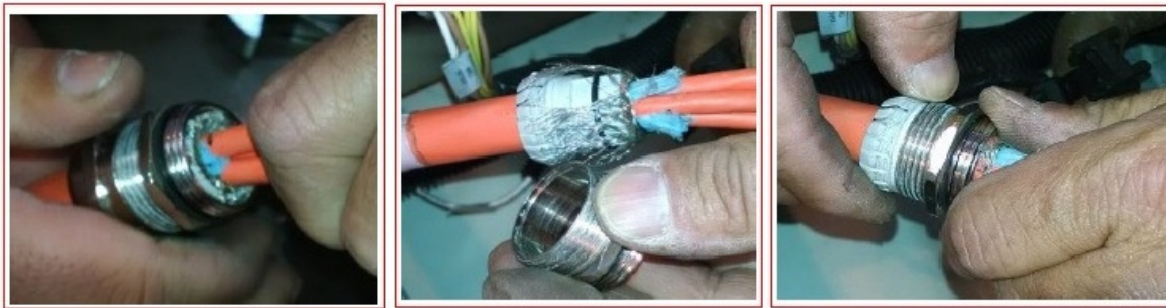
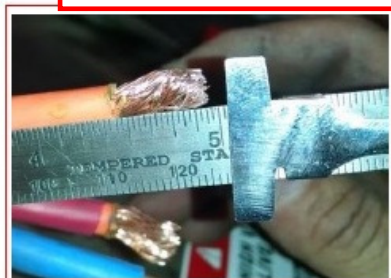
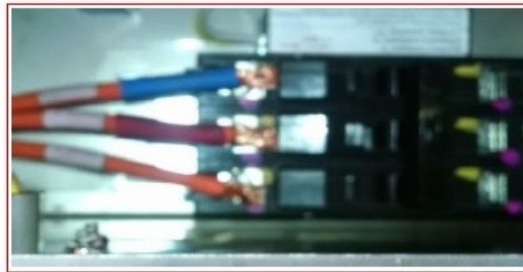
**Repositioning the cable in the sealed cable gland assembly.**

**Measure exposed wire end after Repair for installation**

**Completed Repair after rework.**

**Figure 6. Cable Rework at the HV Junction Box Side.**

3. Open HV Junction box and proceed to inspect connections for either no ferrules, loose wire strands, insufficient wire contact or tightness of strain relief at both 70A circuit breaker load side and 50A contactor. Refer to Figure 2 and 3 for details.
4. Repair connection to each phase wire as necessary depending on what defect is found.
5. If no ferrule is found; use a suitable crimper, attach a ferrule to each phase end. Ensure the wire end is cut to the required **0.50 inch**. If the cable is not at the correct length within the HV junction box, proceed to rework the cable end by cutting back the insulation on the 3 phase cable approximately 0.5 to 0.75 inch. Reposition the cable in the sealed cable gland. Refer to Figure 6. **The internal length of cable as per NF print, PN:**

**NOTE:** Ensure that the finished length of cable has a smooth radius into the enclosures.
