**DART: Rear CNG Roof Cradle Cap Adjustment and**  
**Securement**

**Property name and Top bus number:** DART 304500 – 313000 - 323000

**Issue:** CNG end cap fiberglass cover may rub on roof panel. Rear CNG cradle fiberglass end cap may contact roof panel and cause abrasion to roof panel.

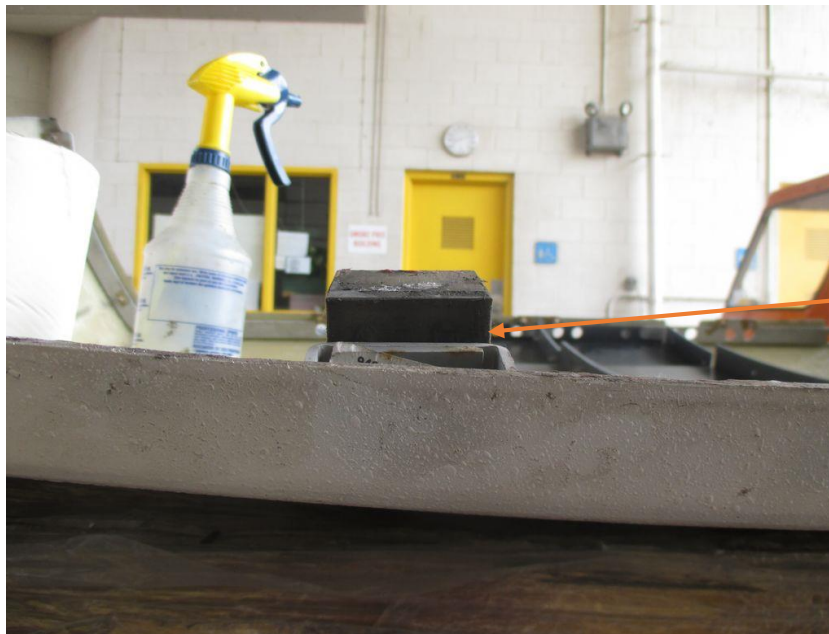
Cleat adjusted properly.

1. Turn off main battery disconnect switch(es)
2. On the roof of the bus open the rear CNG doors. ***Follow all safety rules and requirements when working on the roof. Use safety cable, appropriate scaffolding and a helper who is watching and helping while others are working on the roof. Ensure that nobody can move the bus while work is in process on the roof. See NABI Maintenance Manuals for more details.***
3. With a 7/16 inch wrench remove the 14 bolts that hold the cradle cap in place.
4. If the cradle cap is coming in contact with the roof of the bus mark it so it can be trimmed.
5. Push the cap forward for 6" before trying to pick it up.
6. With the cradle cap loose turn it over and adjust the cleat to the top of the adjustment. Then drill a 3/16" hole in the middle of the two existing bolts. Put a screw with a flat washer on each side and a nylock nut.

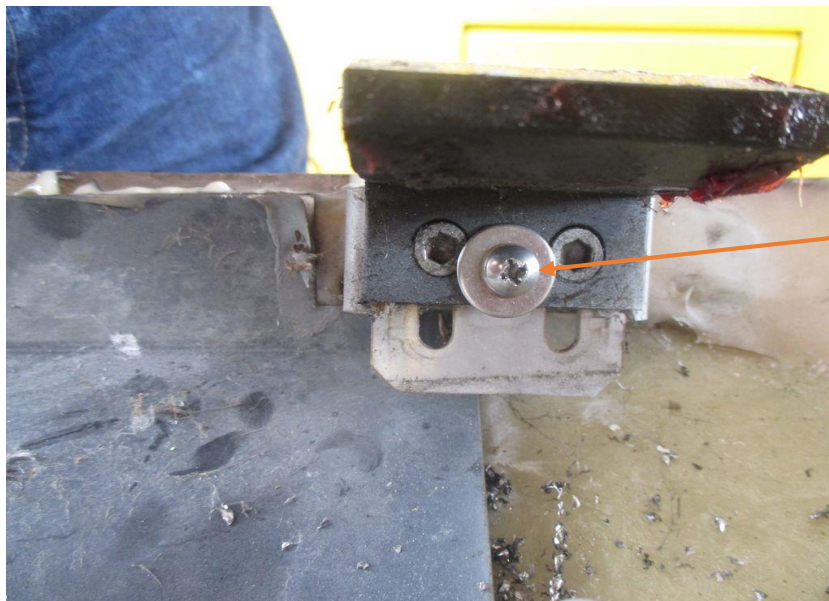
New screw  
added.
