NJT – Air Bag Support Wax Application

Issue: Front axle suspension air bag support corrosion protection.

Reason/ cause: Air bag support not treated with cavity protection during production

Solution: Apply wax to the air bag support cavity & inspect with bore scope per this work instruction

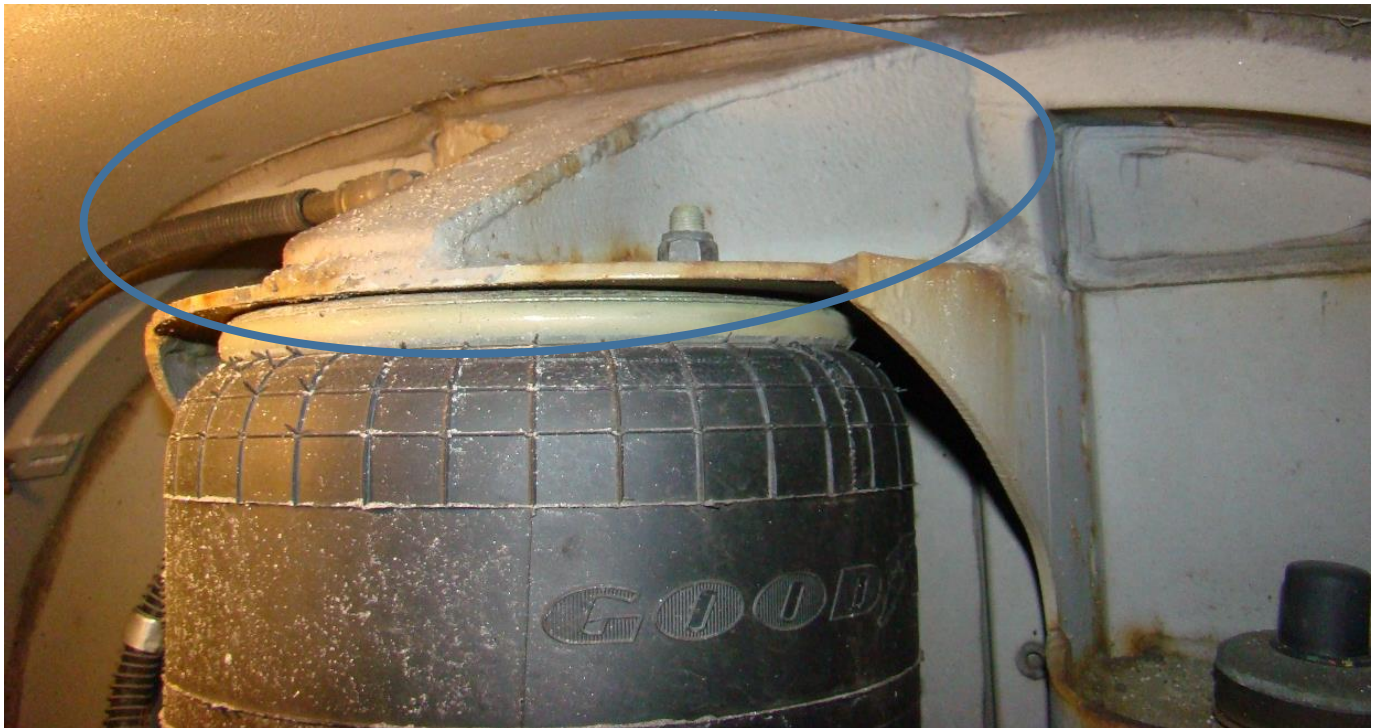
1. Park the bus on level surface and apply parking brake.
2. Turn the wheels to the left to access the curbside air bag support (see below).

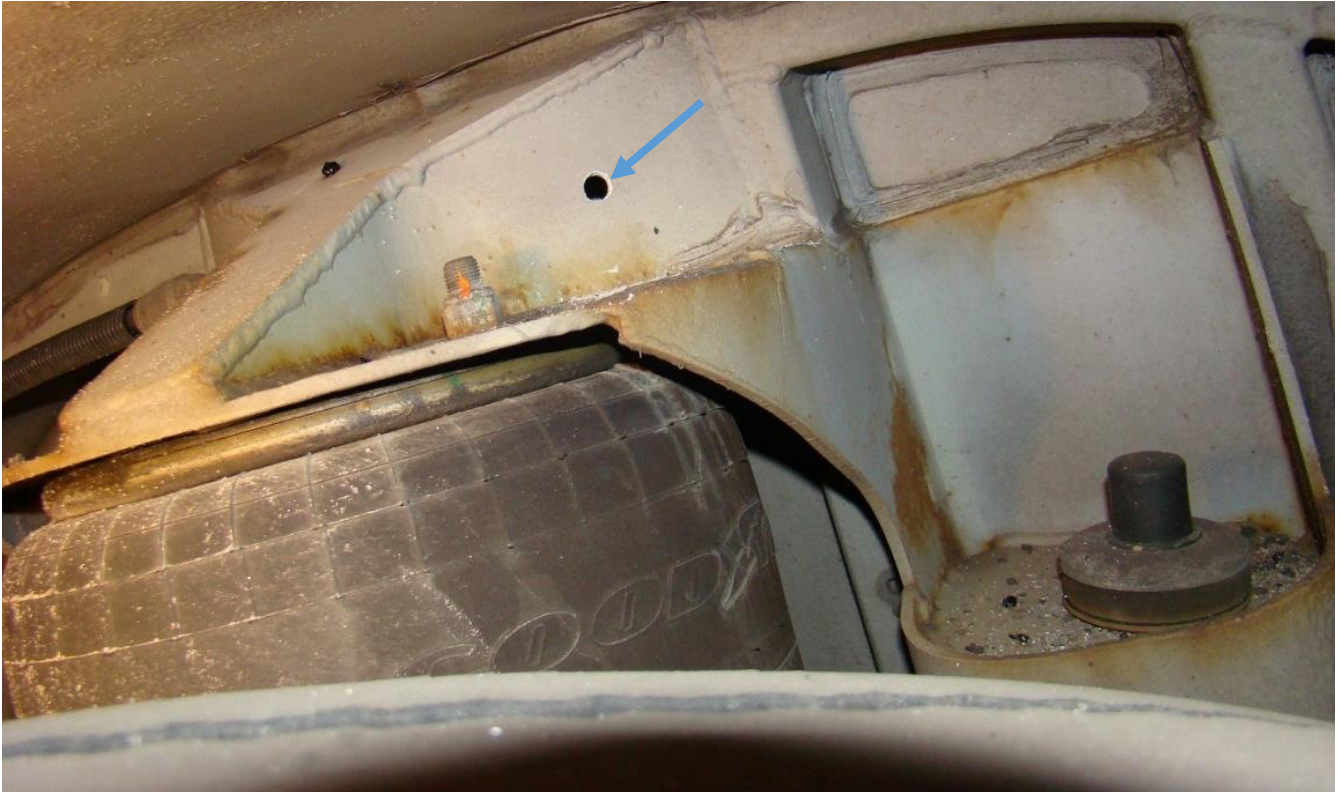
4. Drill a 10mm hole at the location shown below (see below).

5. Insert bore scope into cavity thru the hole drilled in step 3. Document corrosion if present both on paper & by photograph using the bore scope. Document any external corrosion on paper only, photographs not required for external corrosion.
NOTE: If NO corrosion present, documenting by photograph using the bore scope is required for future reference if needed.
6. Apply cavity protection to the inside of the air bag support using the 10mm hole drilled in step 3 to insert the application wand.
