TECHNICAL SERVICE BULLETIN

DATE ISSUED	MODEL YEAR(S) AFFECTED	TSB #
04/14/2015	2014-2015	TSB 414 Recall # 15V-061

RSB15-330-001

SUBJECT: Meritor Wabco – Double Check Quick Release Valve.

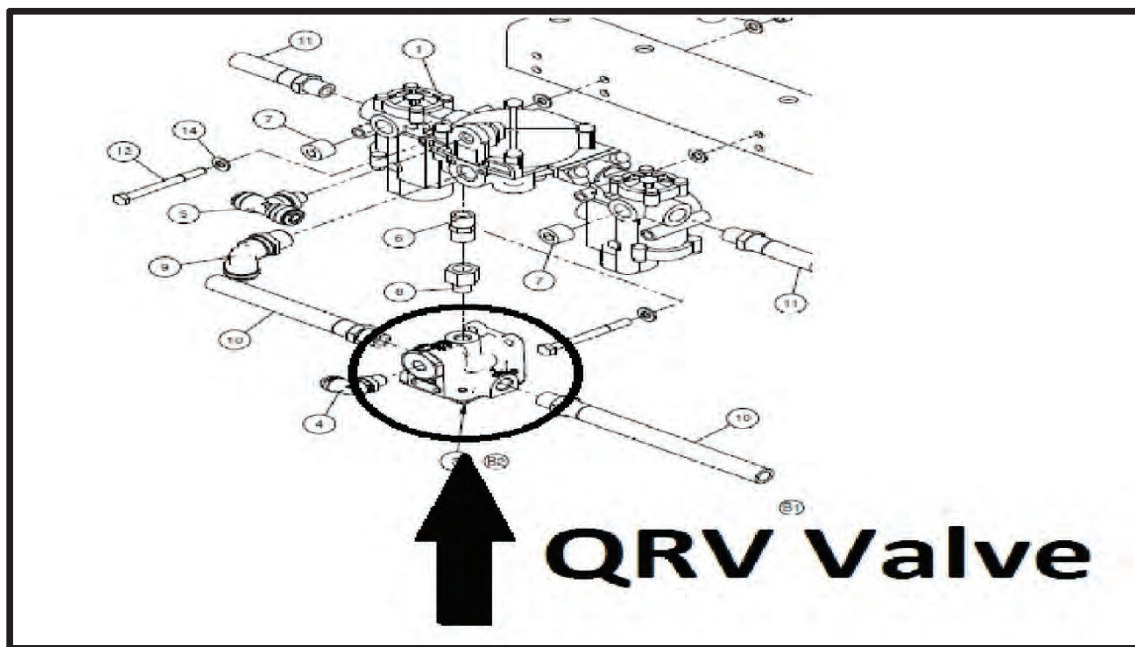
FIG. 2-1

- Drain system air pressure by pulling air tank lanyards or pumping the air brake pedal.
- Locate QRDC valve. QRDC valve is attached to the drive axle ABS modulator assembly mounted to the cross member in front of the drive axle. Refer to FIG. 2-1.

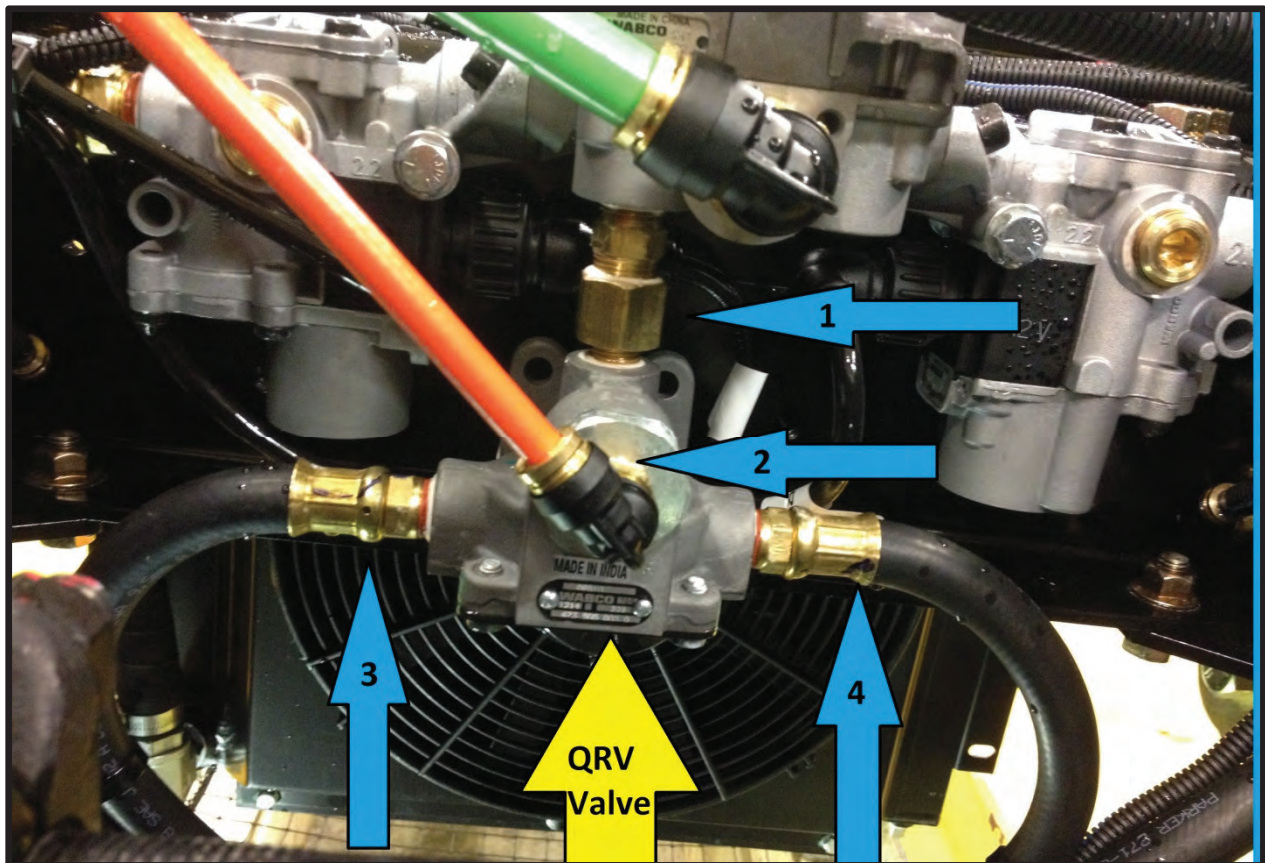
- Using FIG. 3-1 as a guide remove save the following:
 - Brake chamber drop hoses (labeled 3 and 4).
 - Cut cable ties holding ABS sensor cable to drop hoses.
 - Loosen and remove drop hose from brake chamber on both sides (this allows the hose to spin out of the QRDC valve).
 - Loosen and remove the drop hoses from the QRDC valve.
 - Park brake supply line and fitting (labeled 2).
 - Keep orange airline seated in fitting and remove fitting from QRDC valve.
 - ABS to QRDC connect fitting (labeled 1).

- Using an end wrench spin out the QRDC valve from the ABS modulator body (retain brass fittings for new QRDC valve).
4. Install new provided QRDC valve in reverse order, apply 81801 pipe sealer w/Teflon or equivalent to drop hoses, park brake supply fitting and ABS modulator to QRDC valve fitting threads on the first five threads from end.
 5. Run coach to build up system air pressure and check for the following:
 - Park brake operation.
 - Leaks at the QRDC valve.
