Instrument Panel (Dashboard) Sticky/Melting/Cracked

Service Category Vehicle Interior

Section Interior Panels/Trim

Certain 2003 – 2011 model year Toyota vehicles may exhibit a condition where the instrument panel pad (dashboard) becomes cracked and/or has a shiny/degraded appearance. The pad surface may also become sticky or adherent. Follow the procedure in this bulletin to address this condition.

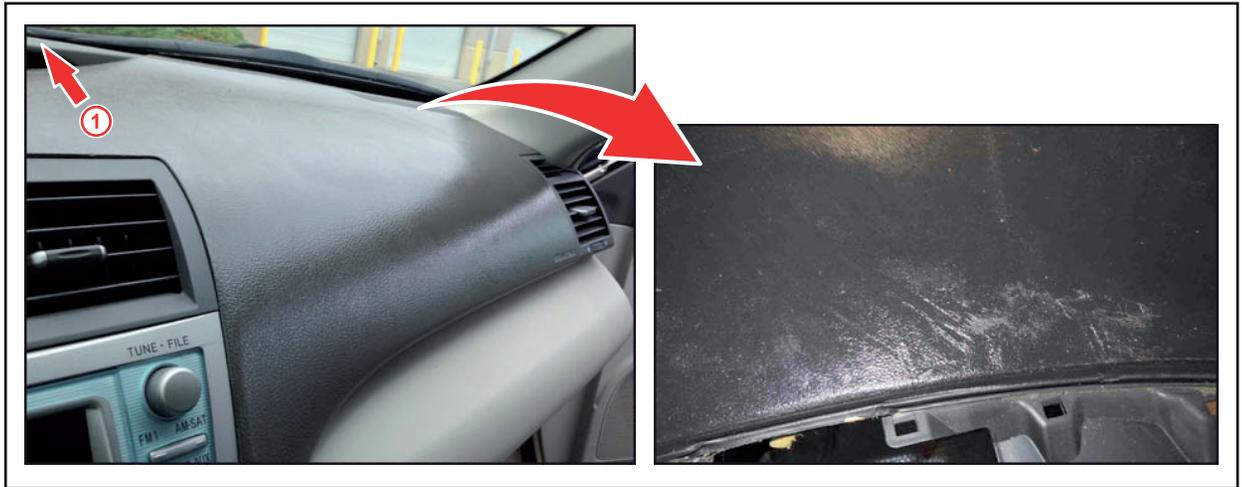
Figure 1. Example of Sticky/Shiny Condition

1	Front of Vehicle
----------	------------------

1. Confirm the dashboard exhibits the cracked and/or sticky and/or shiny appearance condition.
 - Refer to Figures 1 – 3 for examples of these conditions.
 - Refer to the Flow Chart (Figure 4) to help confirm applicable vehicles with the sticky/shiny condition, then proceed to step 2.

5. Replace the Instrument Panel Safety Pad Sub-assembly.

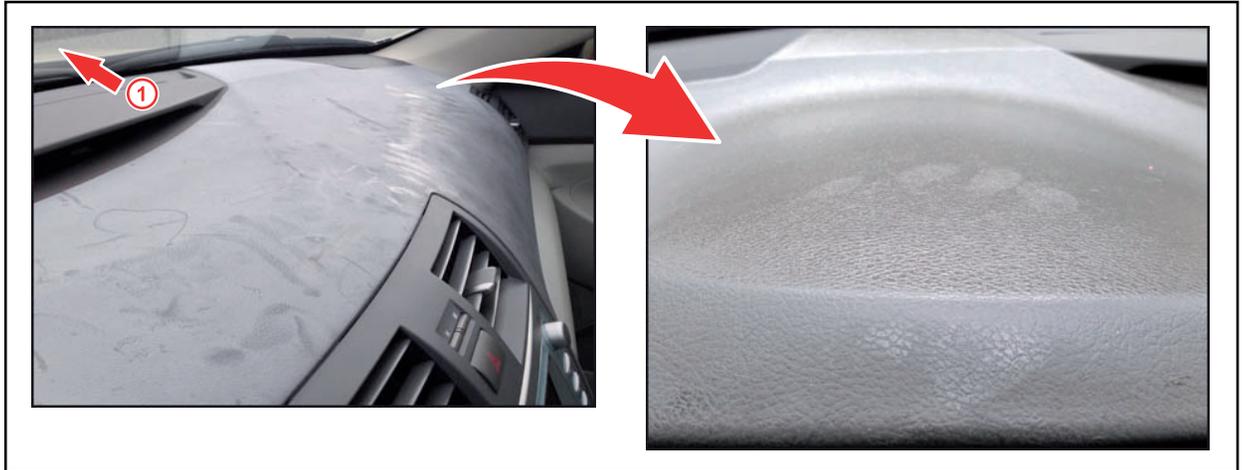
Figure 2. Example of Chalky Condition (Becomes Sticky/Shiny in Heat)

NOTE
 When a vehicle with a sticky/shiny dashboard is parked out of heat and humidity for more than a few hours, the dashboard surface becomes chalky. Once the vehicle is exposed to heat again, the sticky/shiny condition returns.

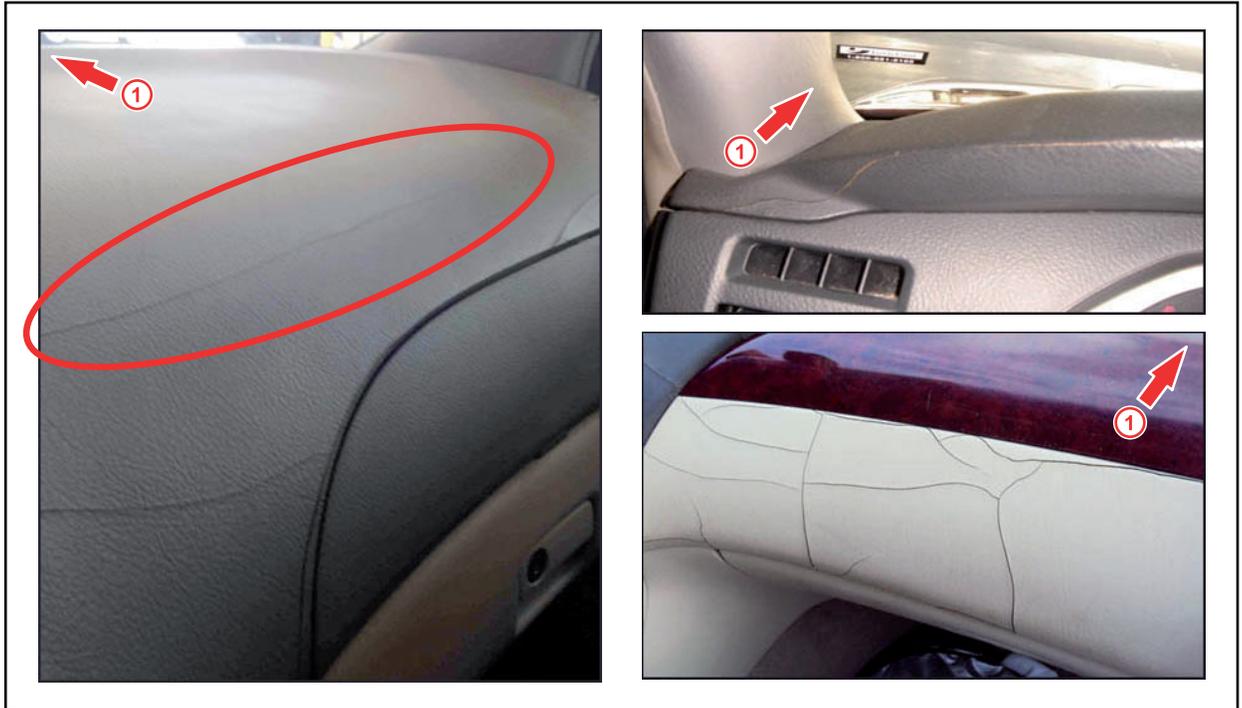
Figure 3. Examples of Cracked Condition

1	Front of Vehicle
---	------------------

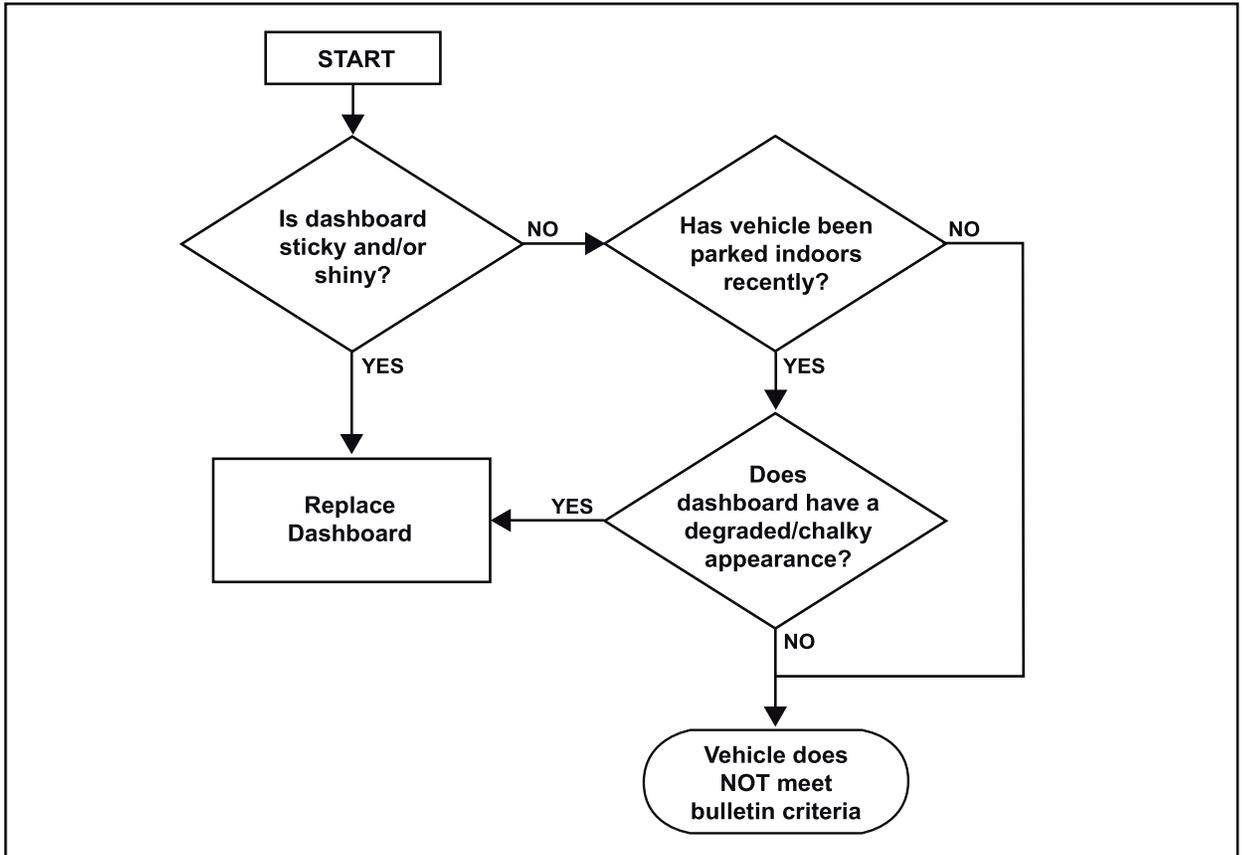
Figure 4. Flow Chart for Vehicles with Sticky/Shiny Condition

- A dashboard can become sticky and/or shiny over time for a number of different reasons and under a number of different circumstances. The majority of vehicles subject to repair under this bulletin are most likely those that have been operated for extended periods in areas of high temperatures and high humidity.
- In some cases, a dashboard may appear shiny due to aftermarket interior dressing products.

2. Confirm the dashboard has a sticky/shiny and/or cracked condition.

If dashboard is cracked, go to step 5.

Is the dashboard sticky and/or shiny?

- **YES** — Go to step 5.
- **NO** — Go to step 3.

3. Has the vehicle been parked indoors recently?

- **YES** — Go to step 4.
- **NO** — This bulletin does NOT apply.

4. Does the dashboard have a degraded/chalky appearance?

- **YES** — Go to step 5.
- **NO** — This bulletin does NOT apply.
