# Outer Rear View Mirror Appearance

**Service Category** Vehicle Exterior

**Section** Mirror (ext)

## Introduction

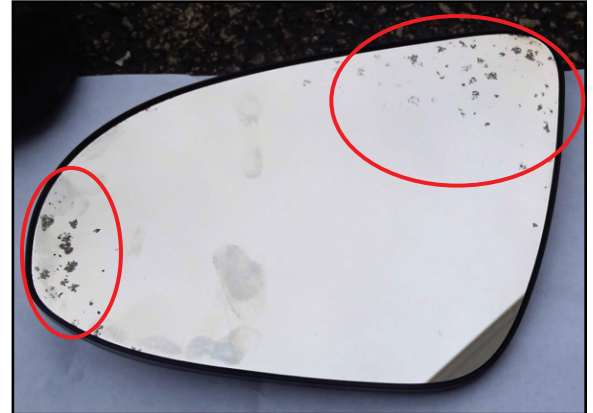
Figure 1.

Some 2014 model year Avalon, Avalon HV, Camry, Camry HV, and Sienna vehicles may exhibit the appearance of dark spots in the mirror glass reflective material. The mirror glass assembly has been updated to address this condition.

1. Does the reflective surface of the LH Outer Rear View Mirror have dark spots or appears that the reflective coating is peeling off?

2. Replace the mirror glass.
