TRD Pro Bumper/Fender Interference

Service Category Suspension

Section Tire/Wheel

Some 2015 model year TRD Pro Edition 4Runner vehicles may experience an abnormal noise when in reverse with the wheels at or near full lock due to interference between the tire and bumper, and/or fender liner. Follow the Repair Procedure in this bulletin to address this condition.

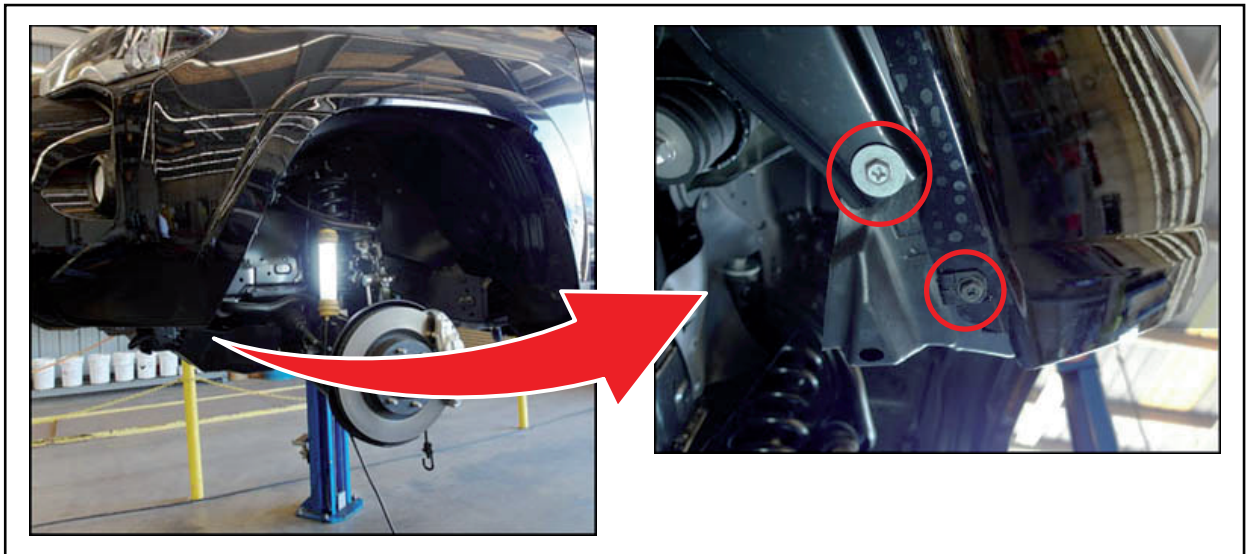
Figure 1.

1. Confirm the abnormal noise condition described in the Introduction.
2. Remove the front wheels.
3. Beginning with the driver side, remove the 2 fasteners on the lower side of the fender liner.

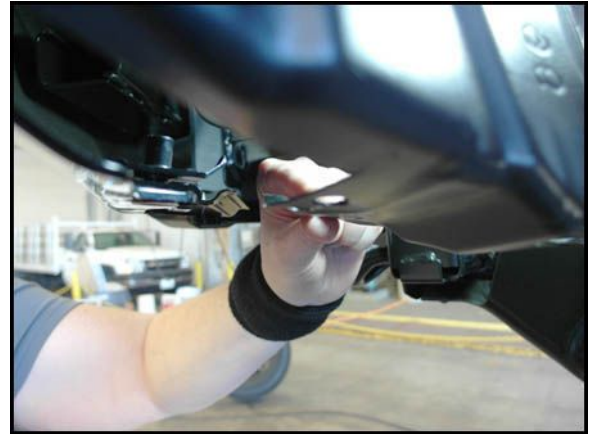
- Unclip the fender liner and carefully pull it towards the rear of the vehicle. **Figure 2.**

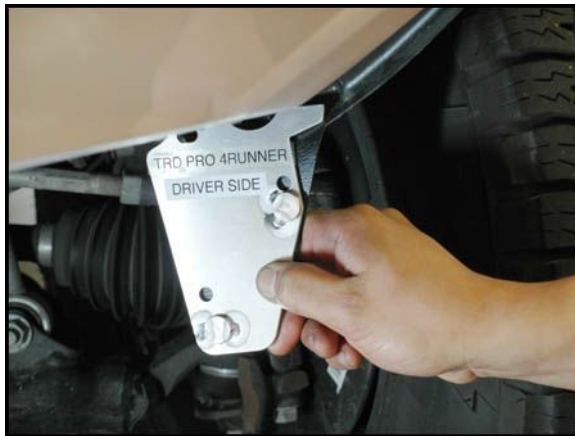
Figure 3.

- Install the driver side (LH) Metal Fender Liner Template (from the TRD Pro Trim Kit) on the front side of the fender liner.

Be sure to place the alignment pins into the 2 existing holes.

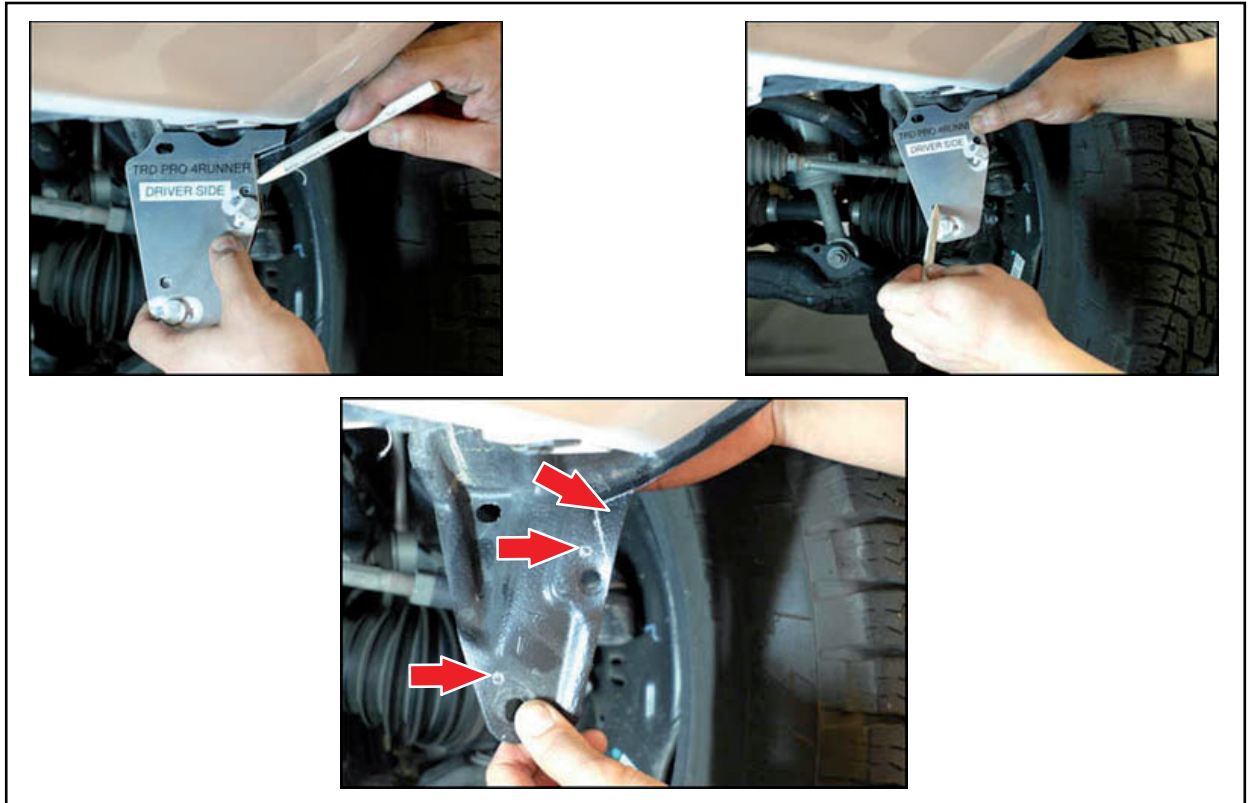
Figure 5.

6. Use a wax pencil to outline 2 new holes and the area to be removed.

7. Use a center punch to mark the center of the 2 holes, and remove the template.

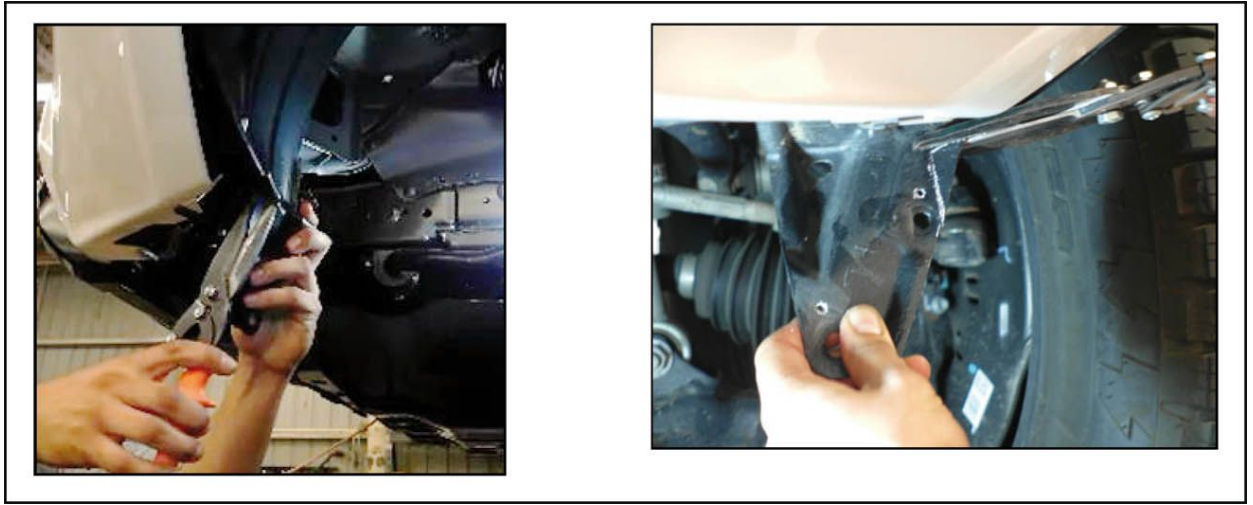
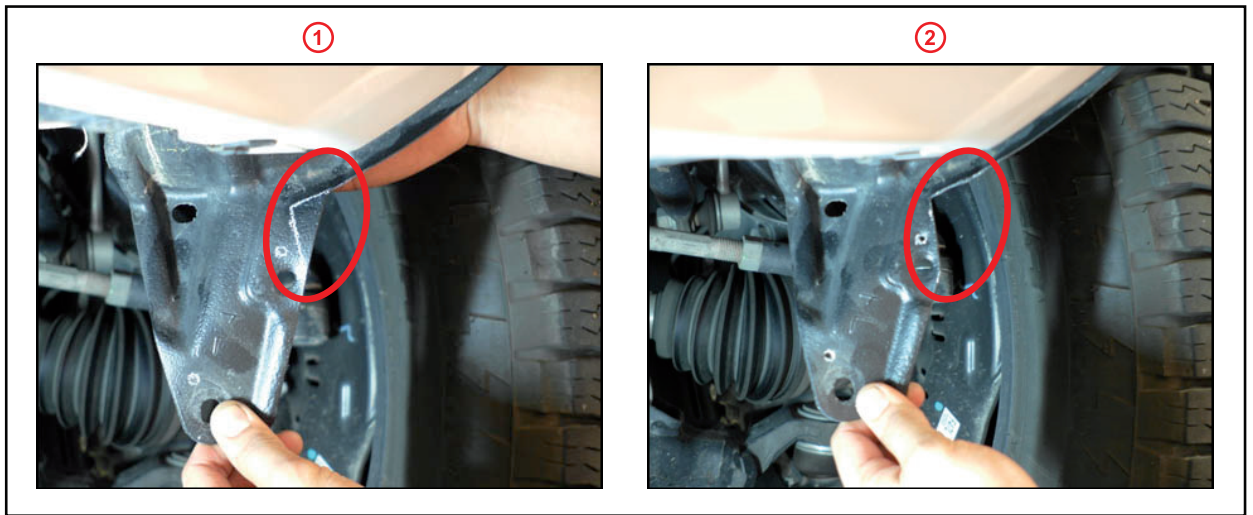
Figure 6.

- 8. Using cutters, remove the marked plastic area as shown.

1 Before Cut

2 After Cut

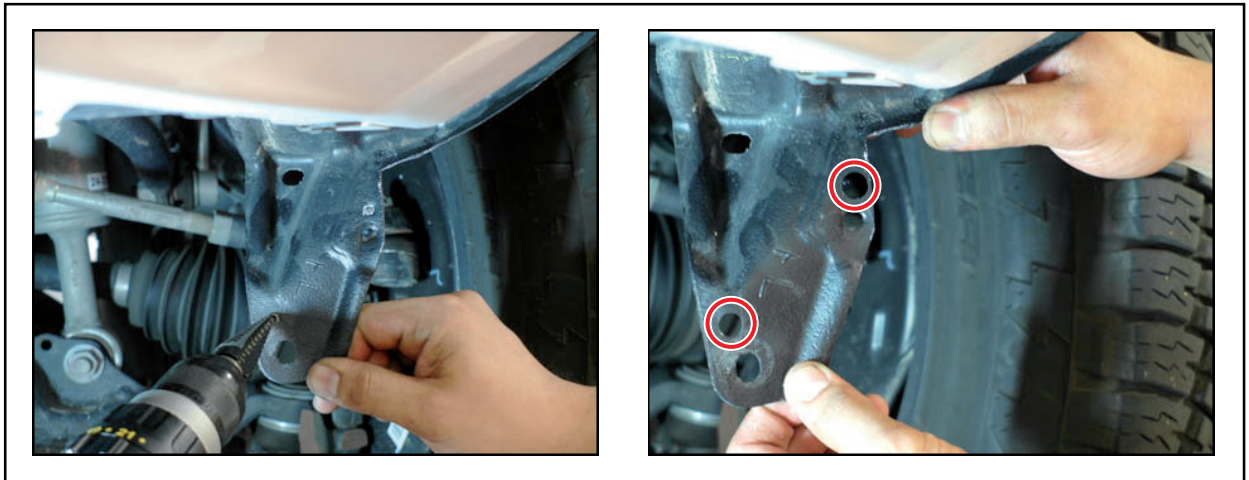
Figure 8.

- Using the step drill bit, drill 2 holes in the fender liner at the identifying marks.

Set the drill stop to 5/16 – 3/8 in. (8 – 9 mm) and drill both sides to remove the flash from the fender liner.

- Repeat the same procedure for the passenger side.

Be sure to use the passenger side (RH) template.

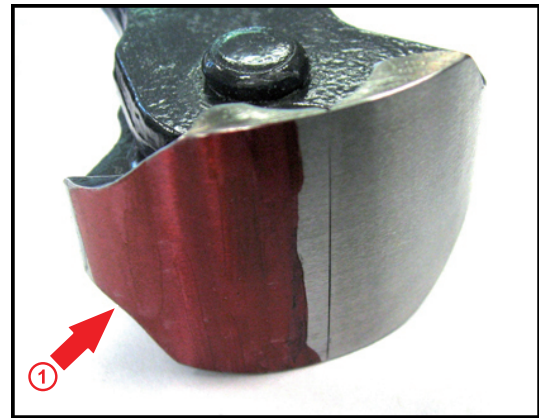
Figure 9.

- One side of the pliers is marked red. THE RED SIDE OF THE PLIERS IS TO BE USED AGAINST THE PAINTED SURFACE ONLY (paint against paint).

| 1 | Red Side |

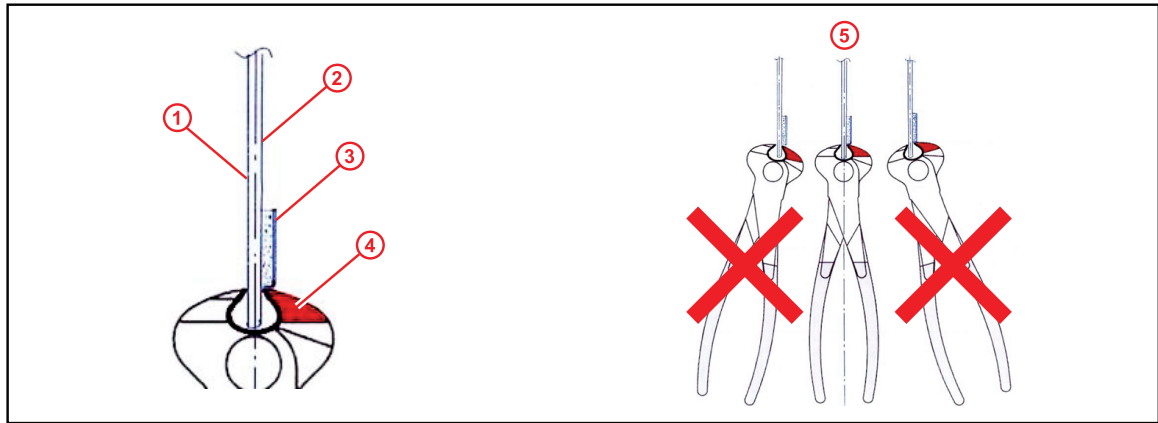
Figure 10.

- When holding the cutting pliers in place, it is important to keep the pliers oriented at a 90 degree angle as shown.

| 1 | Bumper Cover |
| 2 | Paint |
| 3 | Tape |

| 4 | Red Jaw |
| 5 | Edge Must Be 90° to Surface |

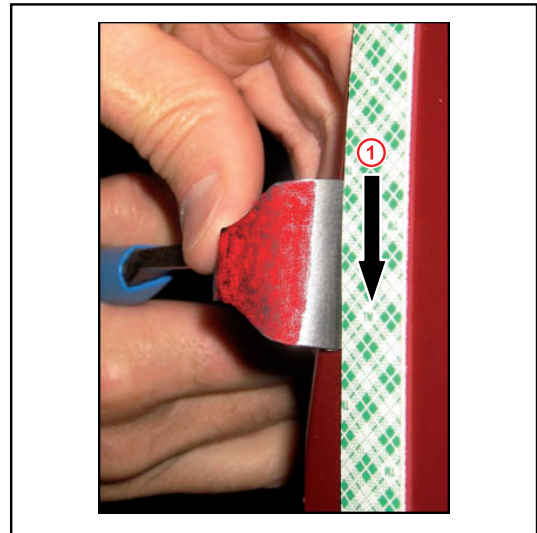
Figure 11.

- DO **NOT** TAKE FULL CUTS across the face of the bumper cover. ONLY MAKE HALF CUTS BEFORE MOVING TO MAKE THE NEXT CUT.

Failure to make only partial cuts may result in uneven cuts or a wavy appearance and the bumper may need to be replaced.

| 1 | Start at Top and Move Down |

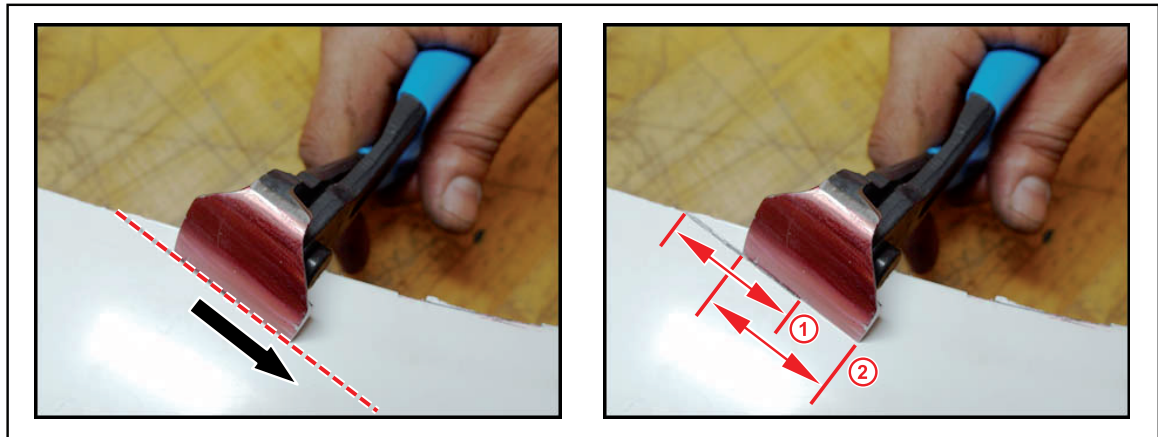
Figure 12. Half Cuts Along Same Line

| 1 | Cut 1 |

| 2 | Cut 2 |

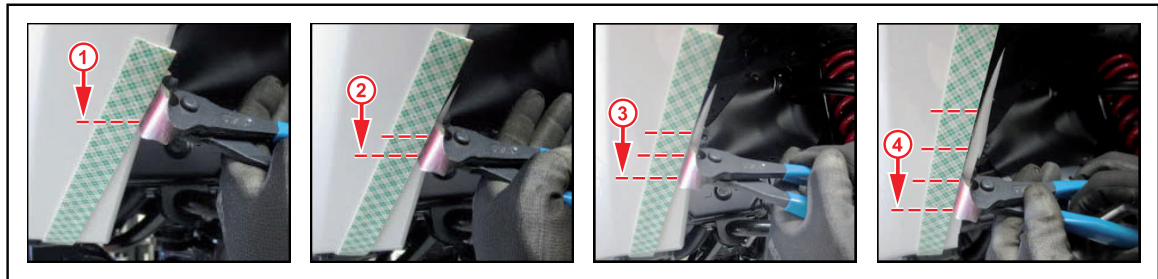
Figure 13. Example of Half Cuts

| 1 | Cut 1 |
| 2 | Cut 2 |

| 3 | Cut 3 |
| 4 | Cut 4 |

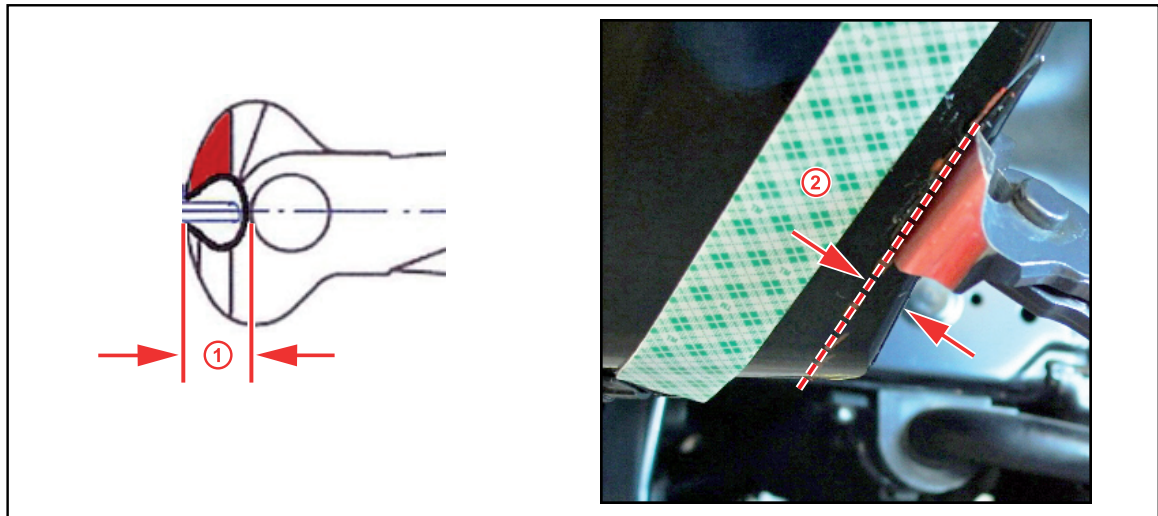
Figure 14.

- Because the depth of the cutting pliers is less than the maximum depth of area to be removed, it is necessary to first make a preliminary cut removing approximately half of the area (between the arrows).

| 1 | Depth of Cutting Pliers |

| 2 | Remove Area Between Arrows |

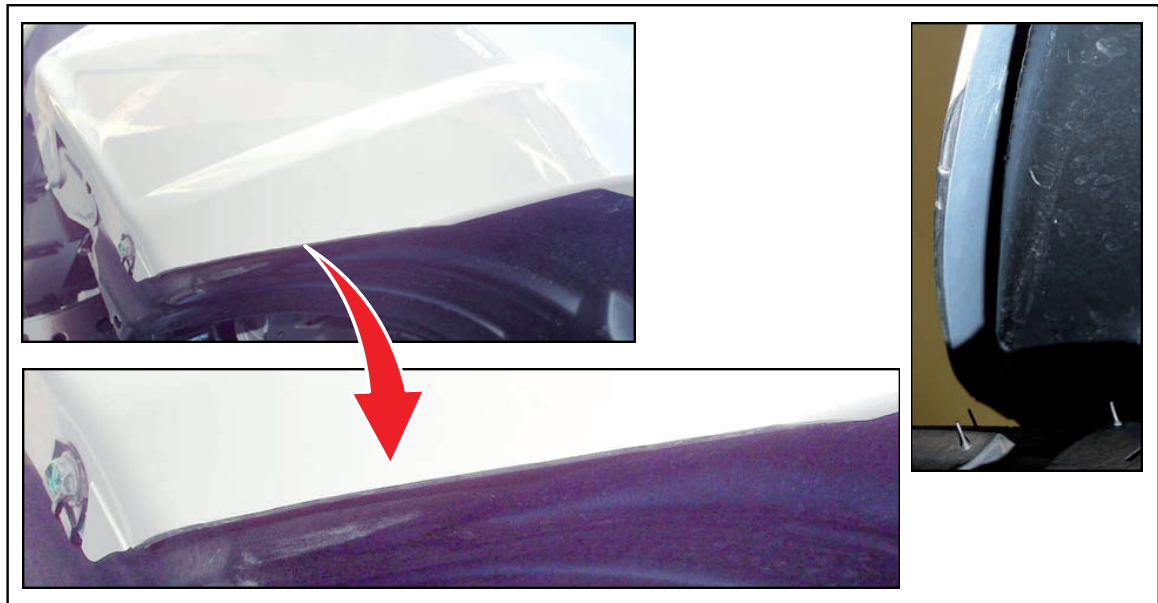
Figure 15. Good Example

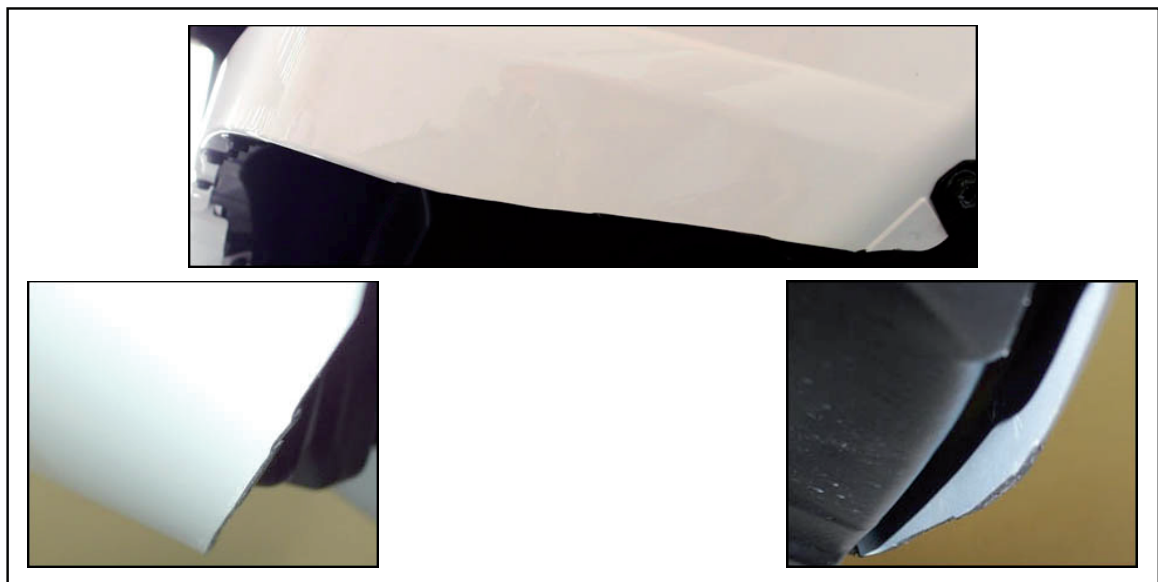
Figure 16. Bad Example

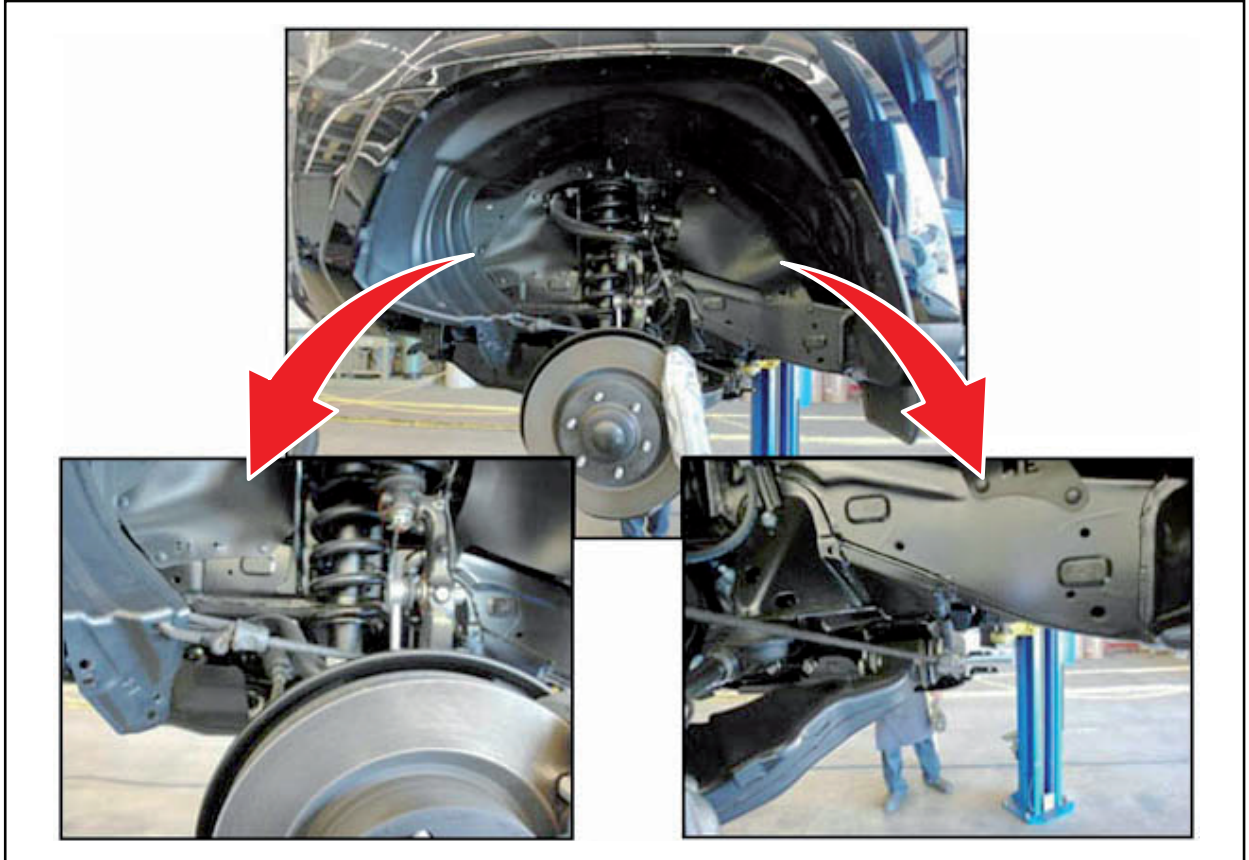
Figure 17.

1. Carefully pull the fender liner back and secure it to the lower control arm.

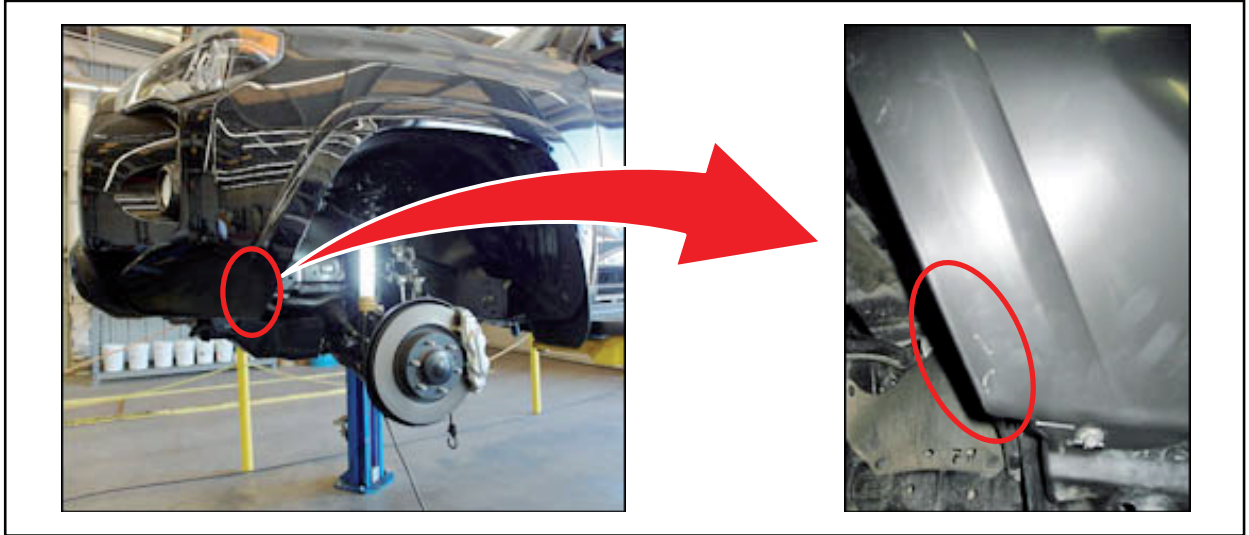
Figure 18.

- Using warm water and a lint-free cloth, clean the work area ensuring all debris is removed.

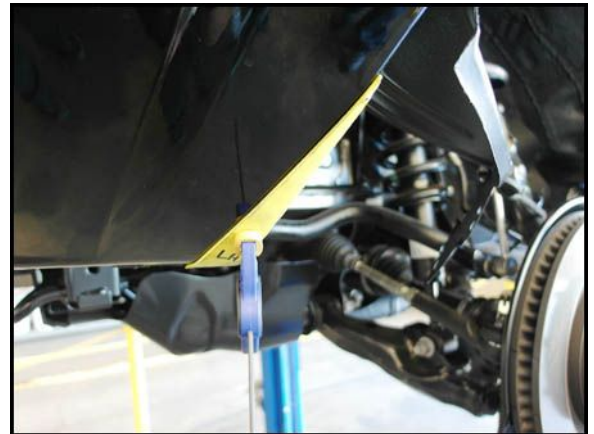
Figure 19.

- Locate the LH bumper template and secure it to the bumper cover with a clamp.

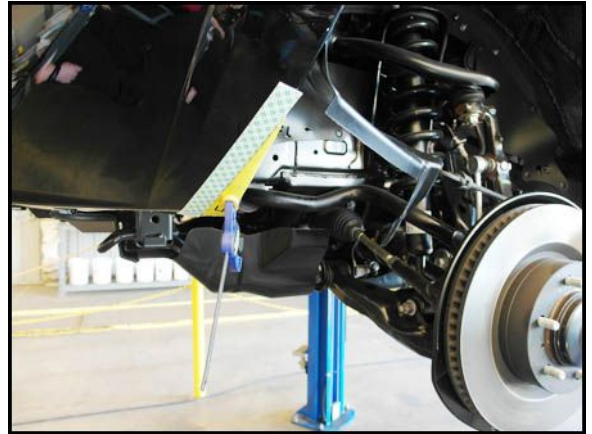
Figure 20.

4. Cut an 8-inch (203 mm) strip of double-sided foam tape and apply it to the edge of the marking template. Ensure the tape is straight and flush against the template.

- Do NOT remove the backing from the tape.
- When repeating this for the opposite side, always use a NEW piece of tape.

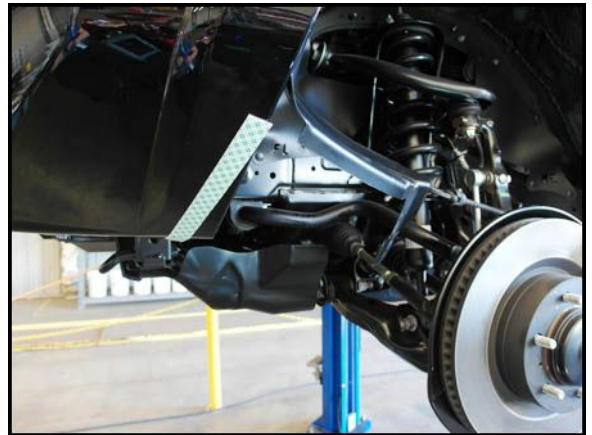
Figure 21.

5. Remove the marking template and clamp.

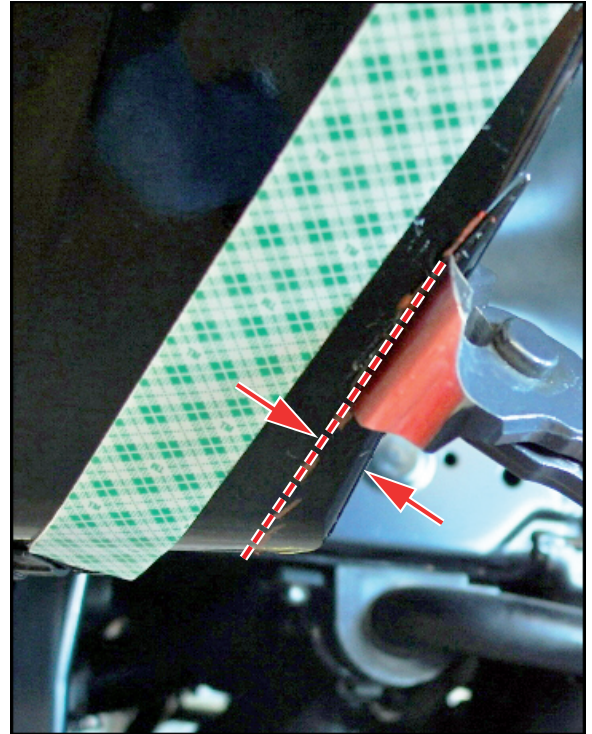
Figure 22.

6. Make the preliminary cut removing approximately half of the area (between the arrows).

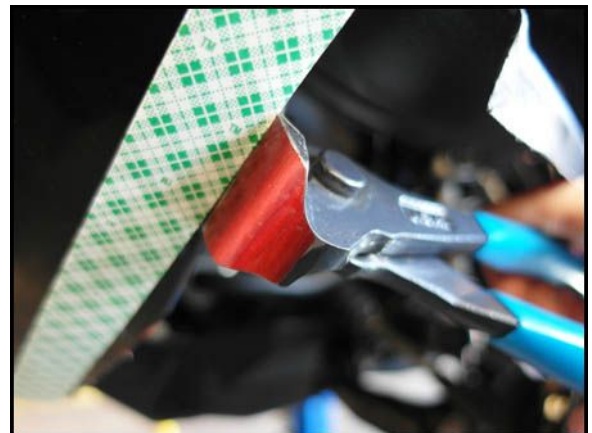
Figure 23.

7. Starting at the outer edge, trim along the tape working towards the inside with overlapping cuts.

Prior to each cut, ensure the cutting pliers are held at a 90 degree angle and rest against the tape. Failure to do so may result in uneven cuts and the bumper cover will require replacement.

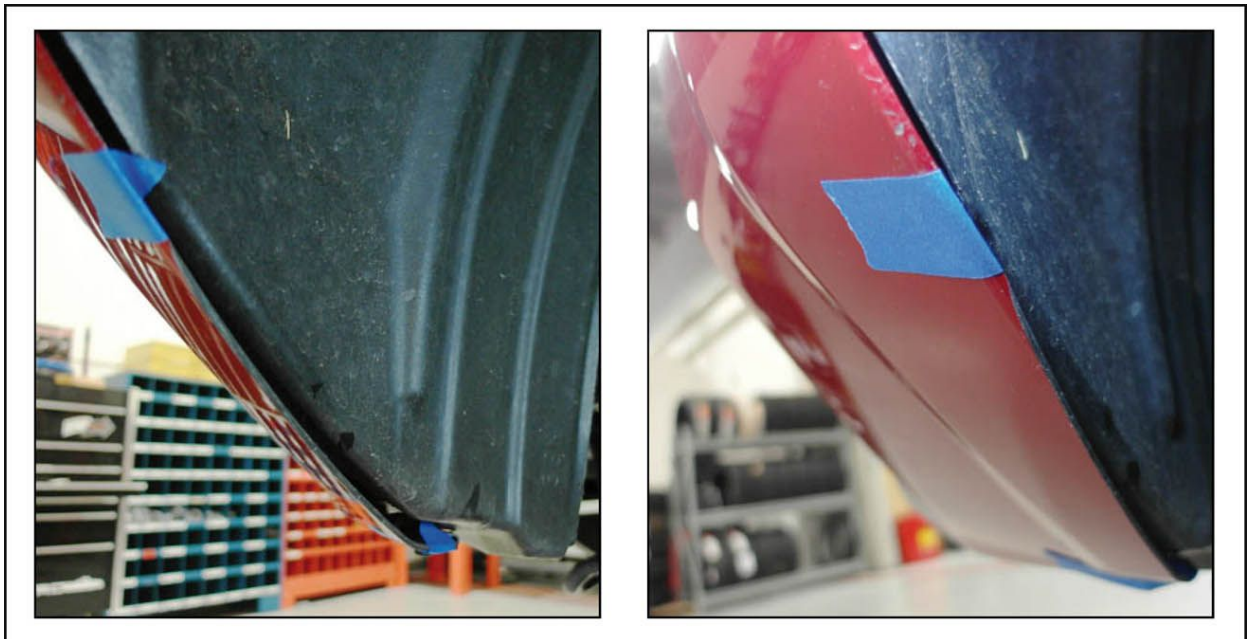
Figure 24.

8. Once the cutting is complete, remove the tape.
9. Apply masking tape to the painted edge of the bumper cover just above and below the top of the cut.

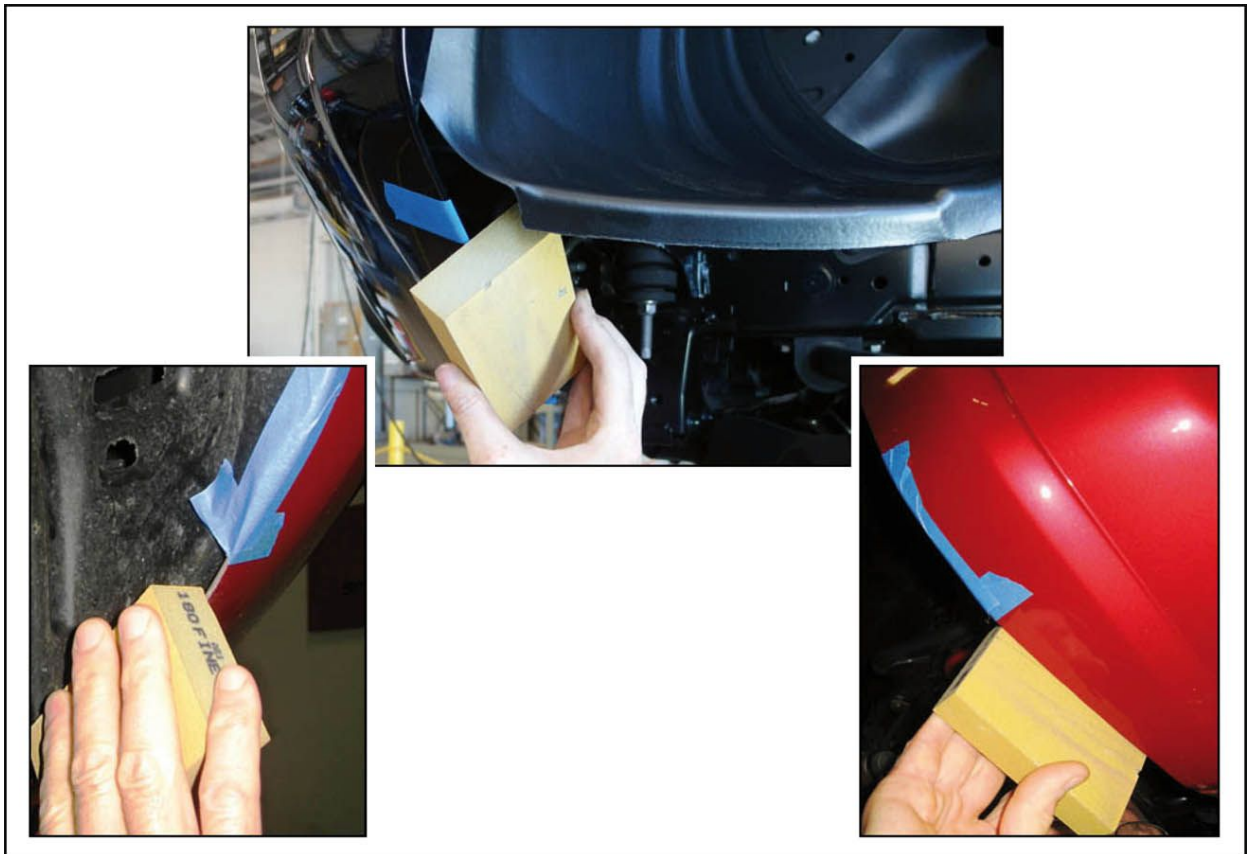
Figure 25.

10. Use the foam sanding block to lightly sand the cut edges to remove any sharp edges or burrs. When sanding, use light pressure and keep the block square with the edge. Only a few strokes should be required to ensure the edges are smooth.

11. Remove the tape and clean the bumper surface as performed in step 2.
12. Return the fender liner back to its original position and reinstall the 2 fender liner fasteners.

The fasteners **MUST** be inserted into the 2 **NEW** holes drilled in step 9 of the “*Fender Liner Modification*” section. (The silver fastener in the front location and the black fastener in the rear location.)

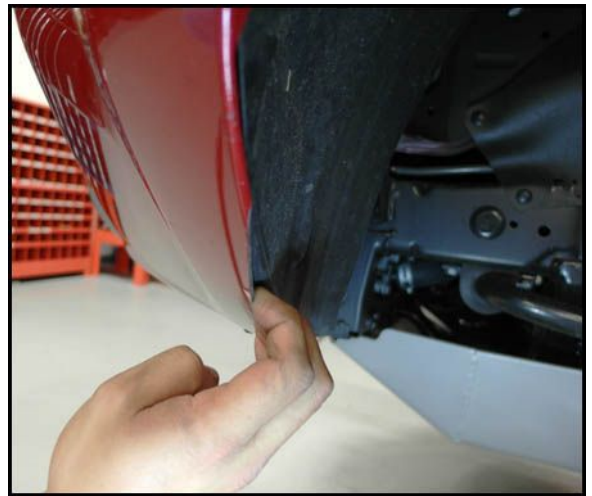
Figure 26.

13. Using your hands, verify the fender liner and bumper are flush.
