## 2AZ-FXE Oil Consumption

### Introduction

Some 2010 model year HS 250h vehicles equipped with the 2AZ-FXE engine may exhibit engine oil consumption. The piston assembly has been changed to minimize oil consumption. Use the following Repair Procedure to address this condition.

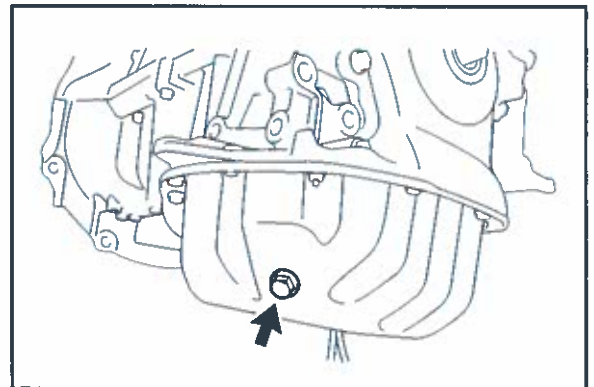
Figure 1.

- A. Remove the oil pan drain plug and gasket.

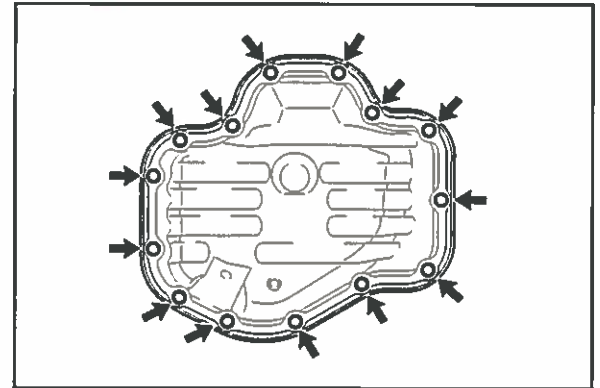
Figure 2.

#### B. Remove the oil pan sub-assembly.

- (1) Remove the 12 bolts and 2 nuts.

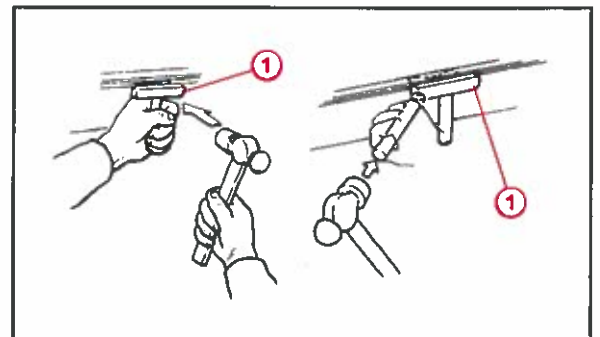
Figure 3.

- (2) Insert the blade of the Gasket Seal Cutter between the crankcase and oil pan. Cut through the sealer and remove the oil pan.

1 Gasket Seal Cutter

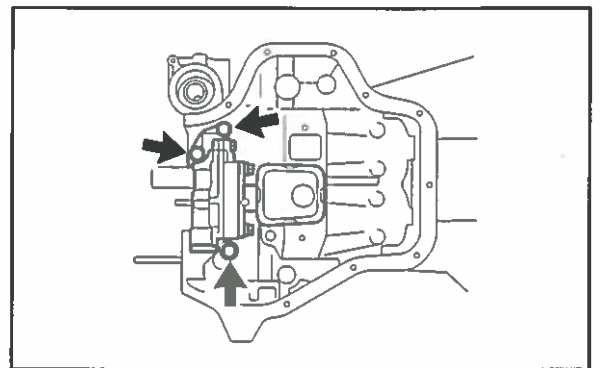
Figure 4.

- C. Remove the oil pump assembly by removing the 3 bolts and gasket.

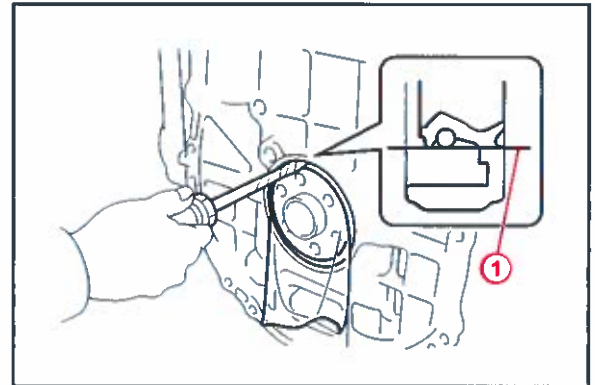
Figure 5.

- (1) Using a knife, cut off the oil seal lip.
- (2) Using a screwdriver (with a taped tip), pry out the oil seal.

1 Cut Position

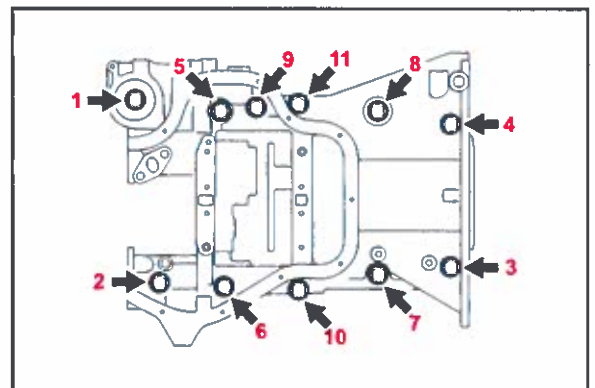
Figure 6.

- (1) Uniformly loosen and remove the 11 bolts in the sequence shown in the illustration.

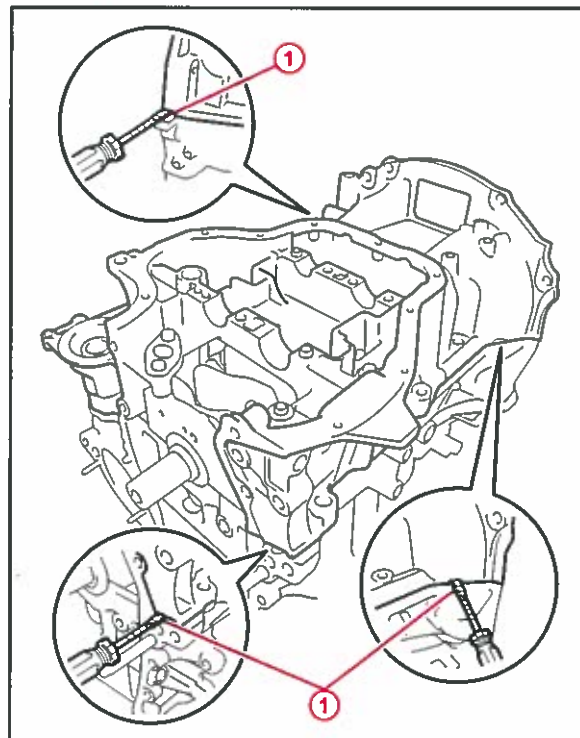
Figure 7.

- (2) Using a screwdriver (with a taped tip), remove the crankcase by prying between the crankcase and cylinder block.

1 Protective Tape

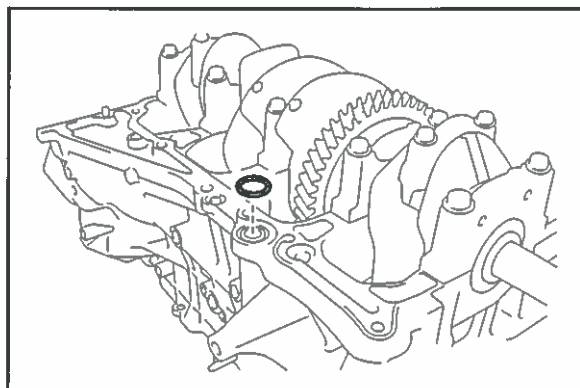
Figure 8.

- (3) Remove the O-ring from the cylinder block.

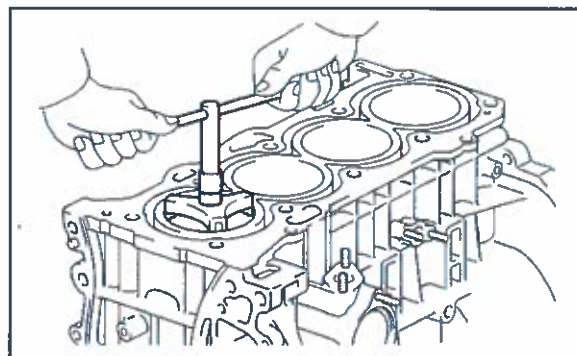
Figure 9.

- (1) Using a ridge reamer, remove all the carbon from the top of the cylinder.

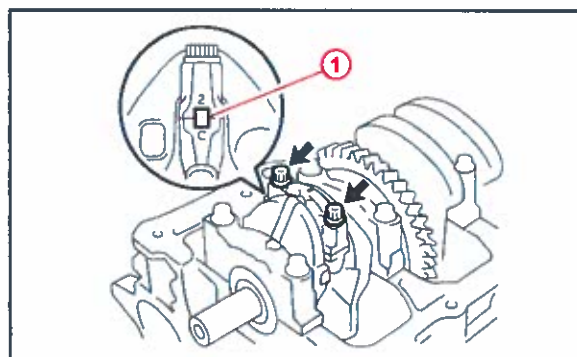
Figure 10.

- (2) Check that the matchmarks on the connecting rod and cap are aligned to ensure correct reassembly.

The matchmarks on the connecting rods and caps are provided for ensuring correct reassembly.

1 Matchmark

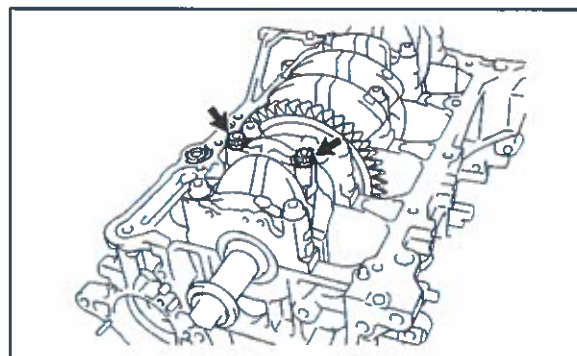
Figure 11.

- (3) Using a 12 mm socket wrench, uniformly loosen the 2 bolts.

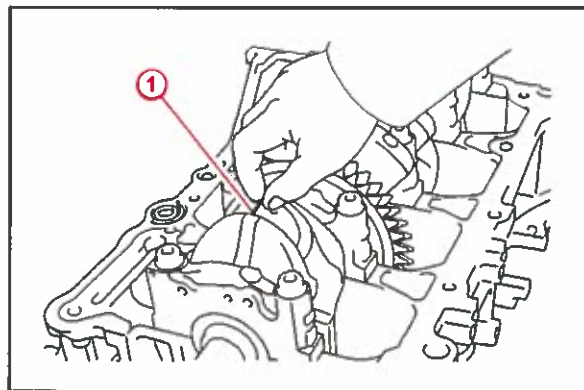
Figure 12.

- (5) Inspect the connecting rod oil clearance.
1. Clean the crank pin and bearing.
  2. Check the crank pin and bearing for pitting and scratches.
  3. Lay a strip of Plastigage™ on the crank pin.

1 Plastigage™

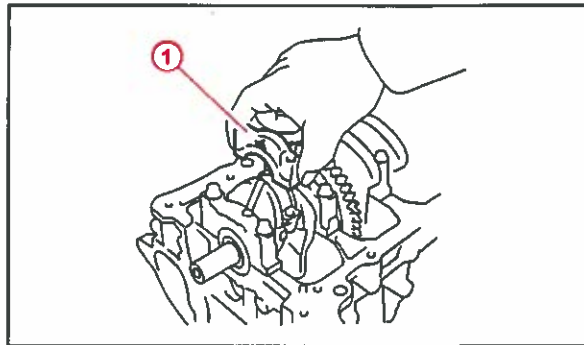
Figure 13.

4. Check that the front mark of the connecting rod cap is facing forward.

1 Front Mark

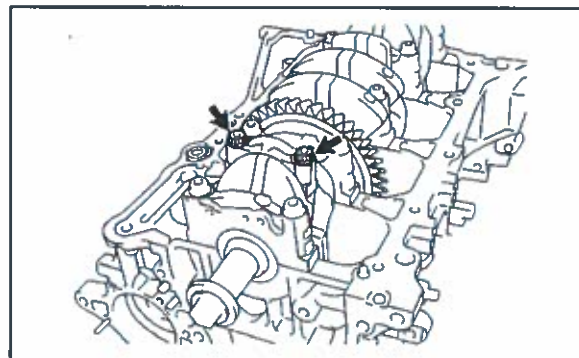
Figure 14.

5. Install and alternately tighten the bolts of the connecting rod cap in several steps.

Torque: 25 N\*m (250 kgf\*cm, 18 ft\*lbf)

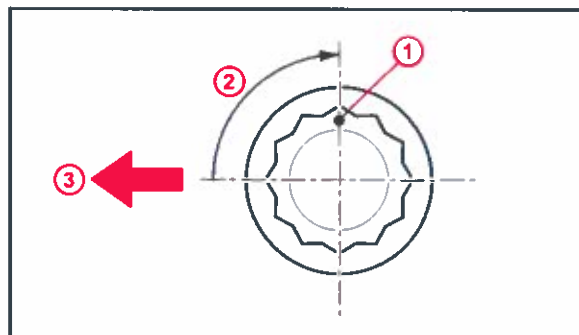
Figure 15.

6. Mark the front of the connecting rod cap bolts with paint.  
Retighten the cap bolts by 90° as shown in the illustration.

| 1 | Paint Mark |
| 2 | 90° |
| 3 | Engine Front |

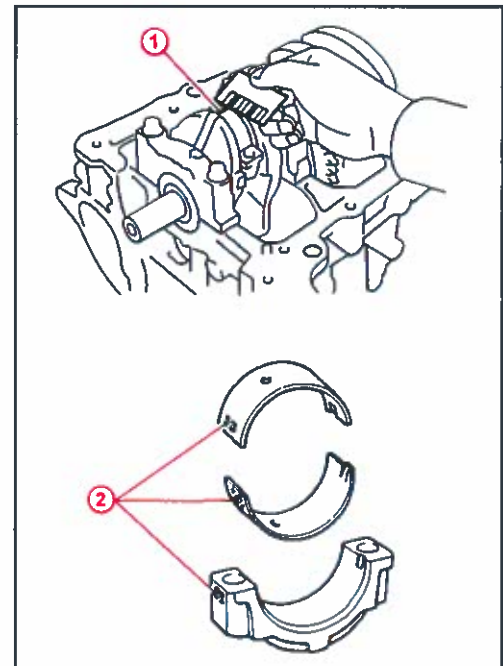
Figure 16.

7. Remove the 2 bolts and connecting rod cap.
8. Measure the Plastigage™ at its widest point.

**Standard Oil Clearance: 0.024 to 0.048 mm (0.0009 to 0.0019 in.)**

**Maximum Oil Clearance: 0.08 mm (0.0032 in.)**

If the oil clearance is greater than the maximum, replace the connecting rod bearings. If necessary, inspect the crankshaft.

If replacing a bearing, replace it with one that has the same number as its respective connecting rod cap. Each bearing's standard thickness is indicated by a 1, 2, or 3 mark on its surface.

| 1 | Plastigage™ |
| 2 | 1, 2, or 3 Mark |

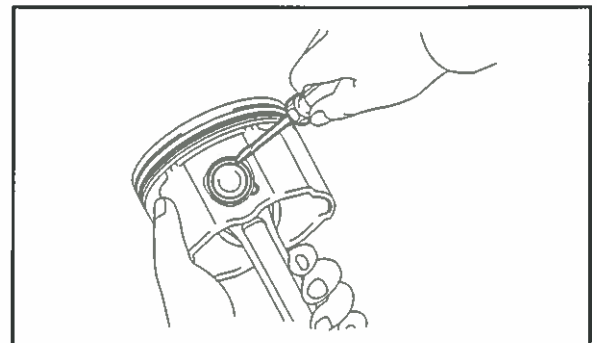
Figure 17.

- I. Using a screwdriver, pry out the 2 piston pin hole snap rings.

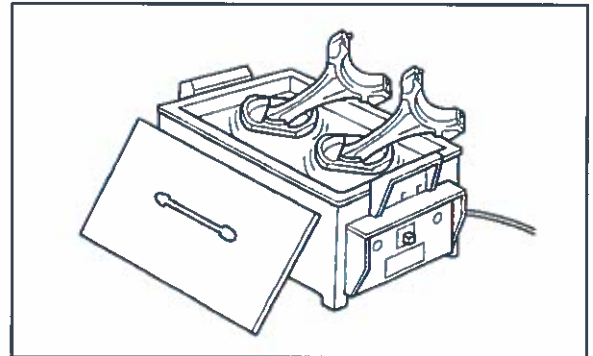
Figure 18.

- (1) Gradually heat the piston to approximately 176° to 194°F (80° to 90°C).

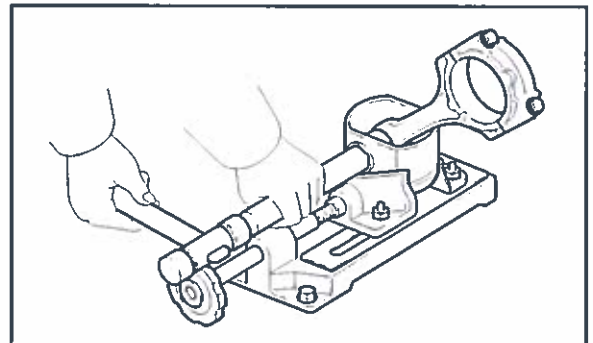
Figure 19.

- (2) Using a plastic hammer and brass bar, lightly tap out the piston pin and remove the connecting rod.

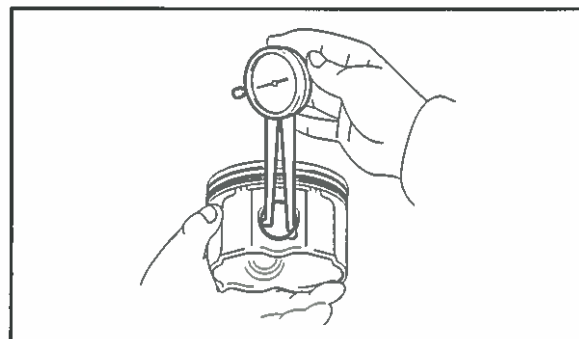
Figure 20.

- (1) Using a caliper gauge, measure the piston pin bore diameter.  
**Standard Piston Pin Bore Diameter:**  
22.001 to 22.010 mm (0.8662 to 0.8665 in.)

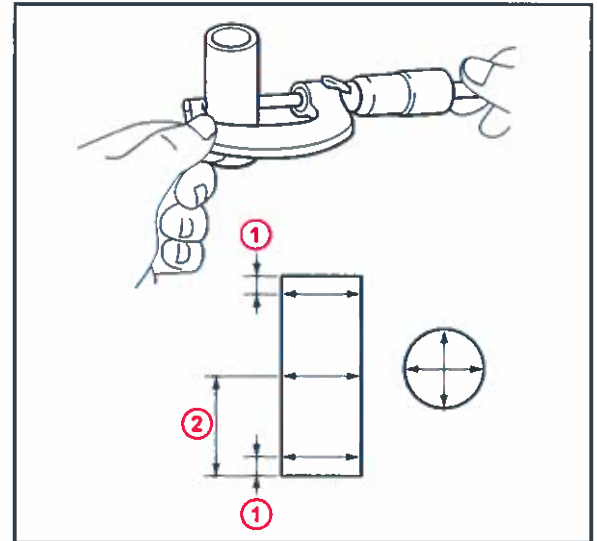
**Figure 21.**

- (2) Using a micrometer, measure the piston pin diameter.

**Standard Piston Pin Diameter: 21.997 to 22.006 mm (0.8660 to 0.8664 in.)**

If the diameter is NOT as specified, replace the piston pin.

| 1 | 5 mm (0.20 in.) |
| 2 | 30 mm (1.18 in.) |

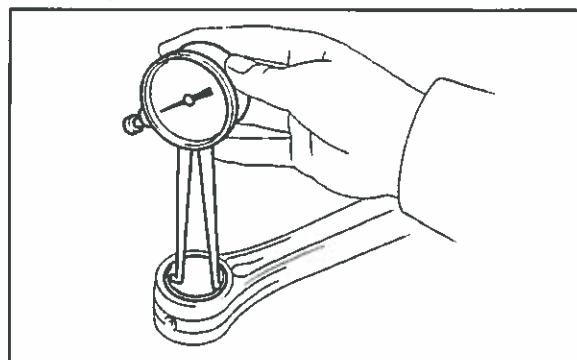
Figure 22.

- (3) Using a caliper gauge, measure the connecting rod small end bore diameter.  
**Standard Connecting Rod Small End Bore Diameter:**  
 22.005 to 22.014 mm (0.8663 to 0.8667 in.)

If the diameter is NOT as specified, replace the connecting rod.

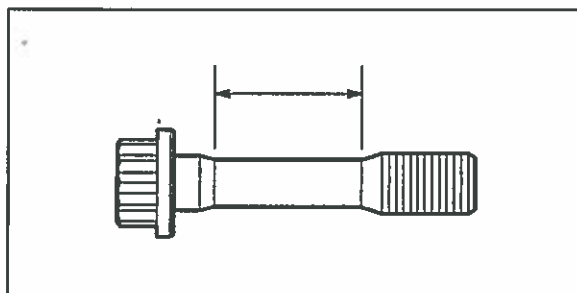
Figure 23.

Using vernier calipers, measure the tension portion diameter of the bolt.

**Standard Diameter:** 7.2 to 7.3 mm  
 (0.283 to 0.287 in.)

**Minimum Diameter:** 7.0 mm (0.276 in.)

If the diameter is less than the minimum, replace the connecting rod bolt.
