# **D/C Cut Fuse Installation During PDS**

YEAR(S)	MODEL(S)	ADDITIONAL INFORMATION	
2016	LX570

L-SB-0055-15

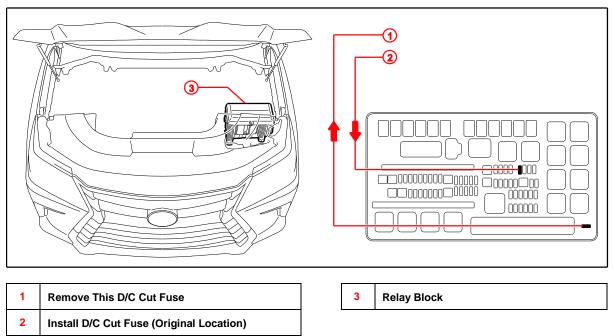
Remove the D/C Cut Fuse (30A) from the blank space of the fuse block in the engine compartment and install it in the location shown in Figure 1 during Pre-Delivery Service (PDS).

To minimize battery discharge during transportation and storage, the D/C Cut Fuse has been removed at the assembly plant and temporarily stored in the engine compartment Relay Block. Reinstall the D/C Cut Fuse into its original location and confirm all related DTCs are cleared during Pre-Delivery Service (PDS).
