Service Bulletin

Subject: Vibration Felt in Drive at Idle

Models: 2014-2015 Chevrolet Impala (VIN 1)

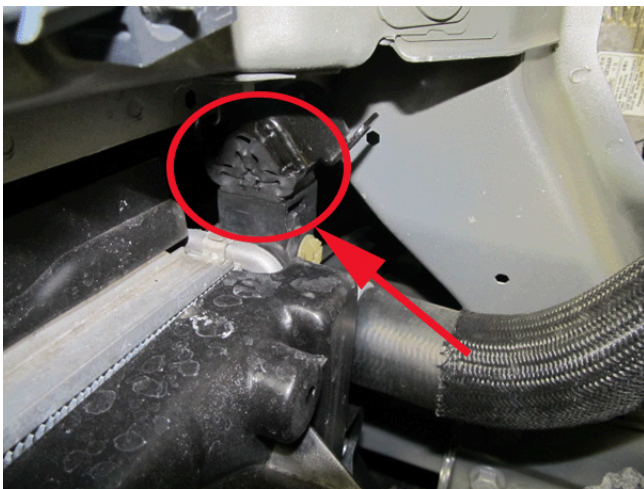
1. Inspect both upper radiator mounts for misalignment.

Note: Both upper radiator mounts are visible without removing any parts.

2. If the mounts are misaligned as illustrated above, skip the next step.

Note: If the mount is misaligned, the honeycomb of the mount will most likely be collapsed.

3. If the radiator mounts are aligned properly, perform the powertrain mount balance procedure. Refer to the Powertrain Mount Balancing in SI. After balancing the mounts, verify the concern has been corrected. If so the repair is complete. If vibration is still present, refer to Service Information (SI) for further diagnoses.
4. Raise and support the vehicle. Refer to the Lifting and Jacking the Vehicle in SI.

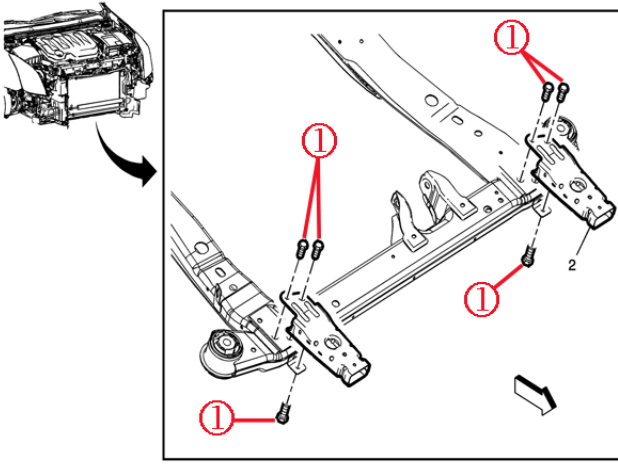
5. Loosen the radiator lower mount bolts (1).

- To access the lower bolts, the front bumper fascia must be partially removed. Remove the lower push-in retainers and the four most inward wheelhouse liner screws.

6. Realign the upper radiator mounts.

7. If any damage to the mounts is noticed, replaced the damaged mount. Refer to the Radiator Upper Mount Replacement in SI.

8. Tighten the radiator lower mount bolts.

Tighten: Tighten the bolts to 22 Y (16 lb ft).

- Re-intall any push-retainers and screws that where previously removed from the fascia.

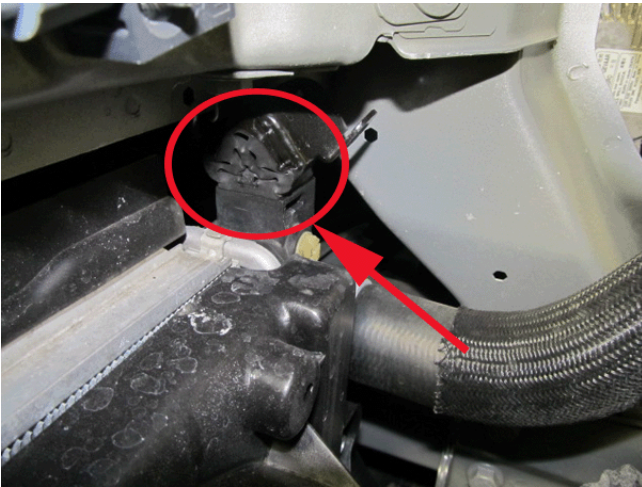
1. Inspect both upper radiator mounts for misalignment.

Note: Both upper radiator mounts are visible without removing any parts.

2. If the mounts are misaligned as illustrated above, skip the next step.

Note: If the mount is misaligned, the honeycomb of the mount will most likely be collapsed.

3. If the radiator mounts are aligned properly, perform the powertrain mount balance procedure. Refer to the Powertrain Mount Balancing in SI. After balancing the mounts, verify the concern has been corrected. If vibration is still present, refer to Service Information (SI) for further diagnoses.

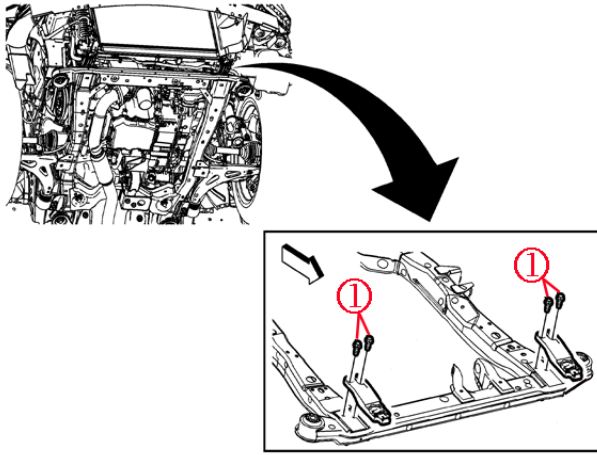
4. Loosen the radiator lower mount bolts (1).
5. Realign the upper radiator mounts.
6. If any damage of the mounts is noticed, replaced the mount. Refer to the Radiator Upper Mount Replacement in SI.
7. Tighten the radiator lower mount bolts.
Tighten: Tighten the bolts to 22 Y (16 lb ft).
8. Verify the concern is corrected. If so the repair is complete. If the vibration is still present, refer to Service Information (SI) for further diagnoses.
