Service Bulletin

Subject: Malfunction Indicator Lamp (MIL) Illuminated, Fuel Tank Hard to Fill, DTCs P0442, P0446, P0455 or P0449 Set

Models: 2011-2013 Chevrolet Silverado
2014 Chevrolet Silverado 1500
2014 Chevrolet Silverado 2500/3500
2015 Chevrolet Silverado
2011-2013 GMC Sierra
2014 GMC Sierra 1500
2014 GMC Sierra 2500/3500
2015 GMC Sierra

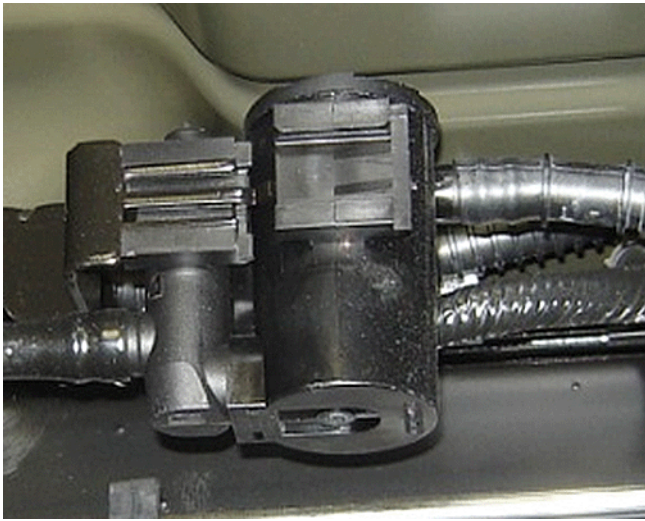
Original design EVAP CVS valve shown above.

After following the published SI diagnostics and determining that the EVAP CVS valve is the cause of the Malfunction Indicator Lamp (MIL) illumination or the hard to fill symptom, replace the existing EVAP CVS valve assembly with the new revised design assembly.

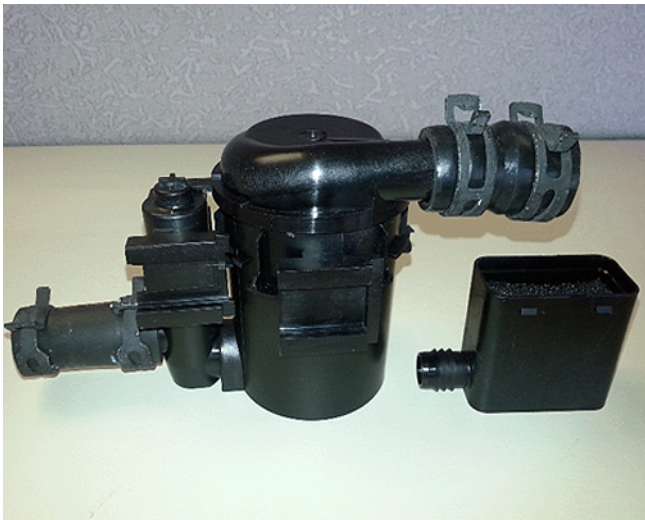
Revised design EVAP CVS valve shown above.

This revised EVAP CVS valve assembly is a sealed unit that is vented through a remote pre-filter mounted atop the fuel filler housing. The revised CVS valve incorporates improved filtering capacity. To ensure correct installation, follow the procedure outlined below:

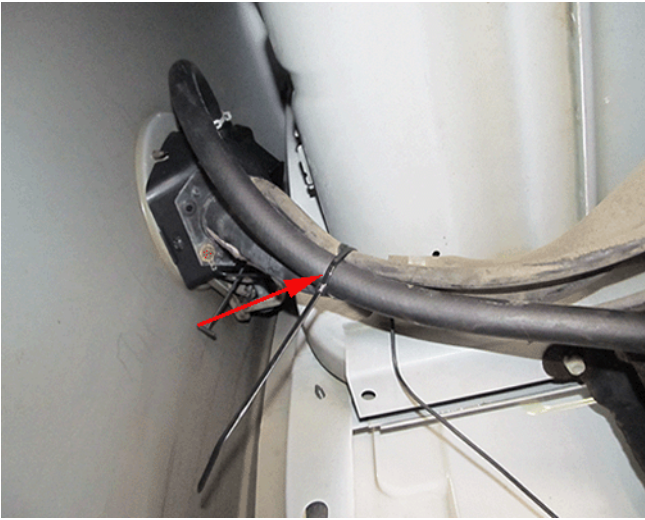
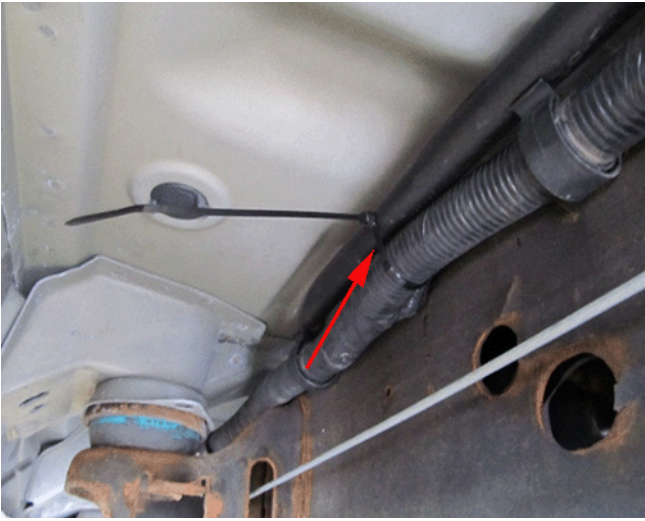
16. Through the fuel tank filler pipe housing opening, install the pre-filter and housing (2) with hose attached to the back of the fuel tank filler pipe housing. Secure the tabs of the filter (1) to the slots in the filler pipe housing.
17. Install the fuel tank filler pipe housing to the body.
18. Raise the vehicle.

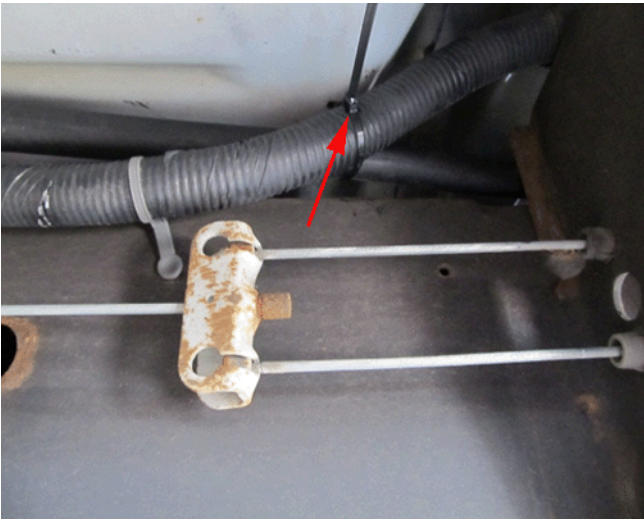
Important: DO NOT make any sharp bends or allow any kinks in the hose when routing the hose.

19. Carefully route the pre-filter hose along the fuel filler pipe and frame rail and over to the CVS valve assembly.
20. Install tie straps along the pre-filter hose to the fuel filler pipe and wiring harness along the frame rail.

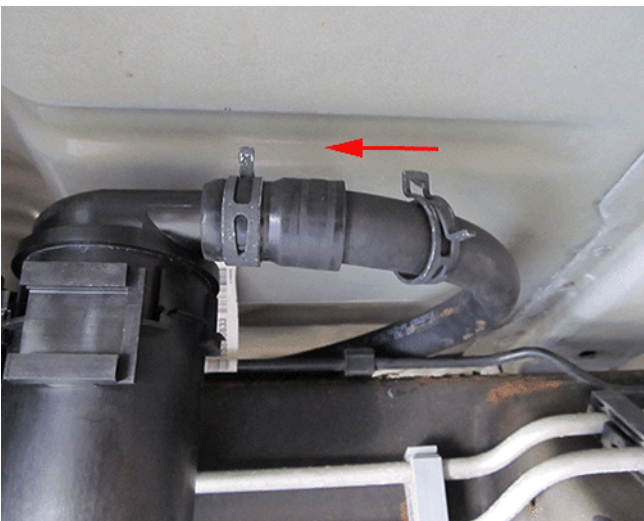
Note: Apply loc-tite 401 or equivalent (SuperGlue, etc.) to the end of the heater hose (1) which will go into the CVS valve rubber coupling.

22. Apply adhesive as indicated and install the hose into the rubber coupling of the CVS valve assembly. Ensure the hose is fully installed and clamp into place.
23. Connect the vehicle chassis wiring harness electrical connector to the CVS valve.
