Service Bulletin

Subject: Diagnostic Tip For the JATCO CVT7 Automatic Transmission RPO M4M

Models: 2014-2015 Chevrolet Spark
Equipped with the Jatco CVT7 transmission RPO M4M

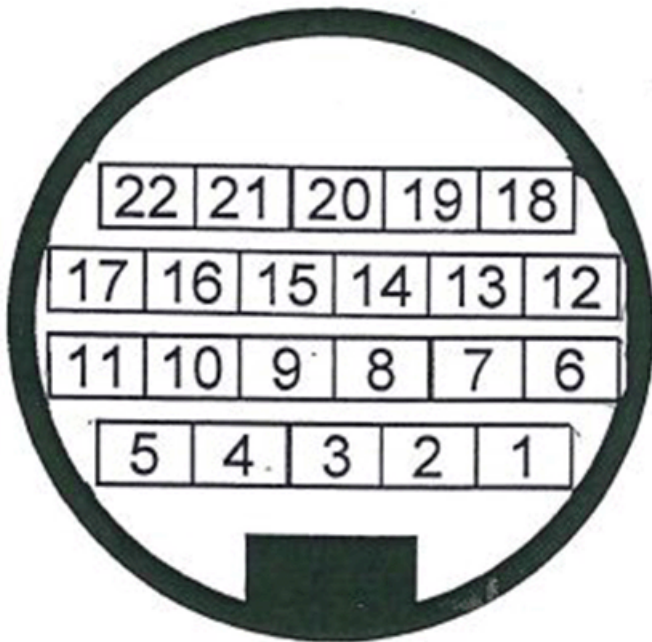
The following picture shows the pin locations inside the transmission pass thru connector which is located on the side of the transmission towards the front of the vehicle

Please refer to this picture when testing the internal circuits or components that are located inside the JATCO CVT7 automatic transmission assembly.

Note pins 5,4,3,2 and 1 are closest to the front of the vehicle.

Note: When performing a pin drag test on the harness end of the transmission connector be sure to remove the TPA or you will get a false drag test as the TPA will also cause a drag on the diagnostic test probe.
