Service Bulletin

Subject: Driver Door Lock Cylinder Cover Missing

Models: 2015 Cadillac Escalade Models

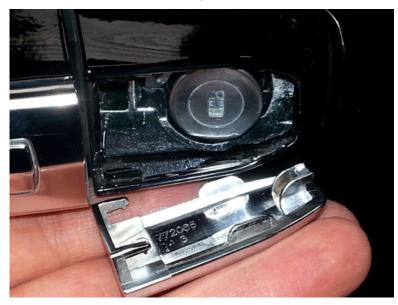
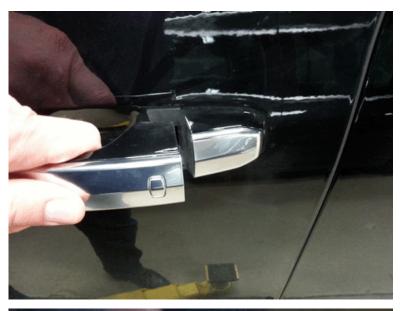
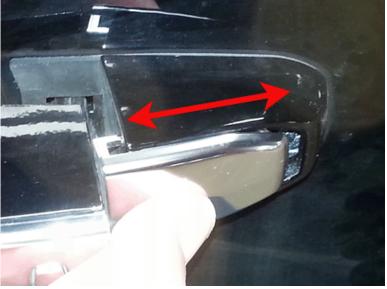
To install or remove the door lock cylinder cover, pull the door handle out and slide the door handle forward, then slide the cover forward to release it or slide the cover rearward to install it. See the pictures below for reference

If the original cover is not found in the vehicle, or if the cover is damaged, a replacement cover can now be ordered from CCA GM part number 13596115.
