# Service Bulletin

**Subject:** Driver Door Lock Cylinder Cover Missing

**Models:** 2015-2016 Cadillac Escalade Models

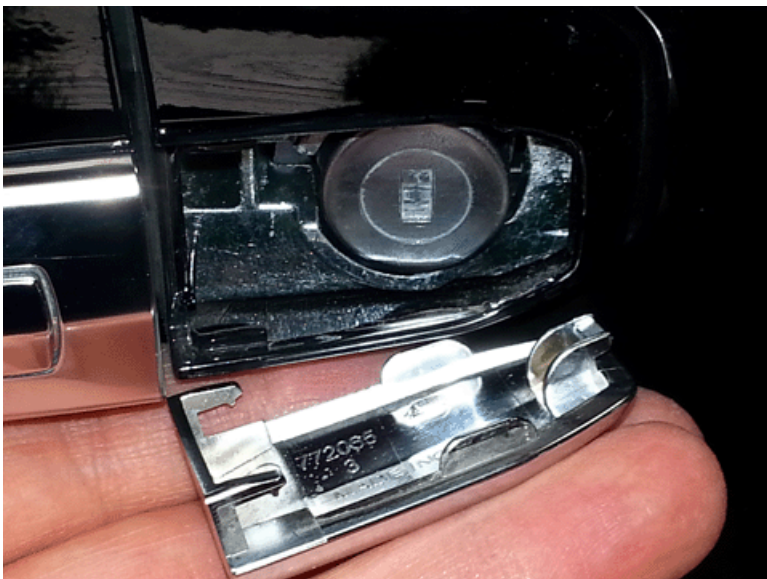
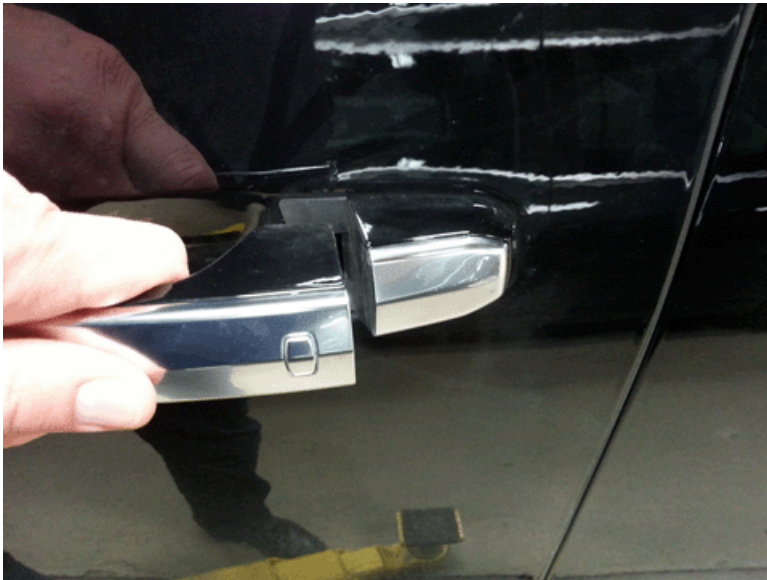
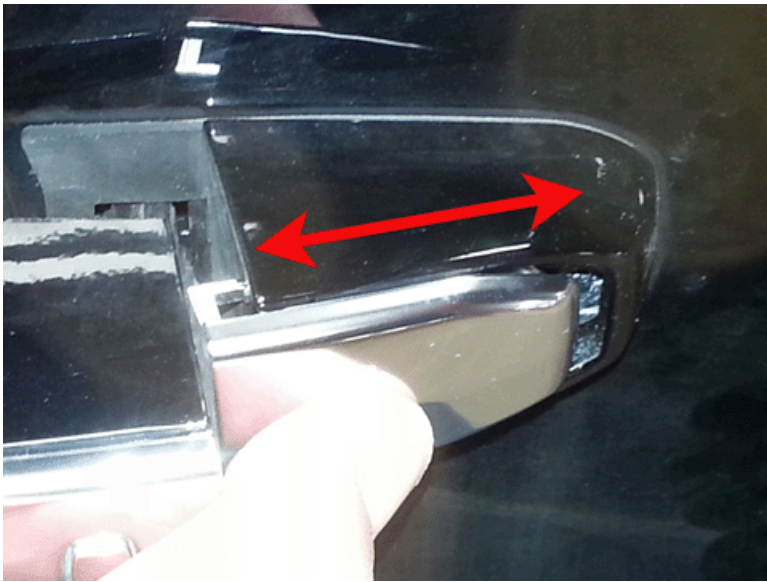
If the driver's door lock cylinder cover is missing, it may have been removed to access the key cylinder while shipping in transport mode, or to enter a vehicle with a dead battery.

If the cover is missing or damaged, it will need to be replaced.

To install or remove the door lock cylinder cover, pull the door handle out and slide the door handle forward, then slide the cover forward to release it or slide the cover rearward to install it. See the pictures below for reference.
