Bulletin No.: PIP5256B

Service Bulletin

Subject: Service 4WD Message Displayed In DIC

Models: 2015-2016 Chevrolet Colorado

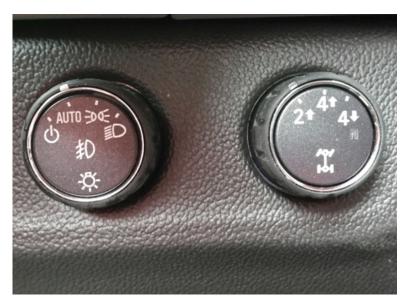
For Colorado (NQ7): Before performing Service Information diagnostics verify that the vehicle has the correct 4WD switch installed in the dash panel.

For 2015 model year the Chevrolet Colorado DOES NOT have the Auto 4WD option. If the vehicle has a switch with the Auto 4WD position the DTC sets when Auto is selected sending an invalid voltage to the TCCM.

For 2016 Chevrolet Colorado with ANY GASOLINE engine, Auto 4WD is NOT an option. If the vehicle has a switch with the Auto 4WD position the DTC sets when Auto is selected sending an invalid voltage to the TCCM.

For 2016 Chevrolet Colorado with the 2.8I diesel Auto 4WD is an option and the vehicle build needs to be confirmed. Vehicles built with NQ7 do not have Auto 4WD and the switch should look accordingly.

Replace the switch with the correct switch listed in the parts catalog. If the vehicle has the correct switch continue with published diagnostics.

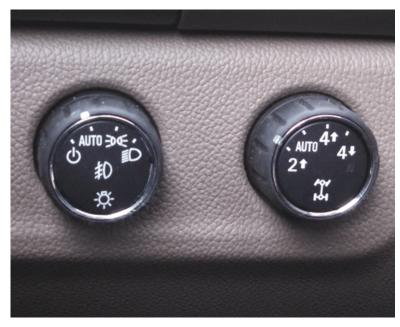
NQ6

For Canyon (NQ6): Before performing Service Information diagnostics verify that the vehicle has the correct 4WD switch installed in the dash panel.

For GMC Canyon the vehicle should have a switch with the Auto position, switch without Auto may set a B0770 DTC which is for the Auto 4WD LED indicator circuit but will not set a B2725.

Replace the switch with the correct switch listed in the parts catalog. If the vehicle has the correct switch continue with published diagnostics.
