Service Bulletin

Bulletin No.: PIC6147

Subject: Clutch Pedal Twisted

Models: 2016 Cadillac ATS-V

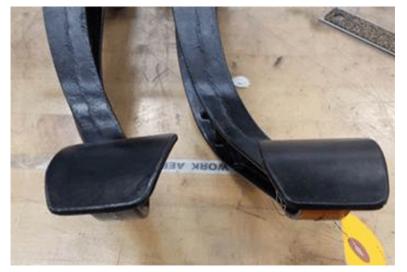
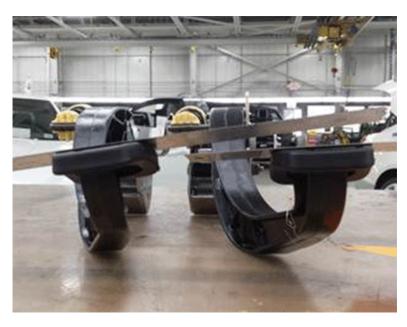
Side-by-side inspection of just the pedal arms indicates the lower portion of the pedal arm is out of position leading to the pedal pad being off position.

In the pictures below, "A" indicates a suspect pedal assembly and "B" indicates a Good pedal assembly:

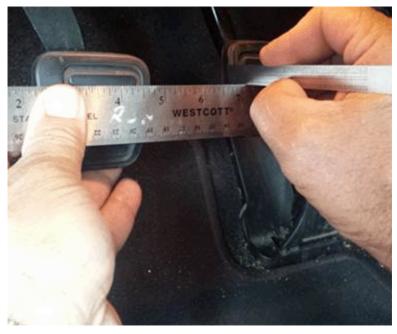
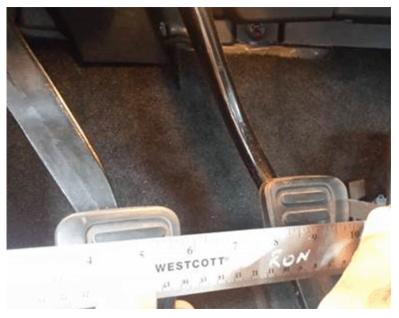
To check for an out of place clutch pedal hold a straight edge across upper portion of Clutch pedal so it spans across the brake pedal as per picture below.

Measure from the top of the brake pedal pad to the straight edge on the Left side of the brake pedal as per A above, Then measure the Right side of the brake pedal to straight edge as per B above. You should have no more than +/- 2mm from side to side measurements. Any more than that will require replacement of the pedal assembly.
