**Title:** 2010 MaxxForce 7 UVC Harness

**Applies To:** All 2010 EPA MaxxForce 7

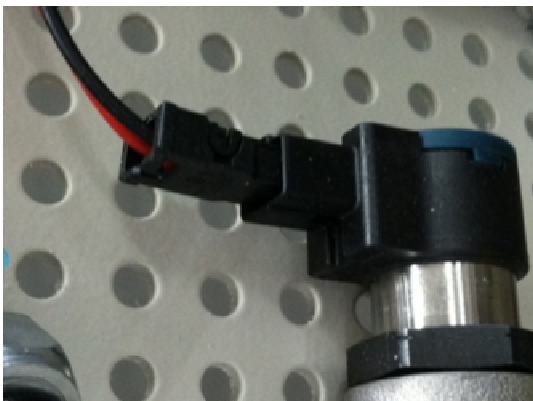
When you have a 2010 EPA MaxxForce7 with an injector open circuit or an injector short code ACTIVE then perform all the injector and harness checks prior to replacing any components.

If the harness and injector checks all come out with in specification then replace the UVC harness for the injector that has the ACTIVE code. Then clear the code and road test.

If the code is still present after replacing the harness open a case file.

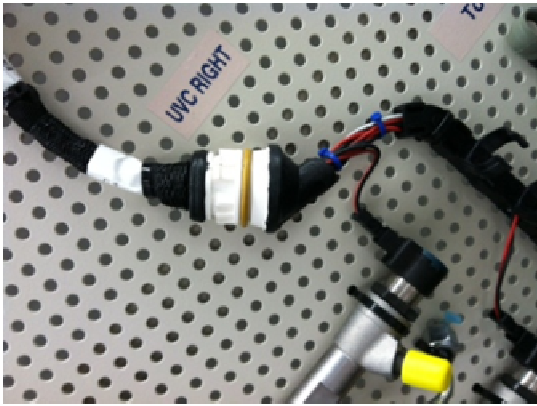
For UVC harness removal tool see [SFN1071](#)
