Title: Pressure Transducer (PT) Switch Install

Applies To: ProStar / LoneStar 2012 -Current

This document will guide the user through the necessary steps to install the Pressure Transducer (PT) Switch Conversion Kit into the 2012 - Current ProStar® (01-39) and LoneStar®.

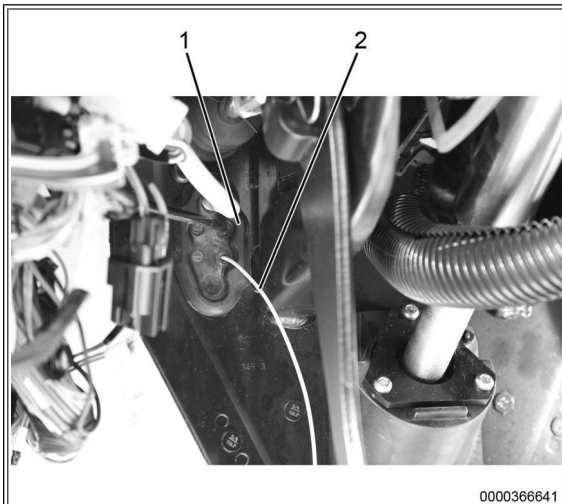
Figure 2: Interior Accessory Grommet.

Item 1: Accessory grommet
Item 2: Kit-supplied wire

7. Locate the interior accessory grommet (Figure 2, Item 1) just forward of the operator pedals.

8. Using pick tool, puncture hole through grommet to create a pass through location.

9. Insert the unterminated side of the kit-supplied wire (Figure 2, Item 2) through the pass through location of grommet, working towards the front of vehicle.

NOTE:
 Following the securing of the kit-supplied wiring harness in the vehicle interior, it is considered a best practice to seal the hole punctured in the interior accessory grommet (Figure 2, Item 1) just forward of the operator pedals.

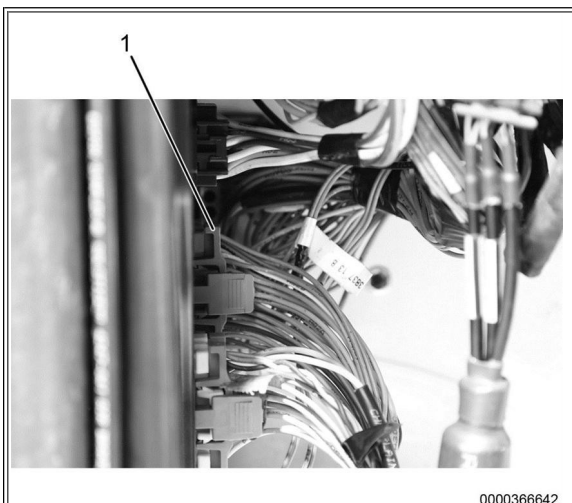
Figure 3: Body Control Module (BCM) - J3 Connector.

Item 1: Connector

11. Locate RED J3 connector (Figure 3, Item 1) on vehicle BCM and disconnect.

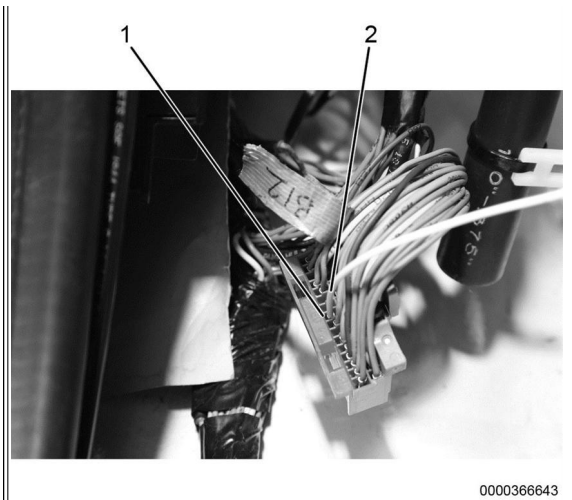
Figure 4: Cavity B9.

Item 1: Cavity B9
Item 2: Kit-supplied harness

13. Route the terminated side of the kit-supplied wire through the J3 connector lock.
14. Populate the terminated side of the kit-supplied wire (Figure 4, Item 2) into cavity B9 (Figure 4, Item 1) of the connector.
15. Engage connector lock.
16. Connect J3 connector to BCM.
17. Inspect A/C machine to verify recovery is complete. Once complete, ensure there is no pressure in either line.
18. Remove air cleaner assembly.
19. From the engine compartment, insert the BCM wire into the kit-supplied split loom.

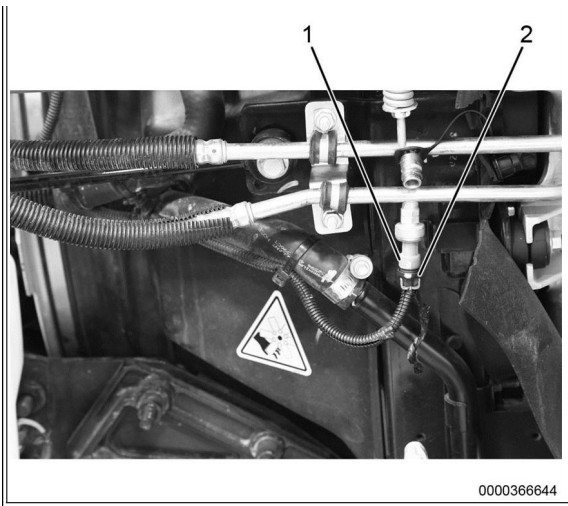
Figure 5: Pressure Transducer (PT) Sensor.
 Item 1: PT sensor
 Item 2: Harness

21. Disconnect harness (Figure 5, Item 2) and remove the existing PT sensor (Figure 5, Item 1) from the liquid line.

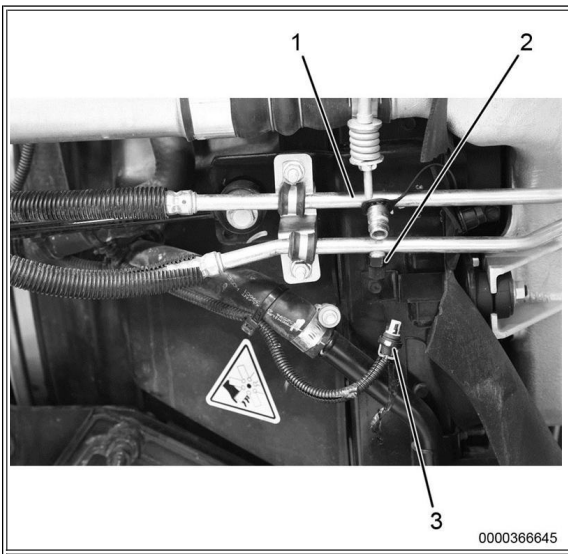
Figure 6: AC Compressor Discharge Line - N13 Equipped ProStar 122.
 Item 1: Discharge line
 Item 2: Kit-supplied cap
 Item 3: PT sensor connector

- 22. **MaxxFace 13 / N13 - engine equipped vehicles**, remove compressor discharge line and discard.
- 23. **MaxxFace 13 / N13 - engine equipped vehicles**, install kit-supplied discharge line (Figure 6, Item 1). Secure using existing P-clamps and new tie-wraps.
- 24. **MaxxFace 13 / N13 - engine equipped vehicles**, install kit-supplied cap (Figure 6, Item 2) into liquid line. Tighten securely.

32. Remove existing PT sensor connector (Figure 6, Item 3) from loom and cut from harness jumper.

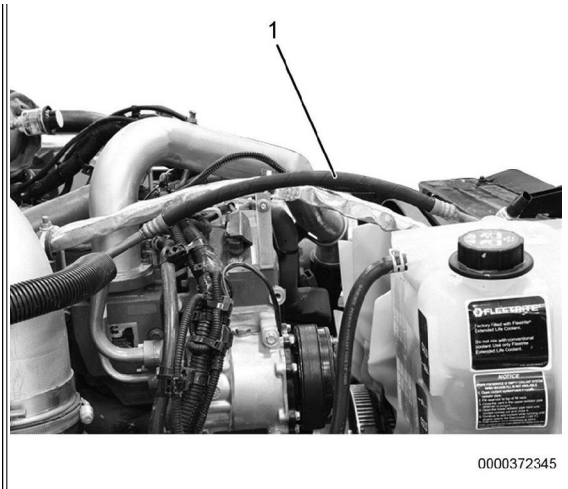
Figure 7: A/C Compressor Discharge Line - Cummins Equipped ProStar 122.

Item 1: Discharge line

- 25. **Cummins - engine equipped vehicles**, remove compressor discharge line and discard.
- 26. **Cummins - engine equipped vehicles**, install kit-supplied discharge line (Figure 7, Item 1) at compressor.

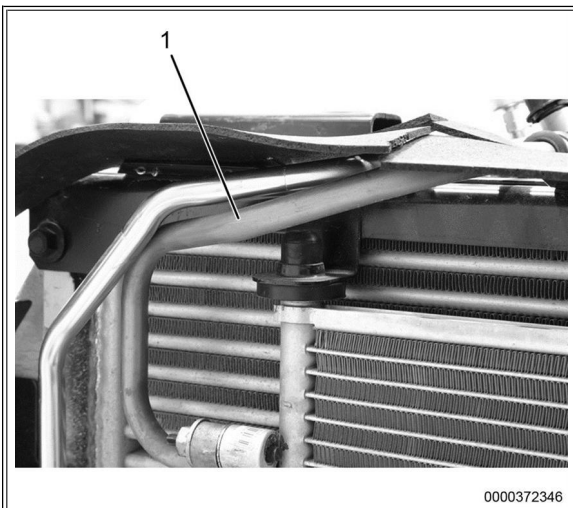
Figure 8: A/C Compressor Discharge Line - Cummins Equipped ProStar 122.

Item 1: Discharge line

Vehicles built before 14 April 2014 may be equipped with A/C lines that resemble those shown in Figure 8.

27. **Cummins - engine equipped vehicles**, ensure the discharge line (Figure 8, Item 1) is installed behind the liquid line:

- Position the discharge line under the liquid line.
- Install fastener at compressor. Ensure there are adequate gaps between the liquid and discharge lines.
- Once properly aligned, secure using existing P-clamps and new tie-wraps.
- Some production build levels may require the installation of the kit-supplied cap into liquid line. Tighten securely.

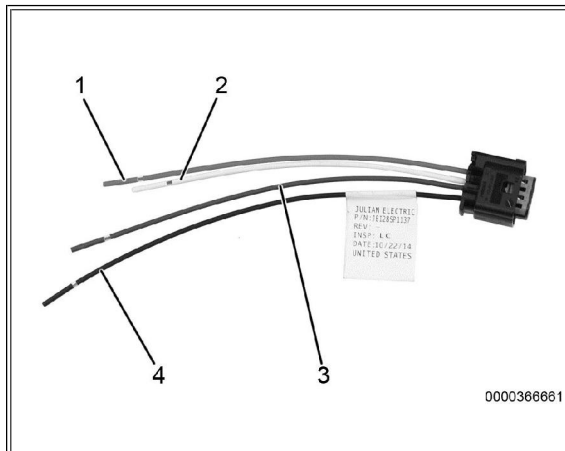
Figure 9: Pigtail

Item 1: Red (Kit) to Gray (Factory) Circuit K6DB
 Item 2: White (Kit) to White (Factory) BCM Circuit
 Item 3: Green (Kit) to Green (Factory) Circuit K77B
 Item 4: Black (Kit) to Gray (Factory) Circuit K9AA or K9AAA

33. Prepare existing PT jumper harness by trimming wire lengths to properly align to new PT sensor connector pigtails (Figure 9, Items 1-4).

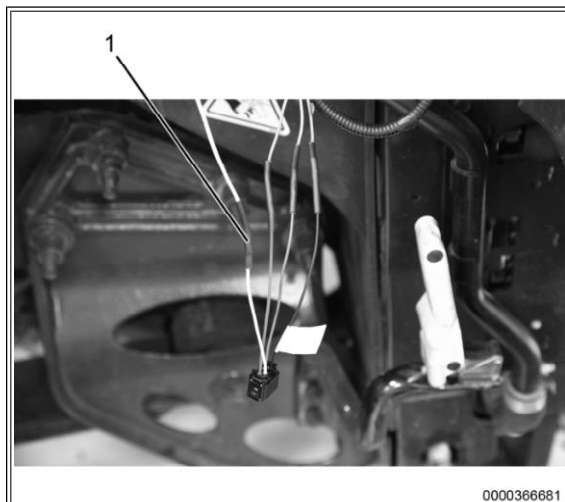
Figure 10: Pigtail Splice.

Item 1: Splice

34. Using Navistar approved Proper Procedure for Wire Repair / Splice Operation (SFN-0639), splice and solder (Figure 10, Item 1) the kit-supplied connector pigtails to the factory PT sensor harness.

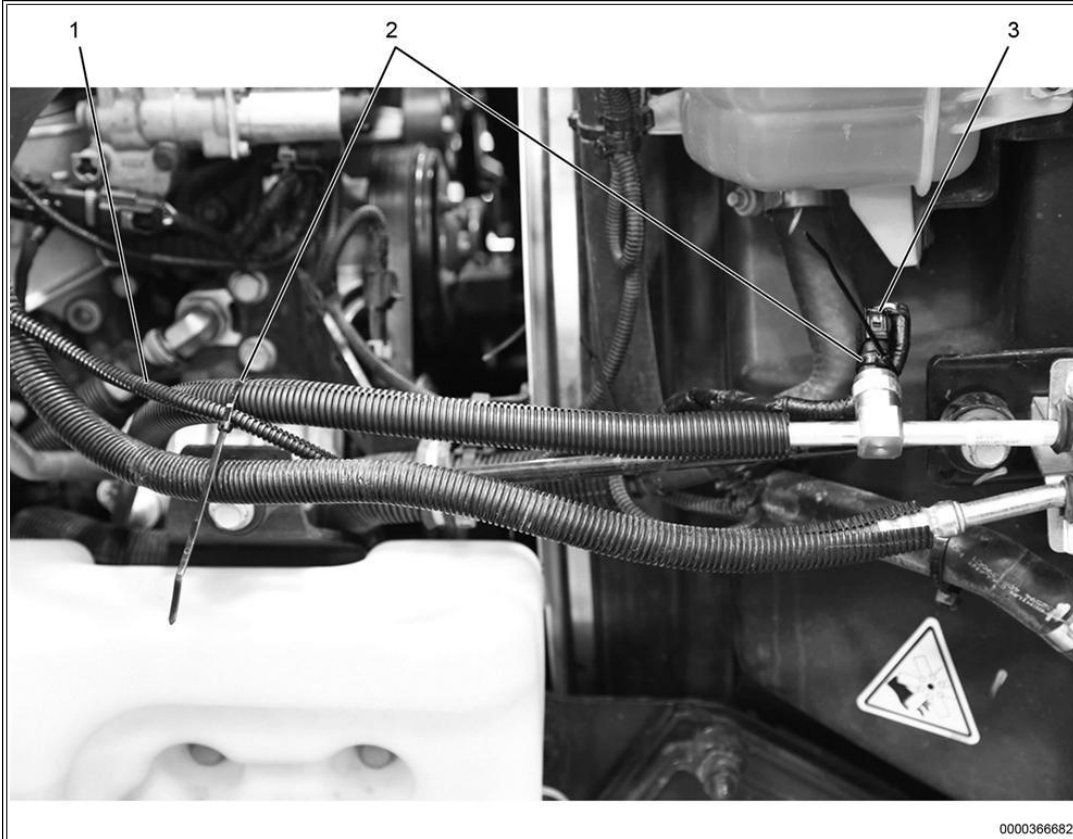
Figure 11: Kit-Supplied PT Sensor - N13 Equipped ProStar 122.

- Item 1: Kit-supplied harness / loom
- Item 2: Tie-wrap (as needed)
- Item 3: Kit-supplied PT sensor connector

36. Connect kit-supplied sensor connector (Figure 11, Item 3, or, Figure 12, Item 1 [Dependent On Engine Equipped]) to new PT sensor, pre-installed on new discharge line.

37. Secure sensor connector (Figure 11, Item 3, or, Figure 12, Item 1 [Dependent On Engine Equipped]) and harness / loom (Figure 11, Item 1, or, Figure 12, Item 3 [Dependent On Engine Equipped]) with tie-wraps (Figure 11, Item 2, or, Figure 12, Item 2 [Dependent On Engine Equipped]).

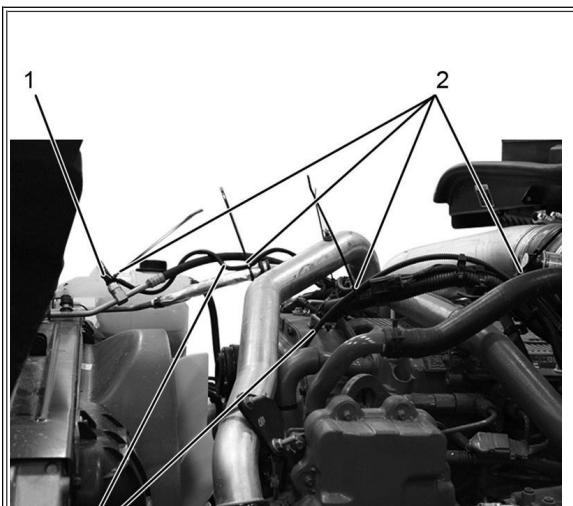
Figure 12: Kit-Supplied PT Sensor - Cummins Equipped ProStar 122.

Item 1: Kit-supplied PT sensor connector
 Item 2: Tie-wrap (as needed)
 Item 3: Kit-supplied harness / loom

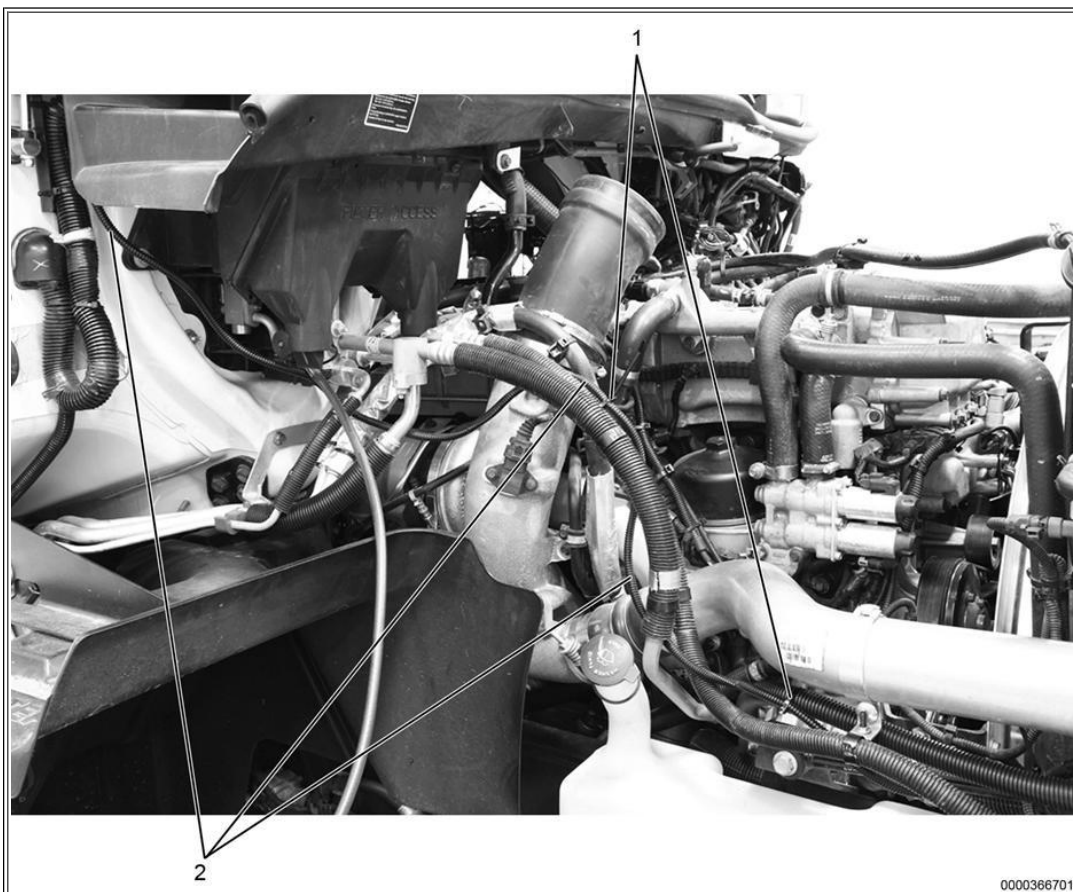
Figure 13: Kit-Supplied PT Sensor - N13 Equipped ProStar 122.

Item 1: Tie-wrap
 Item 2: Kit-supplied harness / loom

39. Continue securing harness (Figure 13, Item 2, or, Figure 14, Item 1 [Dependent On Engine Equipped]) towards cowl using tie-wraps (Figure 13, Item 1, or, Figure 14, Item 2 [Dependent On Engine Equipped]).

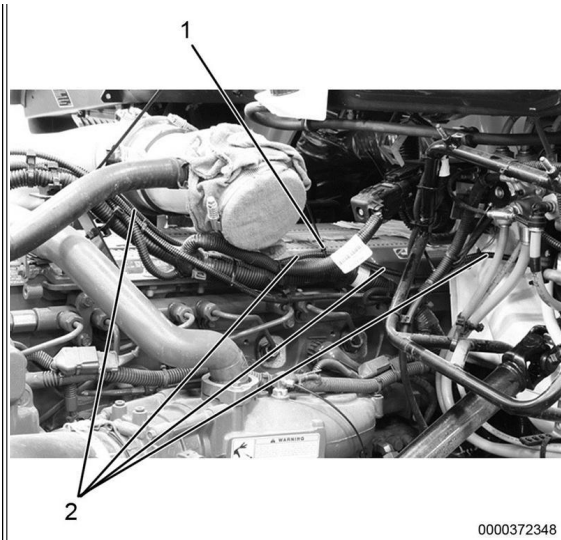
Figure 14: Kit-Supplied PT Sensor - Cummins Equipped ProStar 122.
 Item 1: Kit-supplied harness / loom
 Item 2: Tie-wrap

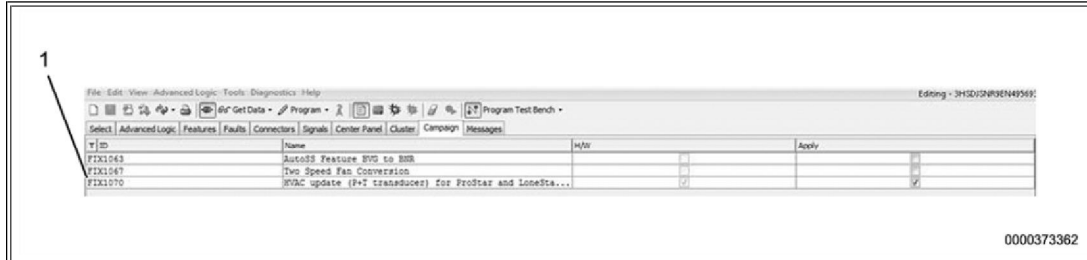
Figure 15: Campaign FIX.

Item 1: Campaign fix parameter

- Launch DLB, connect to internet and verify latest release is installed.
- Connect the vehicle to DLB.
- Click on SELECT tab.
- Verify VIN selected is correct.
- Click on CAMPAIGN tab.
- Verify appropriate FIX parameter is shown (Figure 15, Item 1). Refer to the HVAC FEATURE CODES table listed above.
- Click on APPLY SELECTED CAMPAIGN button.
- Click on FEATURE tab.
- Verify correct parameter is selected.
- Depending on vehicle configuration (Day Cab, Conventional, No-Idle Sleeper), locate and check the new HVAC feature code. Refer to the HVAC FEATURE CODES table listed above.
- After checking on new HVAC feature code, click SAVE and PROGRAM VEHICLE.
