**Document ID:** IK0800231

**Title: ECM and TCM Clean Power Harness Fuse Location**

**Applies To: RE Bus Models, Built November 20, 2009 to April 27, 2010, with VIN BBxxxxxx**

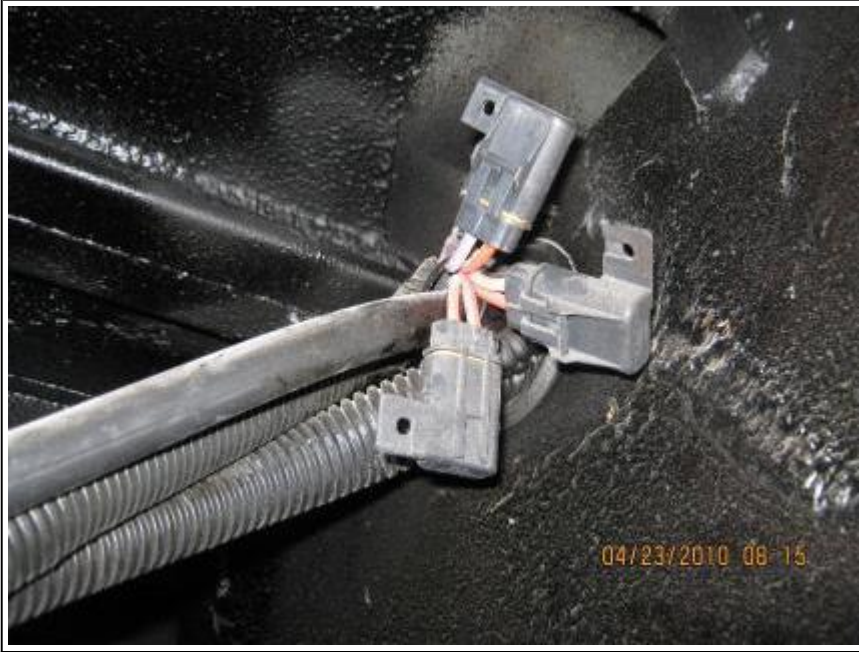
**Figure 1**

Fuses located exterior of the battery box can be found at the chassis harness routing point at the rear of the battery box. (Figure 1)

The clean power harness will have sufficient length to move the fuses to the interior of the battery box if required for standardization. The fuses are sealed connectors and will not introduce additional service issues.

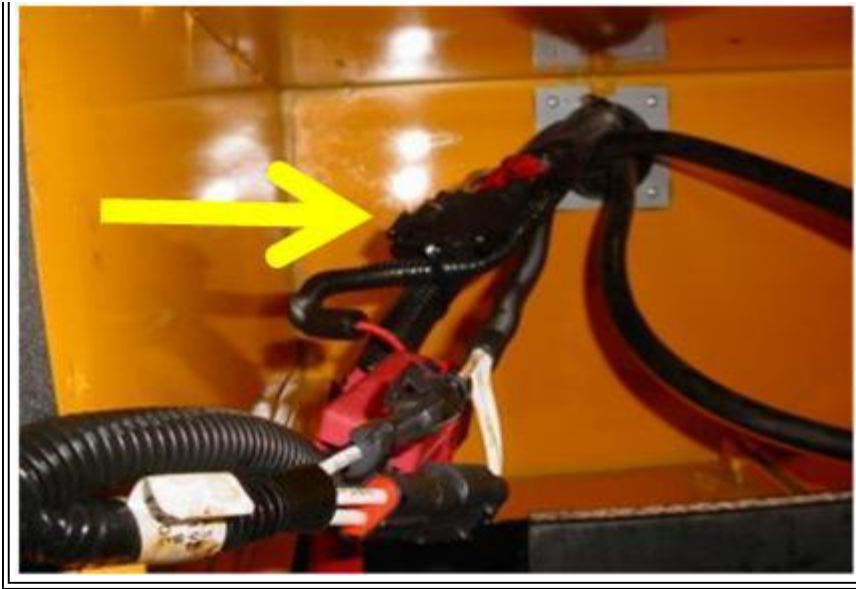
**Figure 2**

Units produced before and after the suspect build range will have the fuses routed to the interior of the battery box with the fuse caps strap locked to the battery cables. (Figure 2)
