Title: Remote Power Module (RPM) Visual Inspection Guidelines

Applies To: WorkStar and DuraStar vehicles built before March 2009

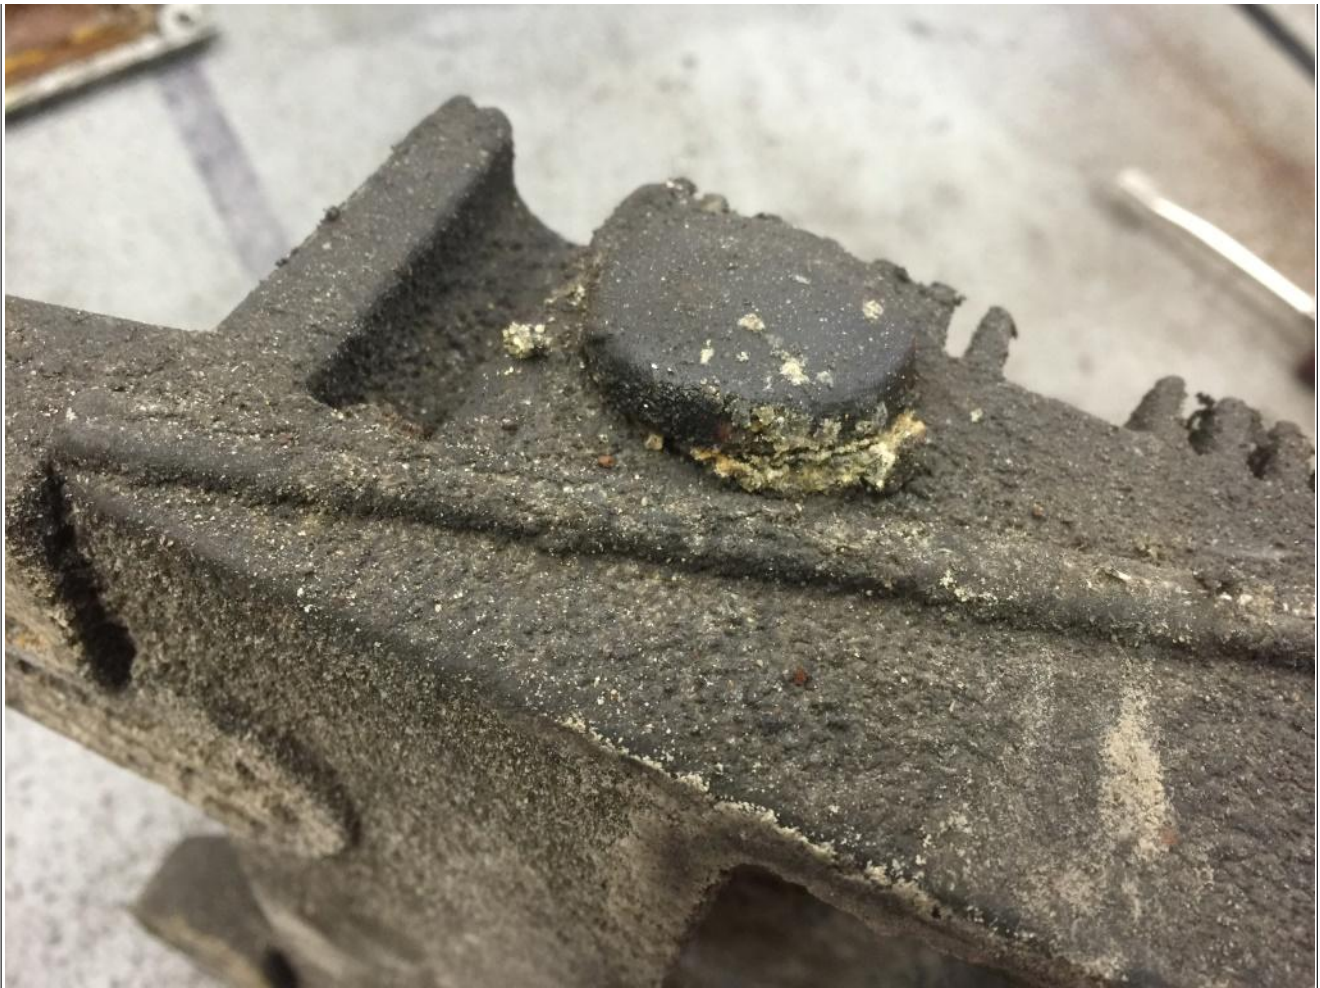
Figure 2: The plug is being pushed upward by debris and it is clear that debris has begun to enter inside of the housing. This RPM should be replaced.

See service manual for removal and installation procedures.
