**Document ID:** IK1600219  
**Revision:** 1  
**Created:** 9/18/2015  
**Last Modified:** 10/22/2015  
**Author:** Andrew Miles

**Title:** ESPAR Preventative Maintenance / Inpection

**Applies To:** Prostar / Lonestar with Feature Code 16UZL

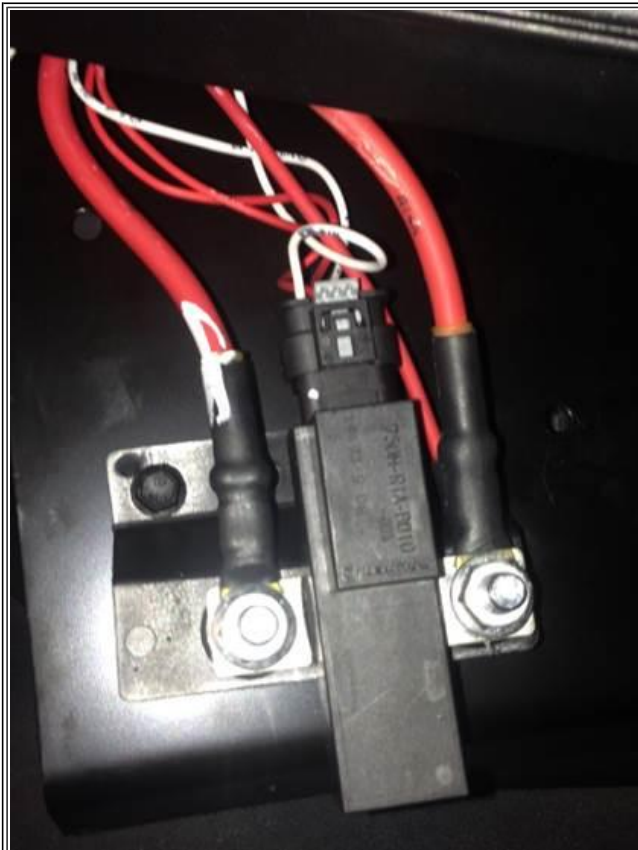
**Figure 1: Load Shed Relay - Correct Wiring Configuration.**

This document will guide the user through a preventative maintenance / inspection procedure of the Load Shed Relay wiring connections. Certain vehicles may have been built with load shed relay wiring incorrectly connected. This could lead to an incorrect shutdown of the ESPAR Hydronic D5 auxiliary heater.

Item 1: A14Y Cable  
 Item 2: A14X / A14XX Cables  
 Item 3: Load Shed Relay

1. With interior doghouse / cover removed, inspect the wiring of the load shed relay (Figure 1, Item 3):

- Cable marked A14Y (Figure 1, Item 1) must be installed on the operator side of the relay.
- Cables marked A14X and A14XX must be installed together on the passenger side of the relay.

2. If necessary, disconnect wiring and correct accordingly.
