**Countries:** CANADA, UNITED STATES, MEXICO **Document ID:** IK1201243  
**Availability:** ISIS, Bus ISIS, FleetSIS **Revision:** 2  
**Major System:** ENGINES **Created:** 11/20/2014  
**Current Language:** English **Last Modified:** 4/10/2015  
**Other Languages:** NONE **Author:** Aaron Mimbs  
**Viewed:** 1628

**Title:** MaxxForce 7 Internal/External Coolant Leak Diagnostics and Repair

**Applies To:** ALL MaxxForce 7

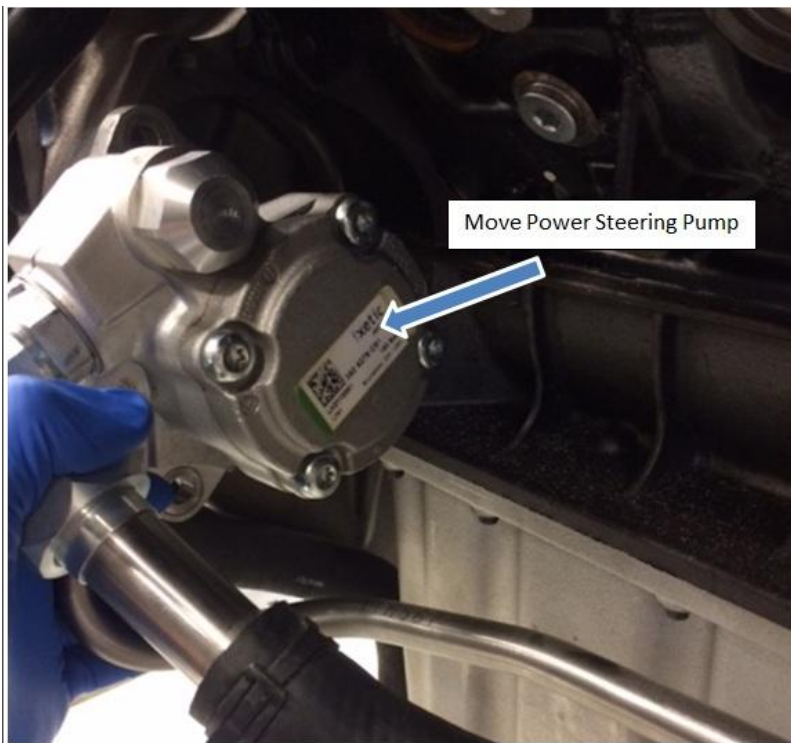
**Figure 8: Move Power Steering Pump Away from Working Area**

5. Swing the Power Steering Pump out of the repair area.

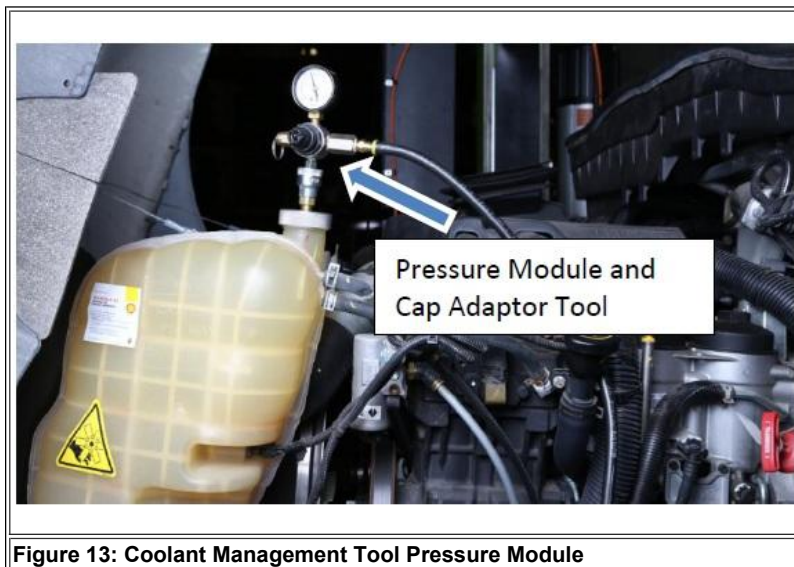
9. Using the CMT pressure regulator, reopen the valve to blow air through the entire block. Allow the air to continue flowing during the entire block preparation portion of this repair.

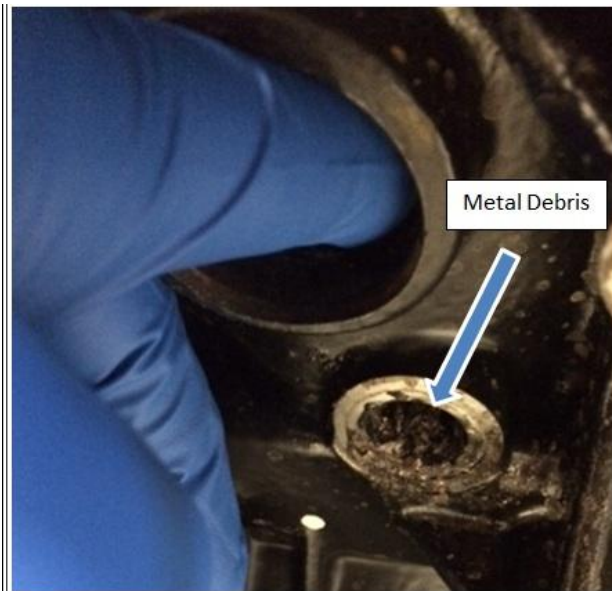
**Figure 14: Metal Debris Removal**

10. Going through the 38mm freeze plug opening, clear any debris in the galley by pushing, flushing, and blowing it out of the 16mm hole (Using your hand will be required to clear the area of debris).

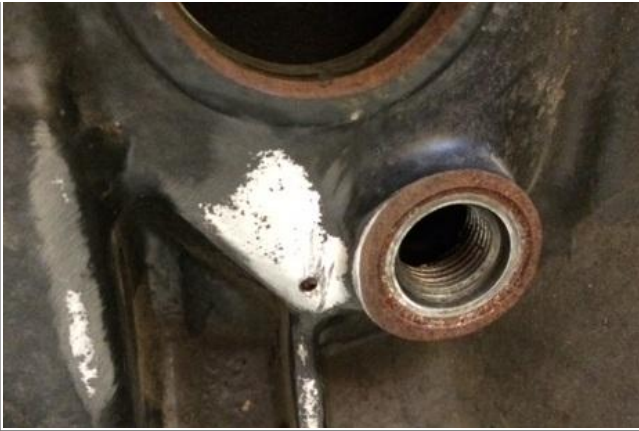
**External Figure 1: External Leak Paint Removed**

**External Leak Step 1.** Buff down and clean block surface around the perforation to remove the paint and expose the metal (This may cause the hole to increase in size, this is OK). Do not grind the block, grinding creates deep grooves which may not seal properly allowing coolant to leak past the epoxy. If the block surface is extremely smooth/glossy the epoxy may also not adhere properly, use sanding material to roughen the surface.

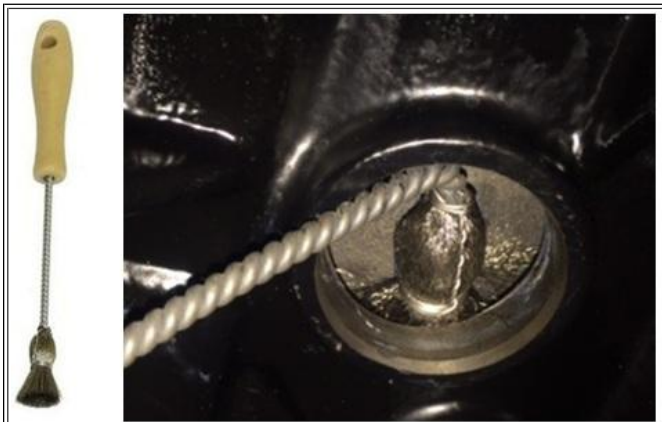
**Figure 16: Using ZTSE4391 to scrub the cavity**

**12.** Using ZTSE4391 scrub the cavity (If necessary degrease and clean the brush before using). Spray a small amount of WD-40 into the cavity to further break down the corrosion build-up and aid in the scrubbing process.

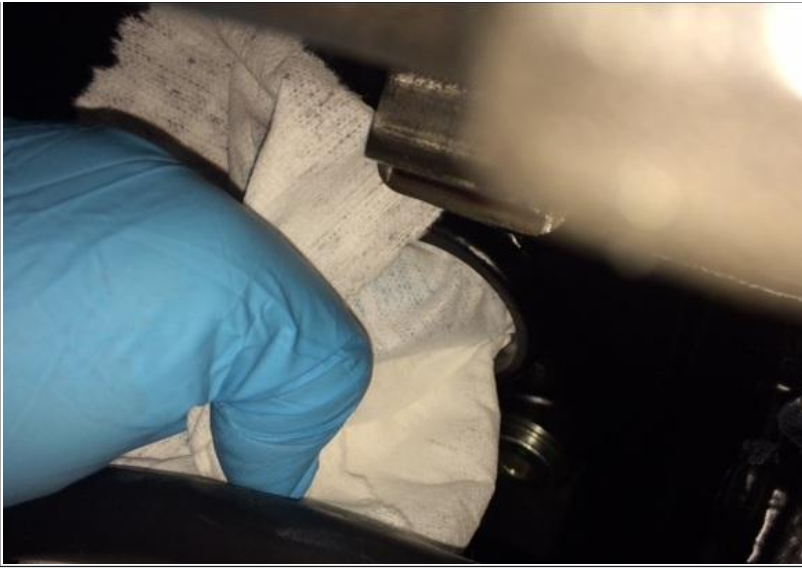
**Figure 17: Wiping the cavity clean**

**13.** Using a clean rag or a clean paper towel wipe the inside of the cavity to remove deposits that could not be flushed. Repeat steps 12 and 13 until no more debris can be removed. Once acceptable, degrease the cavity again with brake cleaner to remove the WD-40 deposits, make sure to wipe it dry several times, preferable with a non-shedding rag.

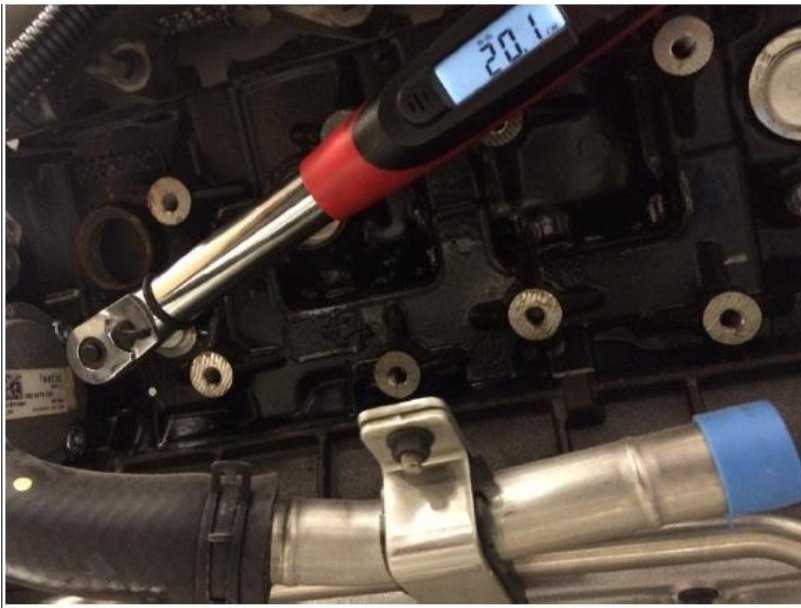
**Figure 20: Install and Torque New Hex Plug**

**16.** Install the new 16mm Hex Plug provided in the repair kit and torque to 20 ft-lb.

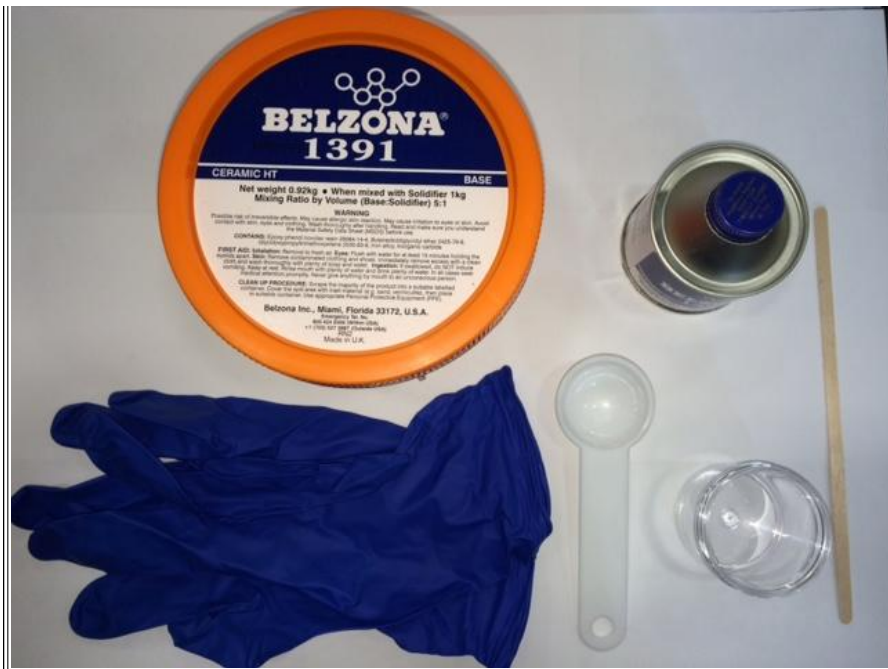
**Figure 21: Belzona 1391 Epoxy Mixing Supplies**

17. Gather the kit 2514509C91 for mixing the Epoxy (Belzona 1391 Base and Solidifier, Gloves, Mixing Cup, Mixing Stick, and 1 Tablespoon (Obtained Locally)).

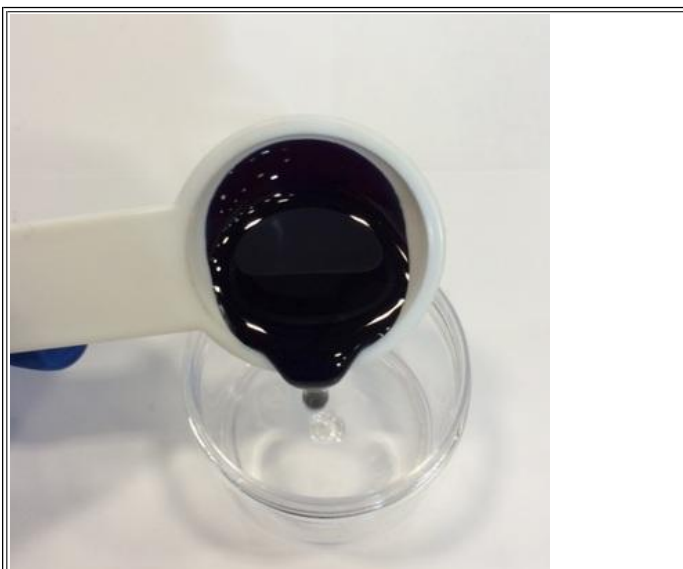
**Figure 22: Belzona 1391 Solidifier (0.6 of a Tablespoon)**

**18.** Measure out 0.6 of a Tablespoon (Just over half of the tablespoon) of the blue solidifier and pour it into the mixing cup. If measuring by weight this is equivalent to 9.1 grams of the solidifier.

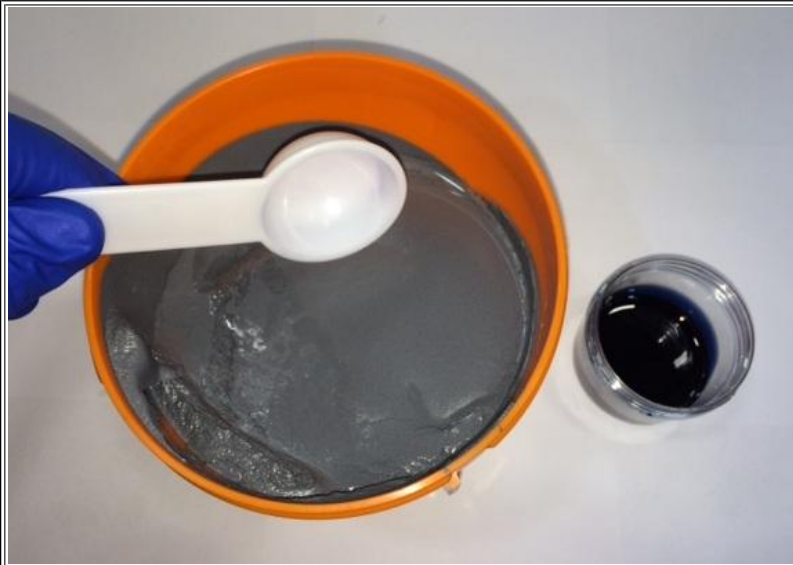
**Figure 23: Clean Tablespoon to Measure Epoxy Base (3 Tablespoons)**

**19.** Clean the tablespoon so it does not mix the Solidifier into the bulk Epoxy Base container. Failure to do so will result in curing and waste of the epoxy base.

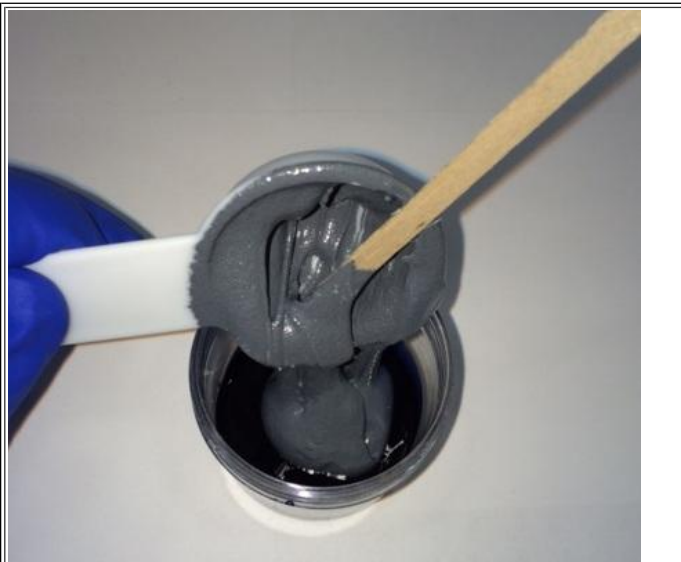
**Figure 24: Scrape Epoxy Base into Mixing Cup**

**20.** Measure out 3 tablespoons of the epoxy base and add to the cup with the solidifier, scrape out as much from the spoon as possible. If measuring by weight this is equivalent to 119 grams of the base or a combined weight of 128 grams. You must discard the measuring spoon if it cannot be fully cleaned. **DO NOT REUSE A DIRTY SPOON OR A SPOON WITH EPOXY RESIDUE.**

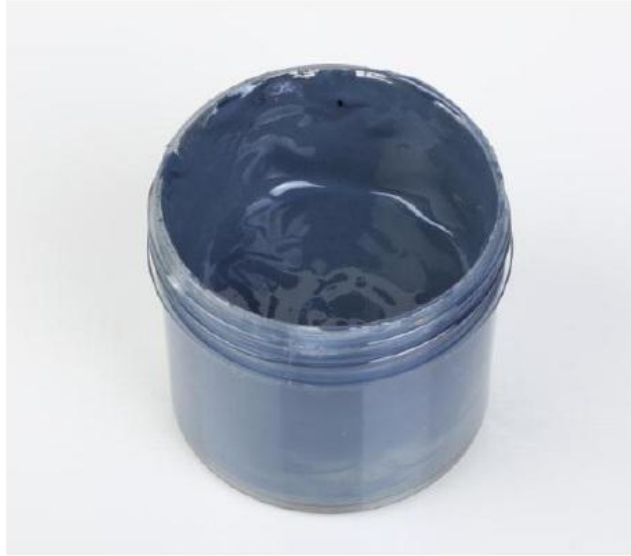
**Figure 25: Fully Mixed Belzona 1391 Ceramic Epoxy**

21. Using the provided mixing stick; thoroughly mix the epoxy until the blue solidifier is no longer visible and the epoxy has become a consistent color. Scraping the bottom and sides of the mixing cup will be required to fully mix the epoxy.

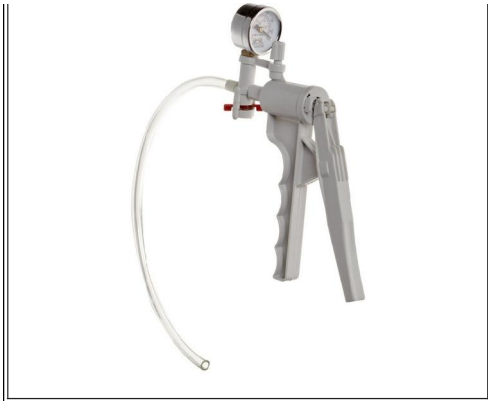
**External Figure 2: Hand Vacuum Gun**

**External Leak Step 3.** If the external perforation is large enough allow some epoxy to seep out of the hole to fill it. If no epoxy seeps out, and if in a good location use a hand held vacuum gun, place the flexible tube opening over the perforation on the outside of the block and draw out a small amount of epoxy to fill the hole. If fluid or debris comes with the epoxy wipe it off the block so it does not contaminate the block's surface and prevent proper adherence of the epoxy to the outside of the block. In some cases the hole may be large enough to allow epoxy to continue to run out, if this is the case temporarily blocking the hole may be required to keep the epoxy in the cavity. Once the epoxy thickens enough the blockage may be removed.

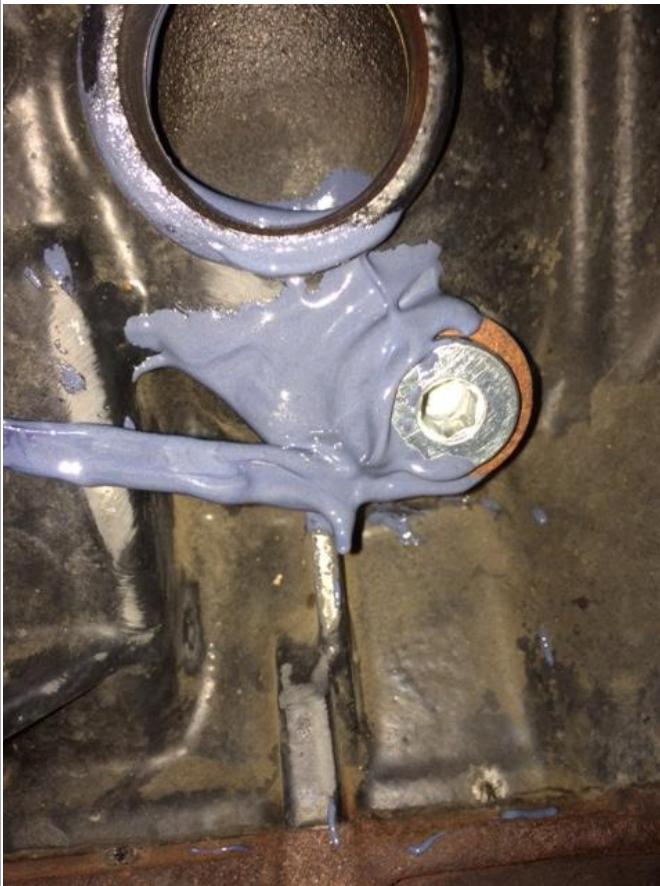
**External Figure 3: Paste epoxy on the outside of the engine block**

**External Leak Step 4.** Using the left over epoxy, paste and press it into the perforation area using the mixing stick; if the epoxy is too thin, allow it to thicken in the ambient atmosphere. Continuously mix and monitor the epoxy to make sure it does not over cure not allowing for proper application. After application, allow the epoxy to cure for 30 minutes before applying the heat gun for final curing. When the epoxy is initially mixed, raising the temperature thins out the epoxy making it harder to work with and may cause it to run off the block.

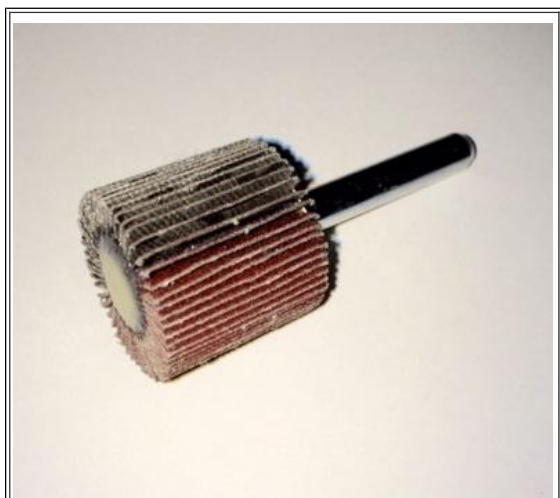
**Figure 30: Flap Disc**

**26.** Once cured, clean off the freeze plug opening with a flap disc to remove any residual epoxy and rust. Once cleaned, install the new 38mm freeze plug using ZTSE4509 with a thin layer of RTV on the rim of the cup. A 24mm socket may be used in substitution if unavailable, note it will be more difficult to align the cup.
