**Countries:** CANADA, UNITED STATES **Document ID:** IK1500080  
**Availability:** ISIS, Fleet!SIS **Revision:** 0  
**Major System:** FUEL SYSTEMS **Created:** 3/16/2015  
**Current Language:** English **Last Modified:** 4/27/2015  
**Other Languages:** NONE **Author:** Jon Pierce  
**Viewed:** 193

**Title:** Updated Snow Valve Motor and Harness Installation Procedure

**Applies To:** All Units Utilizing Snow Valves

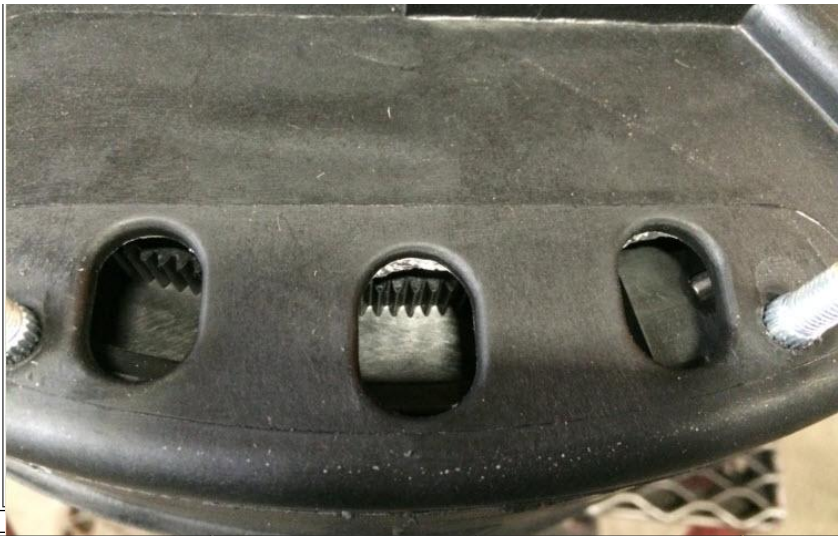
| Item 1: Old style Big Bore Motor (Red) | Item 2: Updated Big Bore Motor (Blue) | Item 3: Updated Medium Duty Motor (White) | Item 4: Old Style Medium Duty Motor (Black) |

| Step | Action | Decision |
|---|---|---|
| 1 | <b>Inspection: Does the snow door rotate to full open and full close?</b> | Yes:<br><br>Inspect color of motor cover on air cleaner assembly. If the motor is blue or white it has already been replaced. |

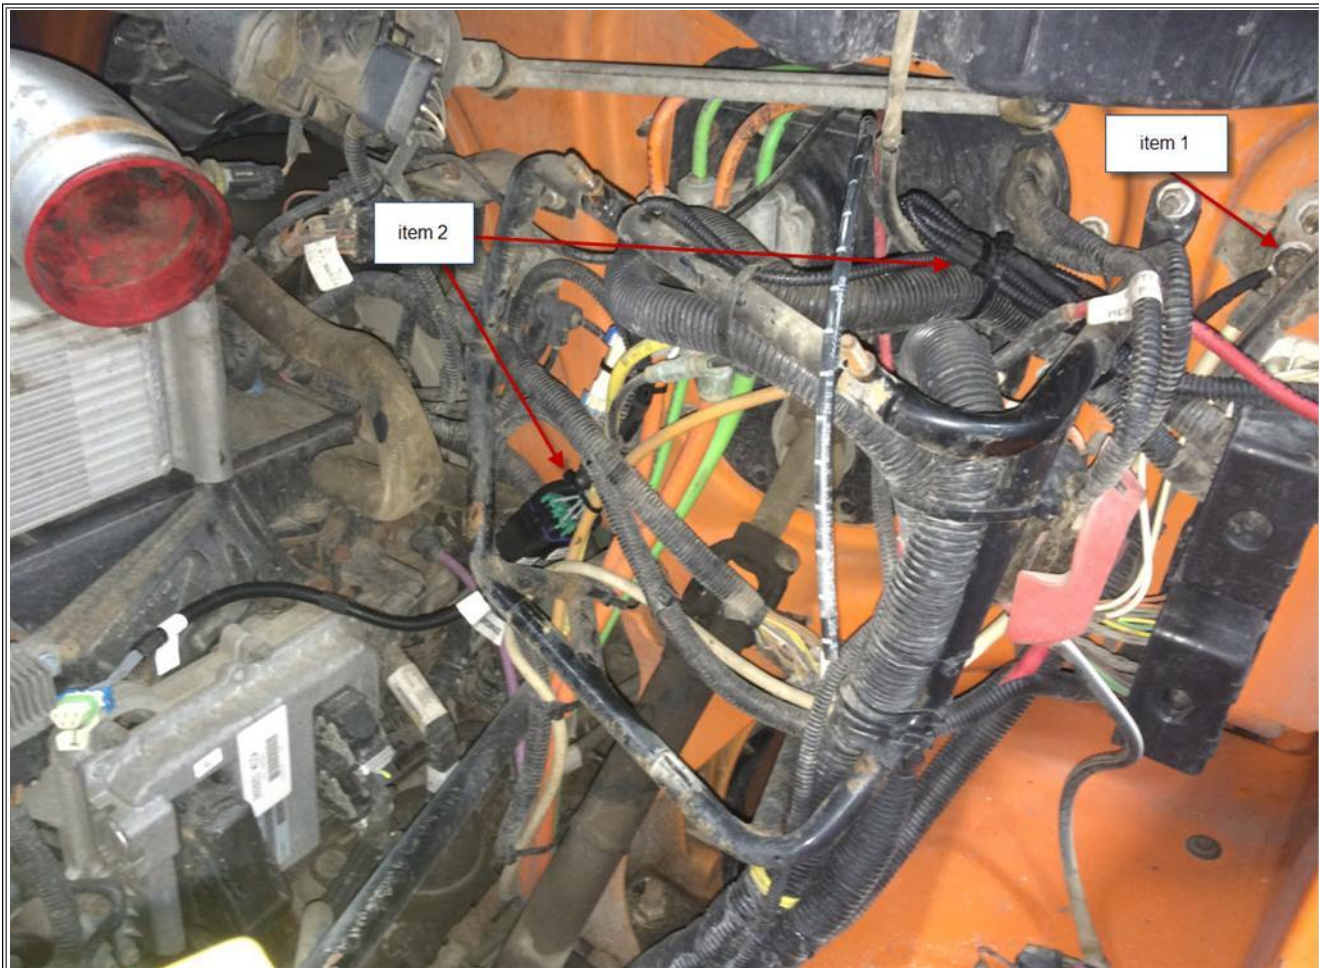
**Figure 3: Suggested Harness Routing for Big bore engines (15" housing)**

Item 1: Ground wire Installation point  
Item 2: Typical route and clipping points.

1. Install the new snow valve motor, and torque nuts to standard torque while applying pressure to the motor to remove clearance between the snow valve motor teeth and snow valve baffle teeth.
2. Install the snow valve relay harness behind the air cleaner housing mounting bracket. Connect the female connector to the truck's original snow valve harness.
3. Route the ground wire to the cab left side ground stud (figure 3, item 1)
4. Secure the new harness to existing harnesses in the truck using zip ties (figures 3 and 4).
5. Reinstall the air cleaner housing, torque hold down nuts to standard torque.
6. Connect the male end of the harness to the snow valve motor.
7. Re-attach intake restriction hose.
8. Re-attach intake hose pipes.
9. Inspect for proper operation.
10. Reinstall air filter and housing cover.
11. Remove all wheel chocks, lower and secure hood.
