**Countries:** CANADA, UNITED STATES, MEXICO **Document ID:** IK1201238  
**Availability:** ISIS **Revision:** 5  
**Major System:** ENGINES **Created:** 11/5/2014  
**Current Language:** English **Last Modified:** 7/24/2015  
**Other Languages:** NONE **Author:** Caleb Iverson  
**Viewed:** 3829

**Title:** Medium Duty (I6) Low Pressure Turbo Center Section Replacement Procedure

**Applies To:** EPA 10 MaxxForce DT/9/10

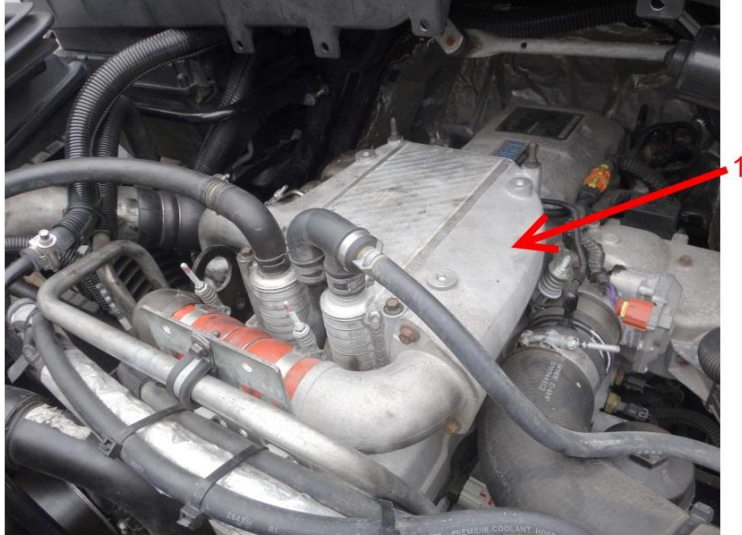
Item 1: Interstage Cooler (ISC)

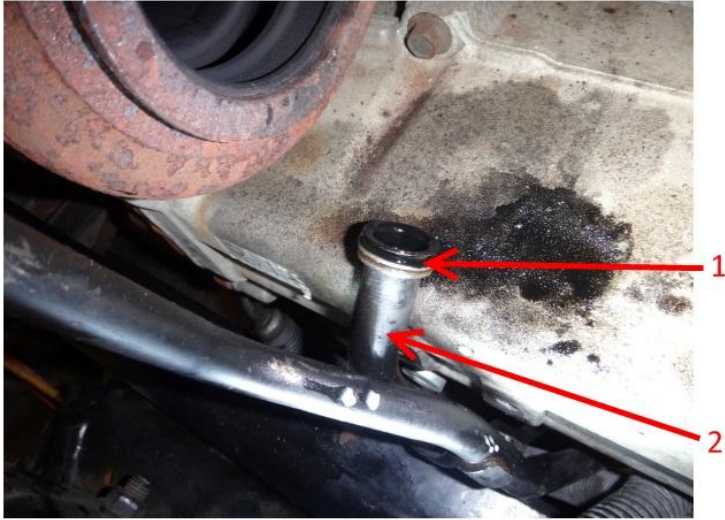
**Figure 4: Oil Supply Tube at Oil Cooler Housing**

Item 1: LP Turbocharger Oil Drain Tube O-Ring (Yellow)  
Item 2: LP Turbocharger Oil Drain Tube

7. Remove LP Turbocharger Oil Drain Tube O-Ring (**Figure 4**, Item 1) from Oil drain tube (**Figure 4**, Item 2) and discard.
