Group:	0-General
Bulletin No.:	SB-15-010
Issue Date:	01-20-2014

## 2011MY-15MY EGR (Exhaust Gas Recirculation) Valve Heater

### OVERVIEW

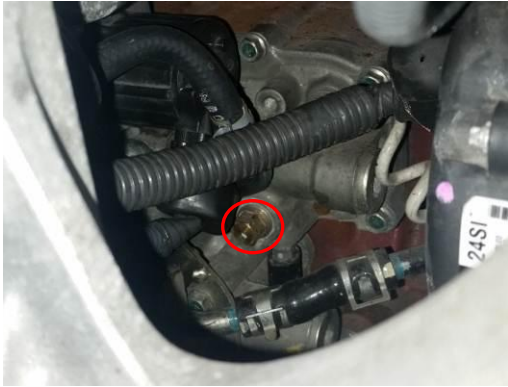
1. Drain the coolant from the engine into an appropriate container by loosening the drain plug on the oil cooler on the passenger side of the engine block. Once the coolant has drained, tighten the drain plug to the specified torque.

**Specified Torque:** 32.5 lb-ft (44 Nm)

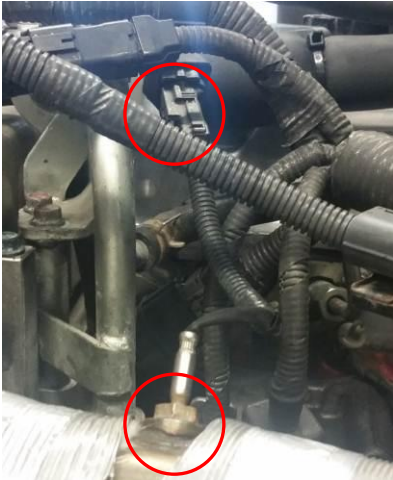
**2011-2013MY**

2. Remove the EGR cooler outlet temperature sensor. For 2011-2013MY, slide the connector off the mounting tab before removing the sensor so the wires can rotate. For 2014-2015MY the sensor uses a rotating threaded collar around the sensor, and does not have to be disconnected. Remove the EGR outlet temperature sensor from the EGR pipe, as shown near the bottom of both photographs below. Retain all parts for reassembly.

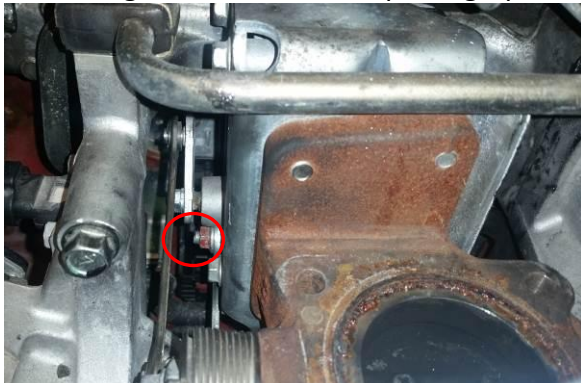
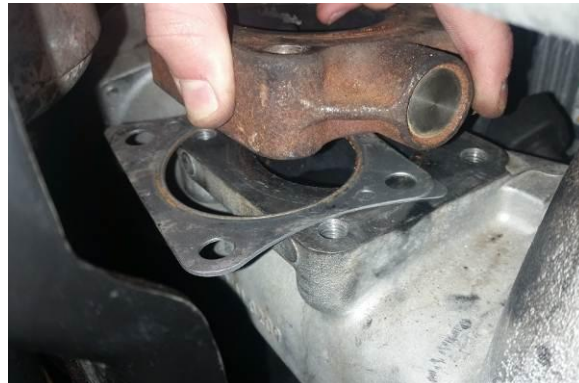
**4.** In order to remove the gasket from under the EGR valve and clean the mating surface of the EGR valve and intake manifold, it will be necessary to remove the nut securing the EGR valve to the brace attached to the side of the actuator. Retain this nut for reassembly and discard the EGR valve gasket. Refer to the photographs below for reference.

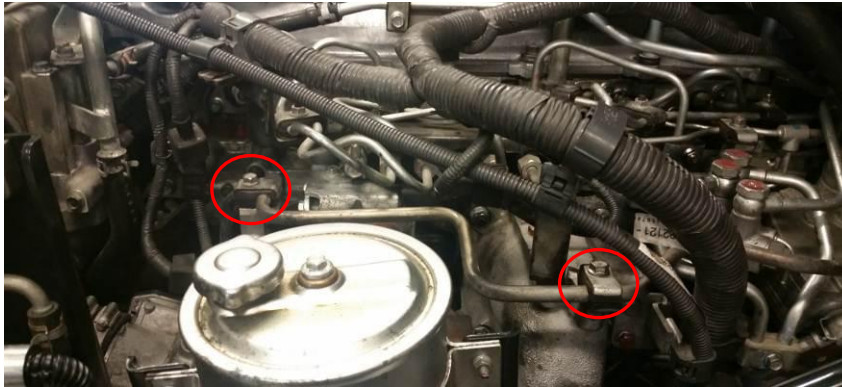
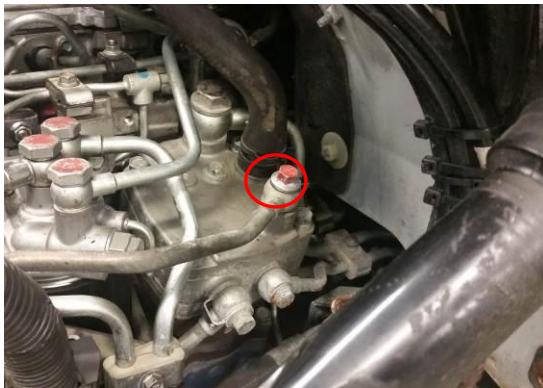
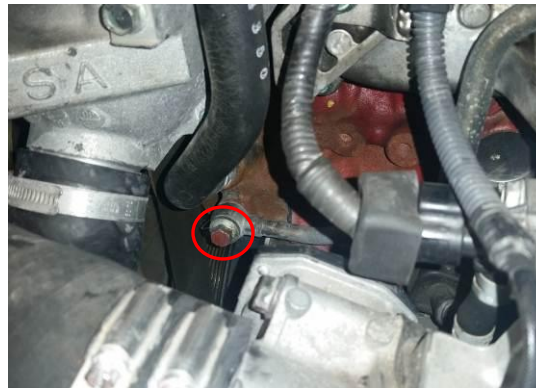
5. Remove the two bolts securing the pipe clips that hold the air compressor coolant pipe to the intake manifold. Remove the union bolts and sealing washers from the air compressor head and engine block. Discard these components. Refer to the photographs below for reference.

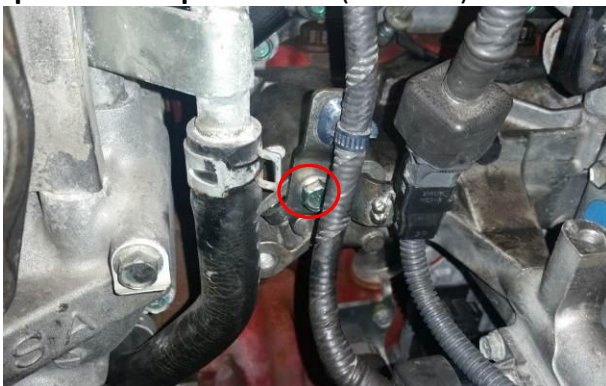
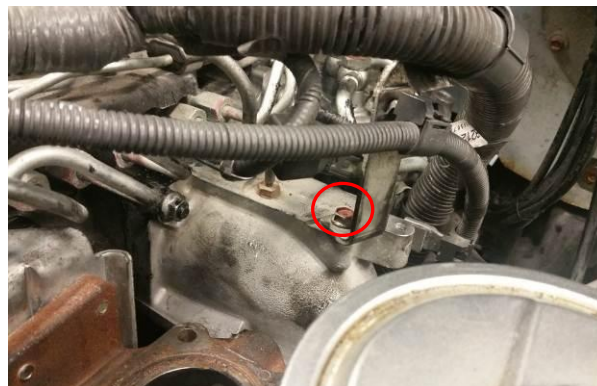
6. To remove the air compressor coolant pipe, two harness retainers at the front and center of the intake manifold will need to be removed to allow clearance. Remove one bolt per harness retainer and then remove the air compressor coolant pipe. Refer to the photographs below for reference. Once the coolant pipe is removed, the harness retainers can be reinstalled and the bolts tightened to the specified torque. Discard the coolant pipe.

**Specified Torque: 21 lb-ft (28.5 Nm)**

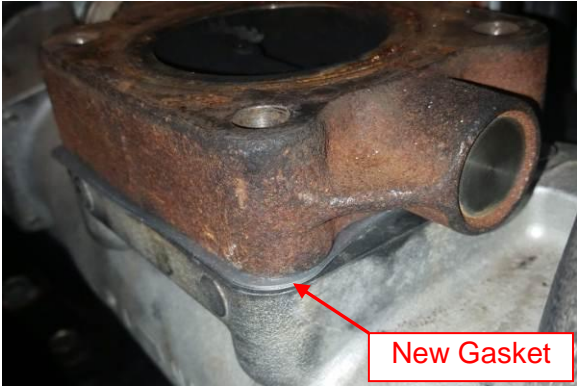
7. Clean the mating surface between the EGR valve and the intake manifold and place a new gasket in between these components

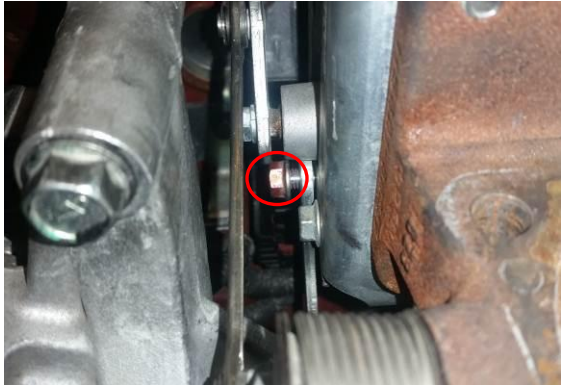
8. Thread the EGR valve brace nut back on the stud on the EGR valve, but do not tighten at this time.

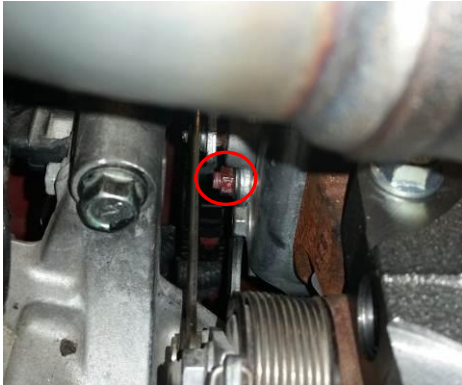
9. Install the new EGR pipe along with two new gaskets and seven new bolts. Hand tighten all bolts prior to tightening to the specified torque. Once the EGR pipe bolts have been tightened to the specified torque, tighten the EGR valve brace nut to the specified torque.

**EGR Pipe Bolts:** 40.5 lb-ft (55 Nm)  
**EGR Valve Brace Nut:** 21 lb-ft (28.5 Nm)

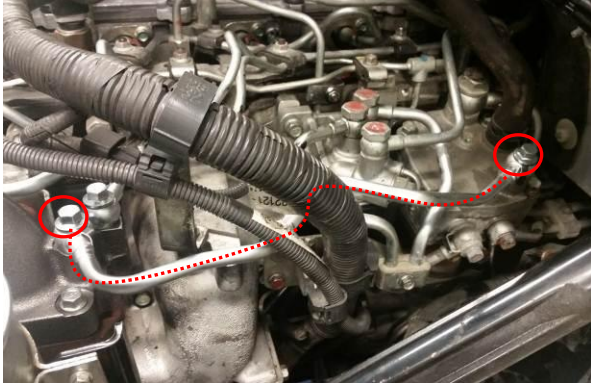
**10.** Install the two new air compressor coolant pipes using the four new union bolts and four new sealing washers to route coolant through the new EGR pipe. Hand tighten all union bolts and then tighten to the specified torque. Refer to the highlighted portions of the photographs below for pipe routing.

**Specified Torque:** 22 lb-ft (29.4 Nm)

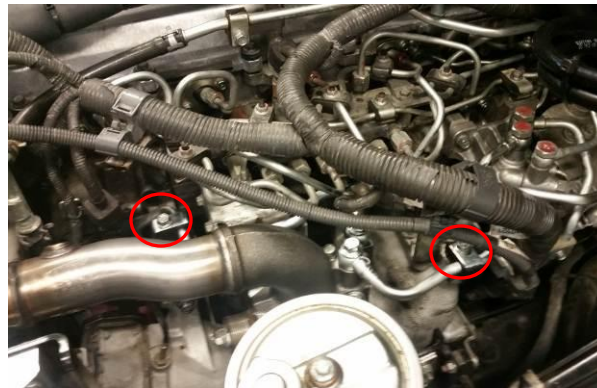
**11.** Install the two new coolant pipe attachment clips and bolts. These install in the same locations on the intake manifold from which the old components were removed. Tighten the bolts to the specified torque.

**Specified Torque:** 2.5 lb-ft (3.4 Nm)

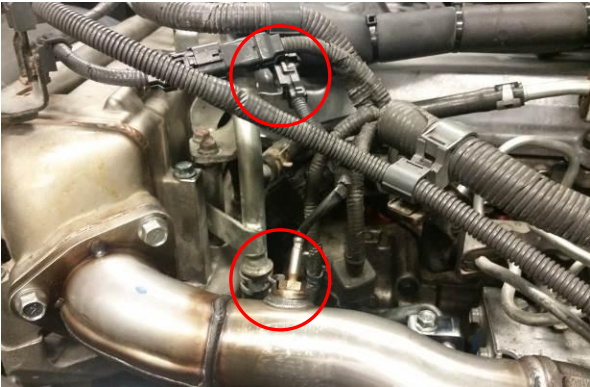
**2011-2013MY**

**12.** Clean the threads on the EGR cooler outlet temperature sensor that was removed in step 2. Reinstall the sensor and torque to the specified torque. Reconnect the electrical connector and harness clip for 2011-2013MY vehicles.

**EGR Temperature Sensor 2011-2013MY:** 14.5 lb-ft (19.6 Nm)  
**EGR Temperature Sensor 2014-2015MY:** 22 lb-ft (30 Nm)

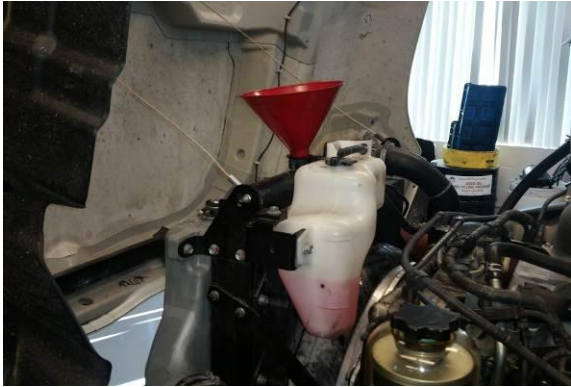
**13.** Refill the cooling system using the coolant that was drained from the vehicle.
