# TECHNICAL SERVICE BULLETIN

## 12MY-16MY 195, 195h COE STABILITY UPGRADE

Certain 12MY – 16MY Hino COE (Cab over Engine) trucks with a J05E engine.

| Bulletin No.: | SB-15-028 |

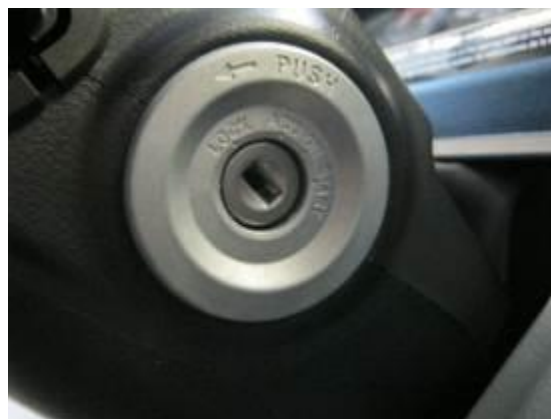
2. Confirm the engine is stopped, the ignition switch in the off (LOCK) position and the key is removed.

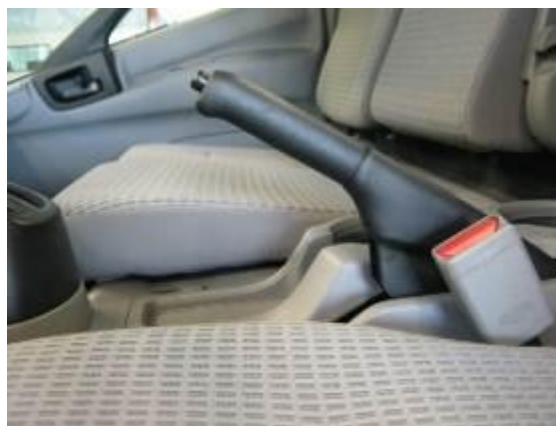
3. Apply the parking brake.

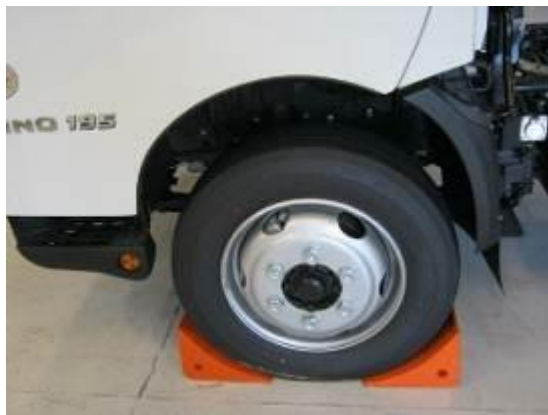
### 4. Chock the front wheels.

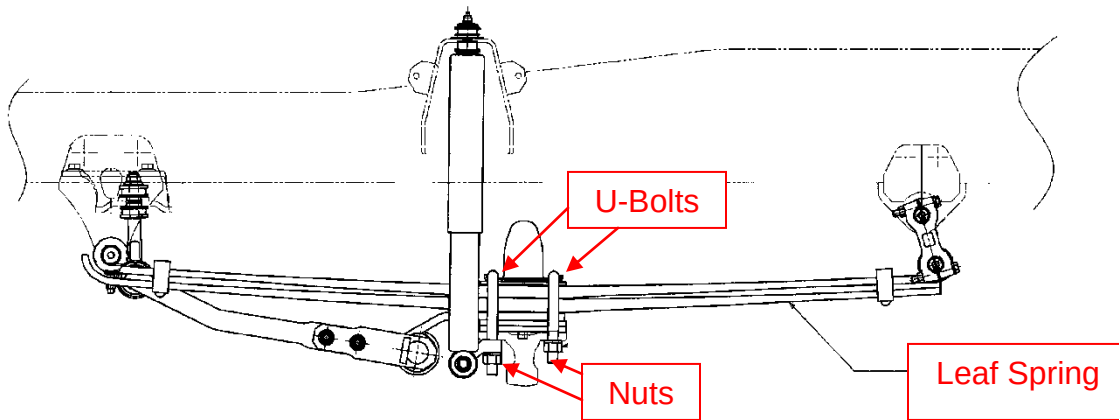
**1.** Raise and support the front of the vehicle using jack stands. Remove and discard the driver's side front leaf spring as outlined in the Suspension section of the Chassis Workshop Manual. The 2 U-bolts and 4 U-bolt nuts which secure the leaf springs to the front axle must be discarded.

**2.** Install the replacement front driver's side leaf spring (Part No. 4811037Y60) into the vehicle using new U-bolts and new U-bolt nuts following the procedure in the Chassis Workshop Manual Suspension section.

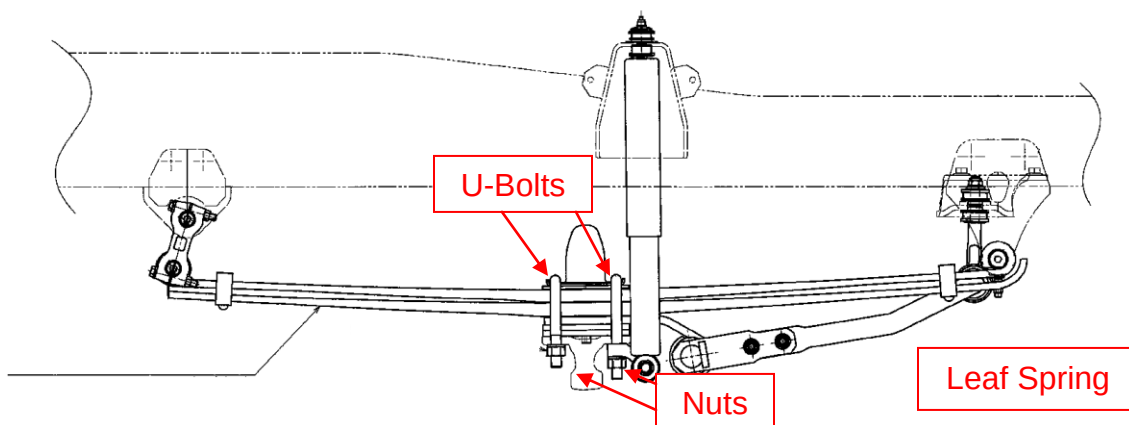
**3.** Remove and discard the passenger side front leaf spring as outlined in the Suspension section of the Chassis Workshop Manual. The 2 U-bolts and 4 U-bolt nuts which secure the leaf springs to the front axle must be discarded.

**4.** Install the replacement front passenger side leaf spring (Part No. 4811037Y70) into the vehicle using new U-bolts and new U-bolt nuts following the procedure in the Chassis Workshop Manual Suspension section. Lower the front of the vehicle onto the ground.

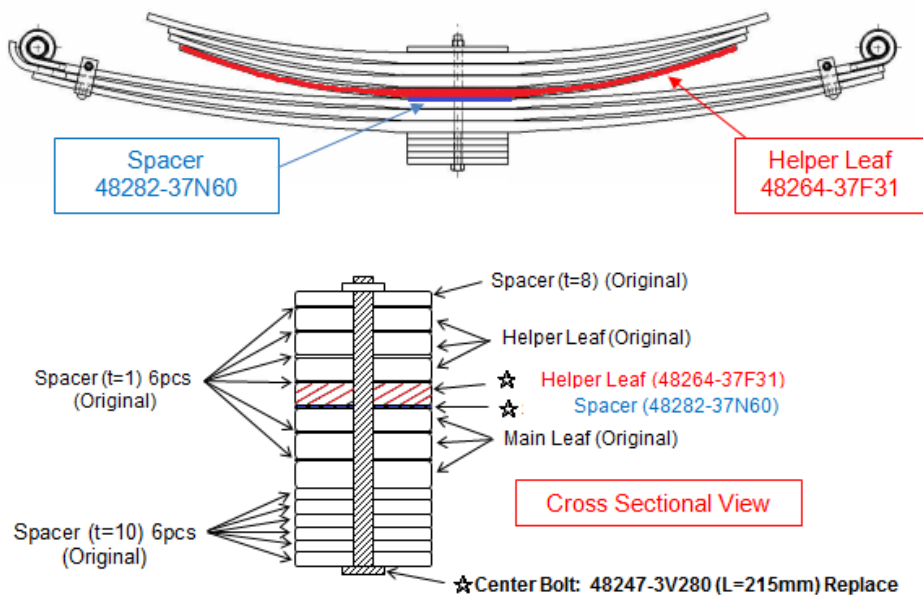
**2.** Assemble the spring pack referring to the diagram below for proper placement of the new helper leaf and spacer. Install the new center bolt (Part No. 482473V280) and center bolt nut (Part No. 482840W070) following the procedure in the Chassis Workshop Manual Suspension section.

**1.** Raise and support the rear of the vehicle using jack stands. Remove the driver's side rear leaf spring from the vehicle as outlined by the Suspension section of the Chassis Workshop Manual. Discard the 2 U-bolts and 4 U-bolt nuts which secure the leaf spring to the axle. Remove and discard the center bolt from the leaf spring as outlined in the manual. Discard the center bolt and center bolt nut. Retain the rear leaf spring for reinstallation. The spring pack will be modified to add an additional helper leaf and spacer.

- Reinstall the driver's side rear leaf spring assembly with the new helper leaf and spacer into the vehicle following the procedure in the Chassis Workshop Manual using new U-bolts and new U-bolt nuts.

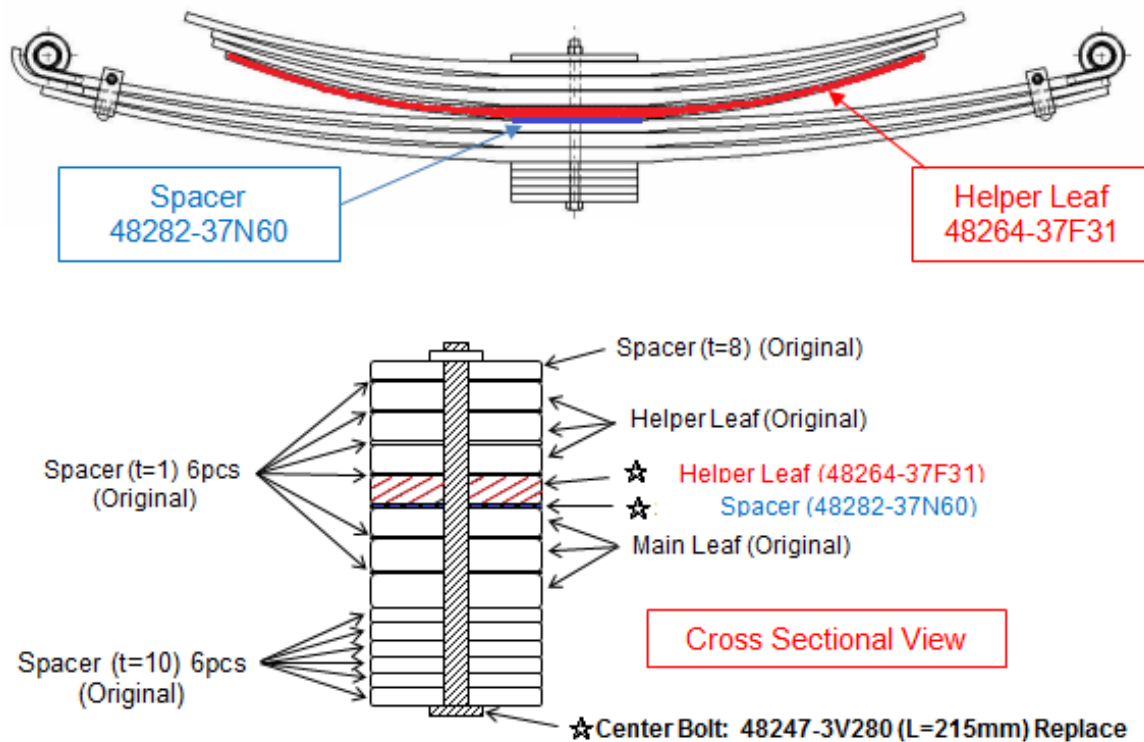
- Assemble the spring pack referring to the diagram below for proper placement of the new helper leaf and spacer. Install the new center bolt (Part No. 482473V280) and center bolt nut (Part No. 482840W070) following the procedure in the Chassis Workshop Manual Suspension section.

- Remove the passenger side rear leaf spring from the vehicle as outlined in the Suspension section of the Chassis Workshop Manual. Discard the 2 U-bolts and 4 U-bolt nuts which secure the leaf spring to the axle. Remove the center bolt from the leaf spring as outlined in the manual. Discard the center bolt and center bolt nut. Retain the rear leaf spring for reinstallation. The spring pack will be modified to add an additional helper leaf and spacer.

- Reinstall the passenger side rear leaf spring assembly with the new helper leaf and spacer into the vehicle following the procedure in the Chassis Workshop Manual using new U-bolts and new U-bolt nuts.

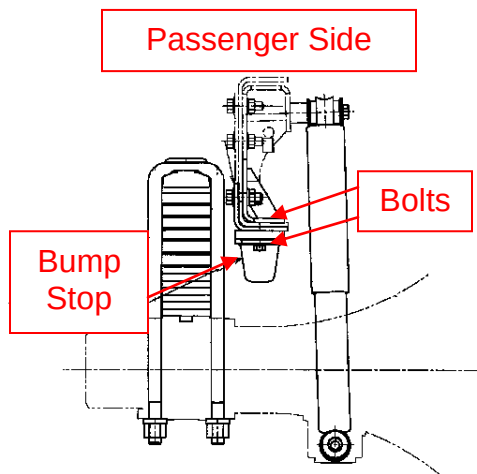
**7.** Remove and discard the 2 bolts retaining the left rear and right rear bump stops onto the frame. Discard the left rear and right rear bump stops.

**NOTICE:** The passenger side is shown in the illustration to the right. The driver's side, not shown, is similar.

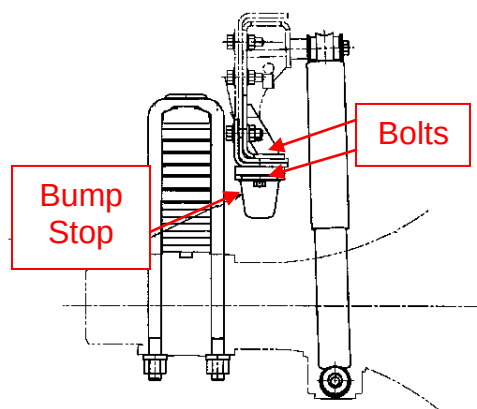
**8.** Install the new left rear and right rear bump stops (Part No. 4834437420). Install the 2 bolts retaining the left and the right rear bump stops onto the frame (Part No. 9155281020). Tighten the 2 bolts to the specified torque.

**NOTICE:** The passenger side is shown in the illustration to the right. The driver's side, not shown, is similar.

**Specified Torque:** 29 lb-ft (39 Nm)
