# TECHNICAL SERVICE BULLETIN

| Bulletin No: | SB-15-035 |

## COE SEAT FRAME BOLT LOOSE OR MISSING

**SUBJECT VEHICLES:** 13MY-16MY COE (Cab over Engine) Trucks (195, 195h)

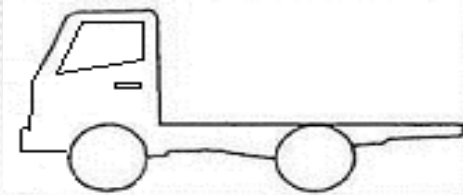
1. Park the vehicle on a flat, level and solid surface.

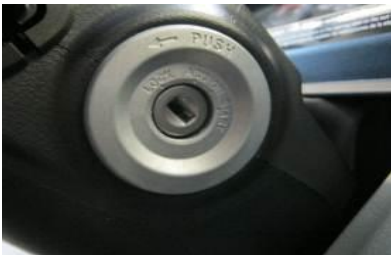
2. Confirm the engine is stopped, the ignition switch is in the off (LOCK) position, and the key is removed.

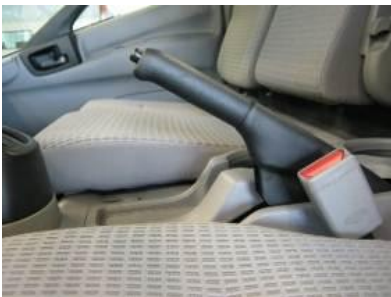
3. Apply the parking brake.

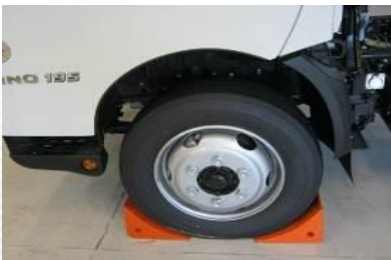
4. Chock all of the wheels.

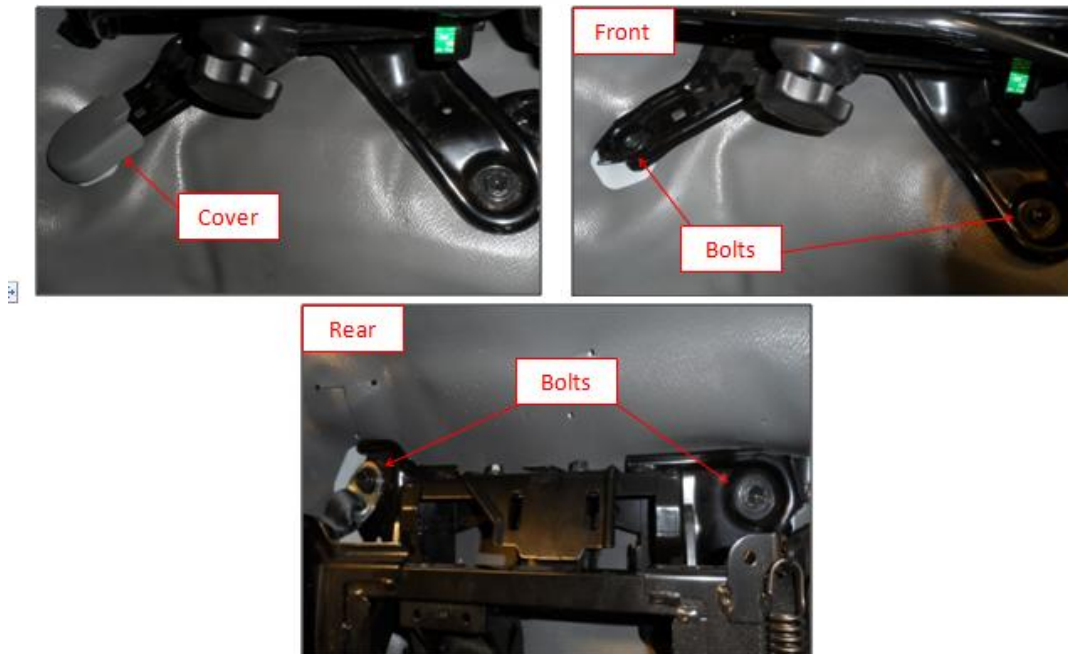
1. Remove the bolt cover from the front inboard side of the driver's seat frame. Remove the two bolts which retain the driver's seat to the floor of the vehicle and retain for reinstallation. Slide the seat to the forward position and remove the two bolts which retain the rear of the driver's seat to the floor. Remove the driver's seat from the vehicle.

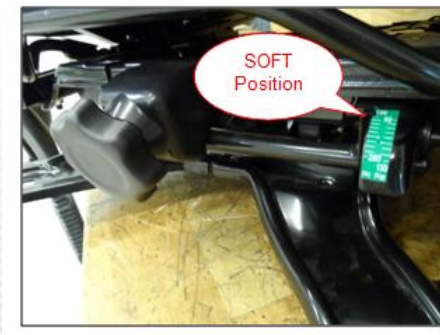
2. Place the seat on a work bench. Set the tension of the adjustment knob to the minimum/soft position.

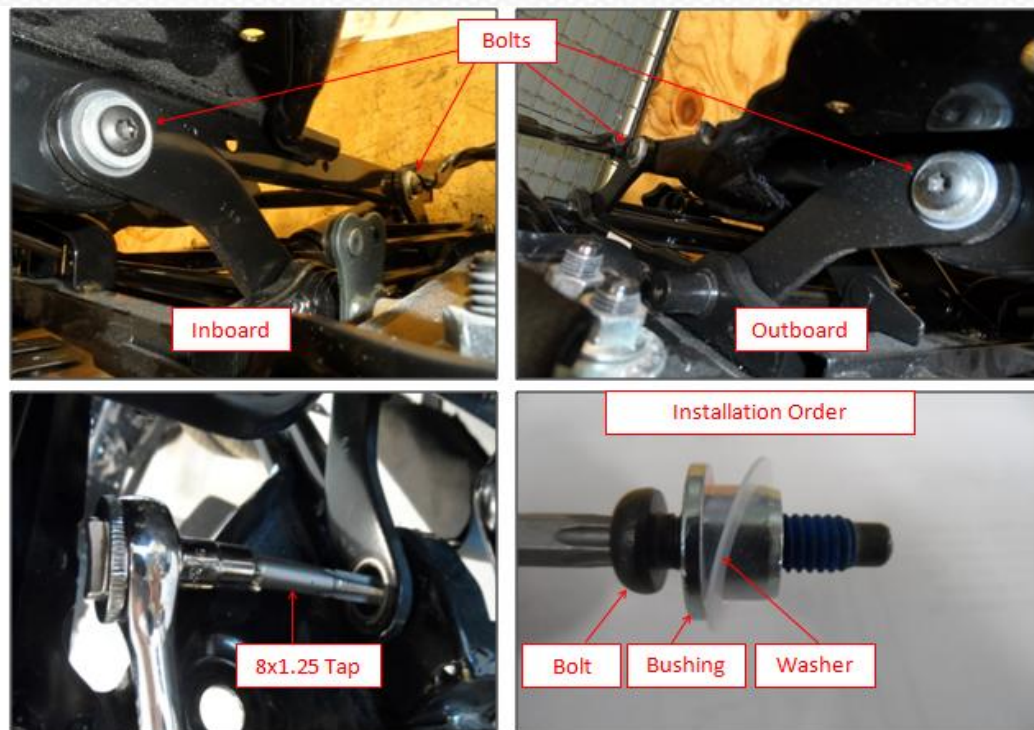
3. While using care not to stain or damage the upholstery, flip the seat over on the work bench. Locate the four pivot bolts under the seat. Remove and discard one of the four bolt, bushing, and washer combinations (unless missing). Clean the threads of the bolt hole using an 8x1.25 tap. Once the threads have been cleaned, install a new bolt, bushing, and washer. See the installation order photograph below. Tighten the bolt until snug using a T-40 Torx bit. The final torque will be applied in the next step. Repeat this process for the remaining 3 pivot bolts on the seat frame, one at a time. The threads must be cleaned, and a new bolt installed at all four bolt positions.

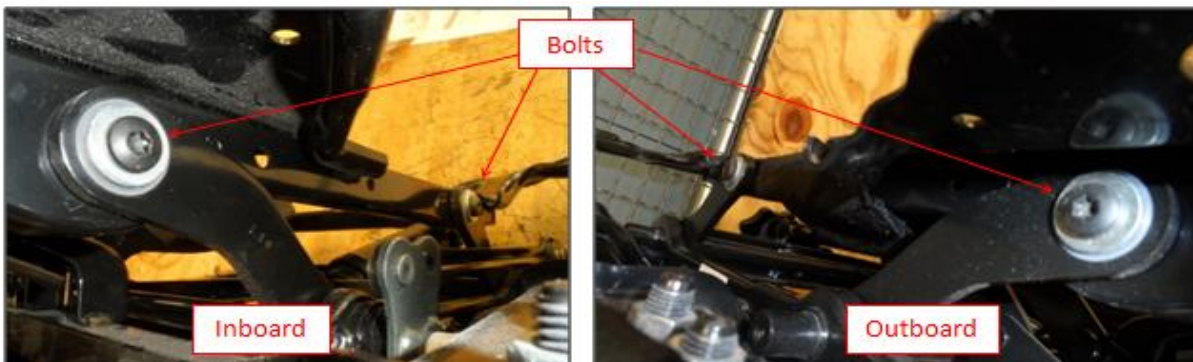
4. Tighten the four new pivot bolts to the specified torque.

**Specified Torque:** 18 lb-ft (25 Nm).

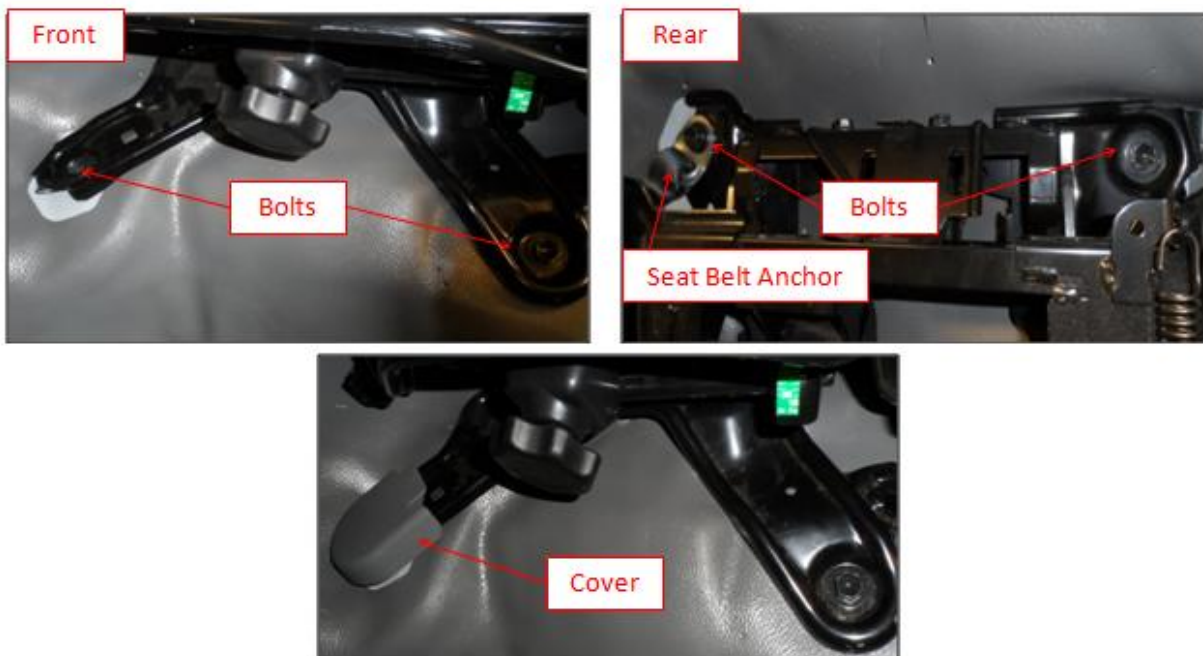
5. Position the driver's seat into the vehicle. Loosely install the four bolts which retain the driver's seat to the floor making certain that the inboard rear bolt is inserted through the seat belt anchor. See the photograph below. Tighten the four bolts to the specified torque. Reinstall the cover over the inboard front bolt once the bolts have been tightened to the specified torque.

**WARNING: NEVER** install the inboard rear seat frame bolt without first inserting it through the seat belt anchor. Failure to fasten the seat belt anchor properly may result in serious personal injury or death in the event of a collision.

**Specified Torque:** 29 lb-ft (39 Nm)
