# TECHNICAL SERVICE BULLETIN

| Bulletin No: | SB-15-036 |

## RADIATOR RESERVOIR TANK HOSE REPLACEMENT

**SUBJECT VEHICLES:** Certain 13MY-16MY Conventional Trucks (238, 258, 268, or 338) built between 8/1/2012 and 7/2/2015

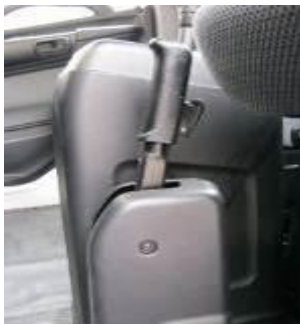
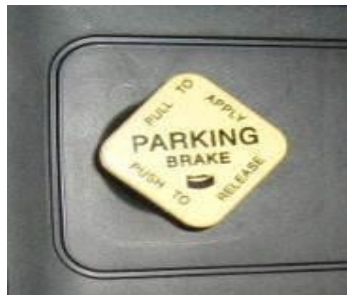
3. Apply the parking brake.

4. Chock all of the wheels.

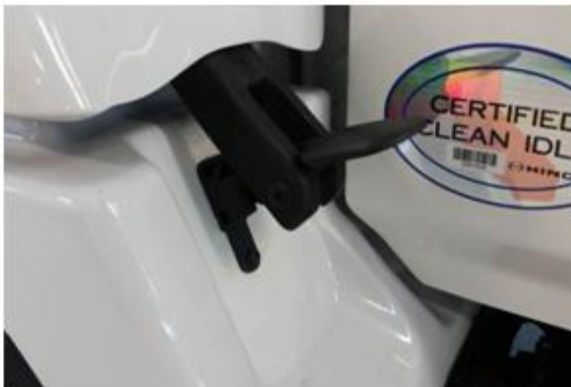
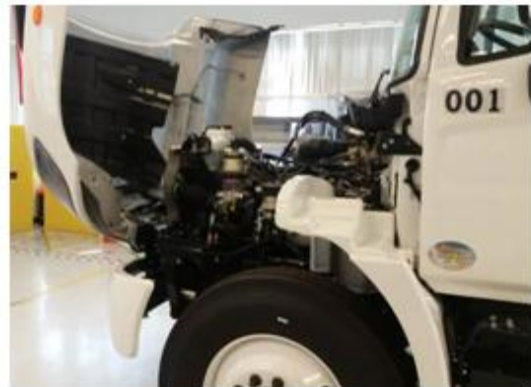
1. Release the hood latches and open the hood.

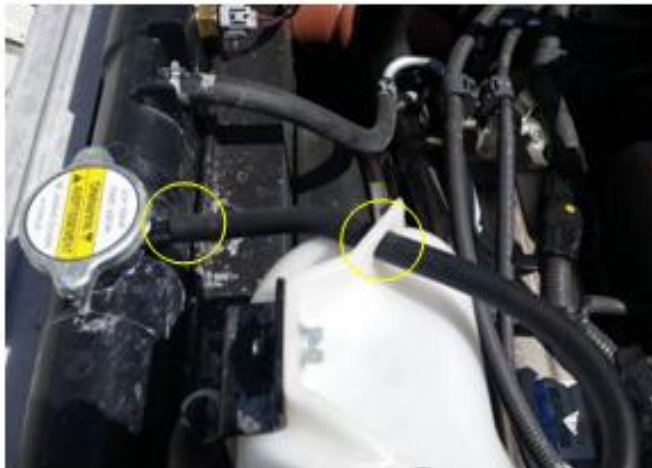
2. Disconnect the recovery hose from the radiator and feed it through the opening in the reserve tank.

The subject vehicle experiences coolant leakage from the radiator reserve tank recovery hose due to wear of the hose on the eyelet of the reserve tank. A protective cover has been added to prevent this wear from occurring.

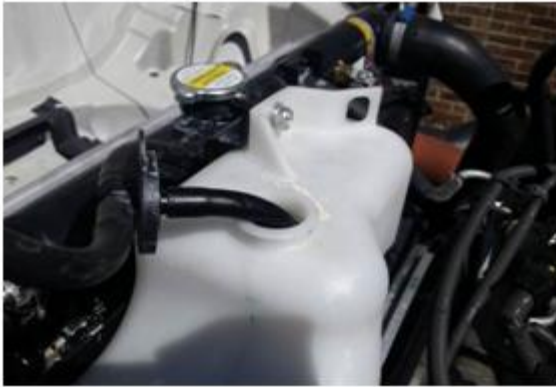
3. Remove the reserve tank cap.

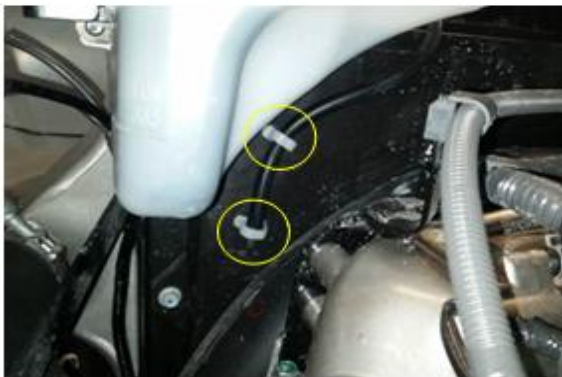
4. Working below the reserve tank on the radiator shroud, carefully slide the overflow hose out of the clips.

**NOTICE: Hold the clip while removing the hose to prevent breakage.**

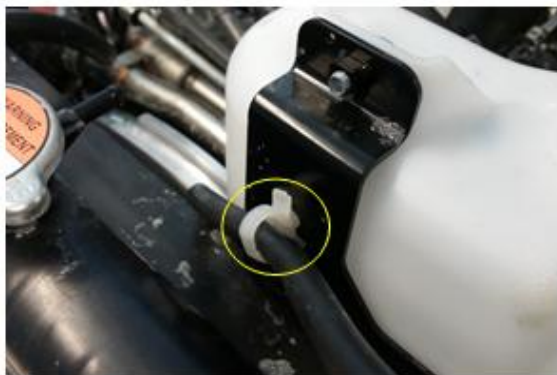
5. Slide the overflow hose out of the clip on the reserve tank bracket. Discard the old reserve tank cap and hose assembly.

**NOTICE: Hold the clip while removing the hose to prevent breakage.**

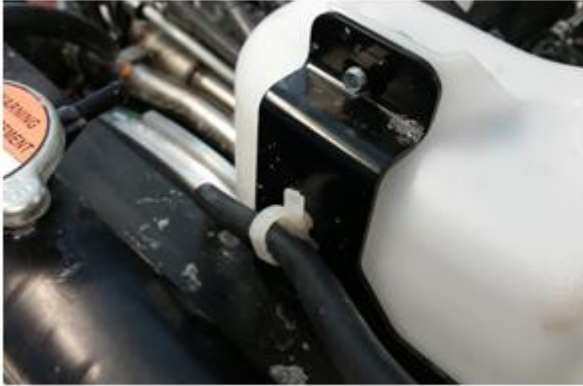
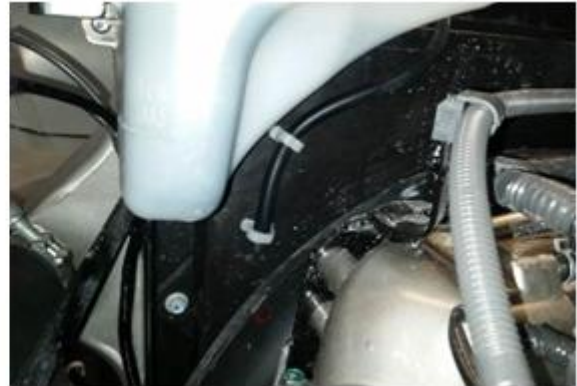
6. Feed the overflow hose on the new reserve tank hose and cap assembly in the reverse order of steps 4 and 5.

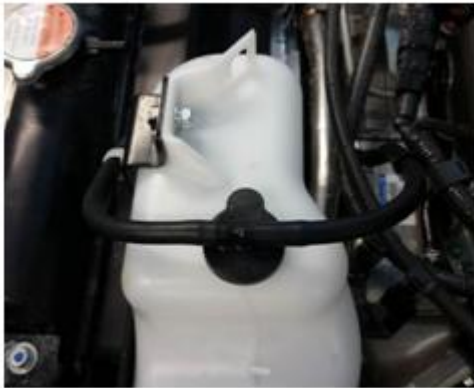
7. Secure the cap in the radiator reserve tank.

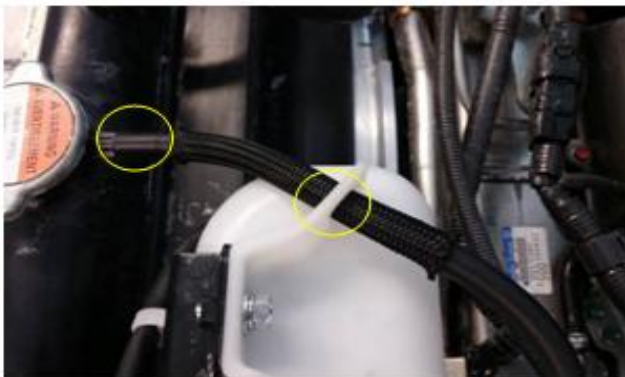
8. Feed the new recovery hose through the eyelet on the reserve tank and reconnect to the radiator. Ensure the hose protector is positioned as shown below.

1. To complete this Technical Service Bulletin, review the bulletin and confirm the following:
  - The recovery hose protector is positioned around the hose where it passes through the reserve tank eyelet.
  - The overflow hose is properly routed through the securing clips and is not kinked.
