# TECHNICAL SERVICE BULLETIN

| Bulletin No: | SB-15-046 |

## Subject: FRONT SPRING HANGER BOLT MAINTENANCE

**RELEVANT MODEL:** 16MY and earlier Hino Conventional Trucks (238, 258, 268 or 338) that were assembled before 2/9/2015.

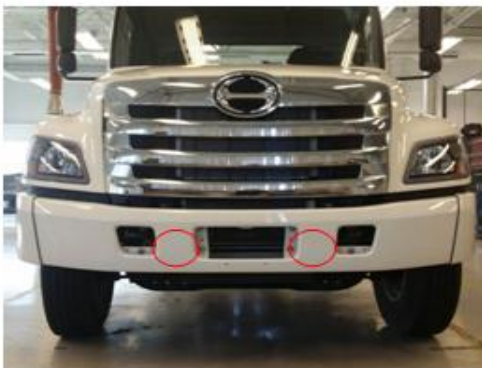
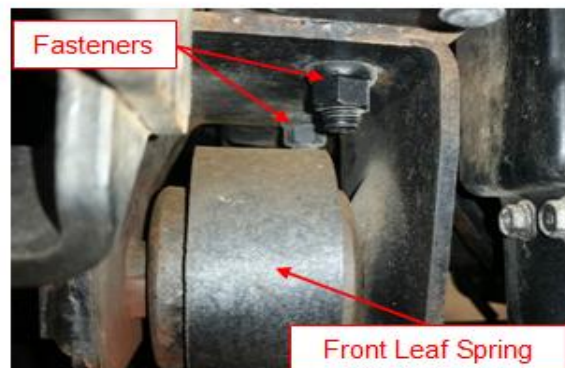
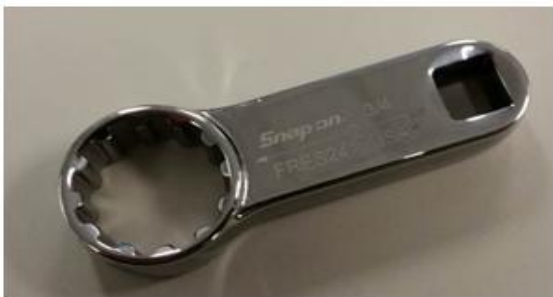
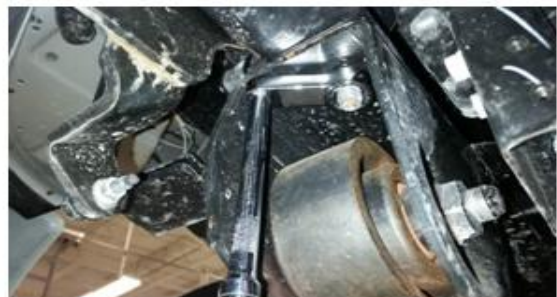
1. Using a torque wrench set to 66 lb-ft (90Nm), check the torque of the lower two fasteners on each front spring hanger bracket. A Snap-on™ FRES24 ¾ inch adapter or equivalent is the recommended tool to perform this check. If the fasteners are not loose, do not continue with this procedure.

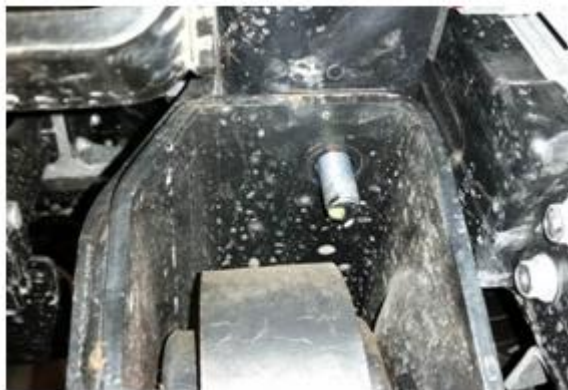
**3.** Remove the nuts from all four of the fasteners so that the Loctite 263 can be applied. Replace any missing, rusted, or worn fasteners as needed using the part numbers referenced in this bulletin.

**2.** If the fasteners are found to be loose, inspect the spring hanger brackets for any damage. Damaged brackets must be replaced.

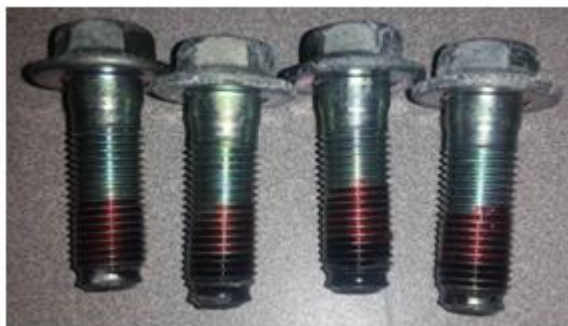
**4.** Clean the bolt and nut threads with a wire brush and apply Loctite 263 Threadlocker to all four spring hanger bracket bolts.

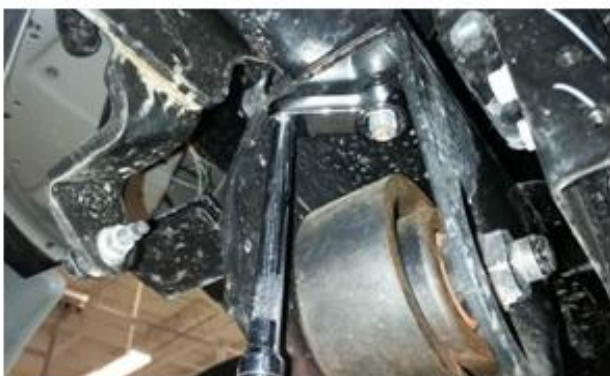
5. Install the nuts and tighten to the specified torque using the FRES24 or equivalent adapter. Allow the vehicle to sit for at least one hour before returning to the customer. Proceed to final inspection.

**Specified Torque:** 110 lb-ft (150 Nm)
