Service Bulletin No. 424B

<i>MODEL</i>	D / J4500 Series	<i>TYPE</i>	Field Change Program	<i>SECTION/GROUP</i>	8-Engine	<i>DATE</i>	Aug. 27, 2015
<i>SUBJECT</i>	CUMMINS ISX LUBRICATING OIL FILTER BYPASS VALVE						
<i>CONDITIONS</i>

Lubricating Oil Filter Bypass Valve

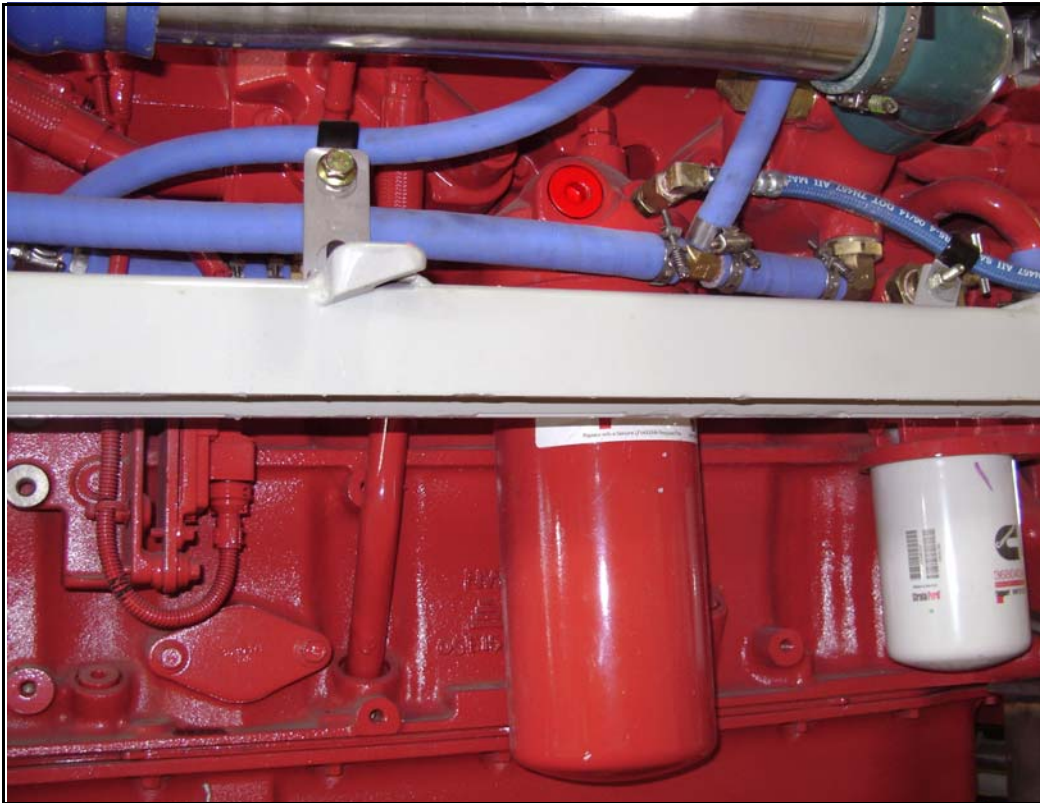
Figure 1. Location of lubricating oil filter bypass valve on roadside of engine.

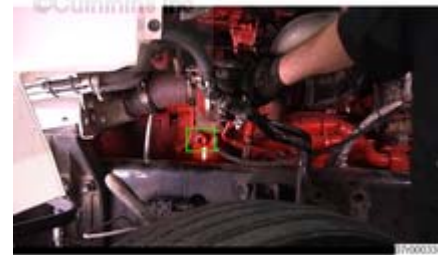
Locate turbocharger on exhaust side of engine.

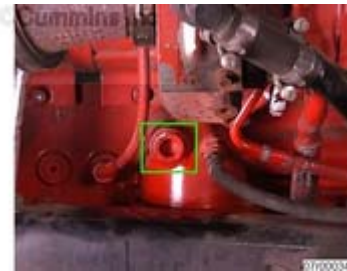
Locate lubricating oil filter bypass valve retaining plug just below turbocharger.

Inspect face of retaining plug for a highly visible paint marking (such as white or yellow paint).

A paint marking indicates the new lubricating oil filter bypass valve has already

been installed. No further action is necessary.

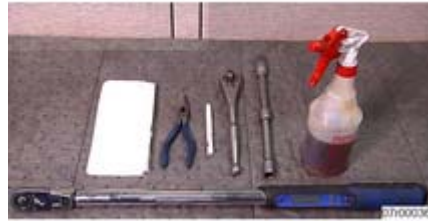
- Locate the following items in order to complete the repair:
1. Gloves
 2. Safety glasses
 3. Lint free cloth
 4. Paint marker (white or yellow)
 5. Needle nose pliers
 6. Ratchet wrench and extension
 7. 17 mm Allen® wrench or hex socket
 8. Torque wrench
 9. Clean engine oil
 10. Drip pan or absorbent mat

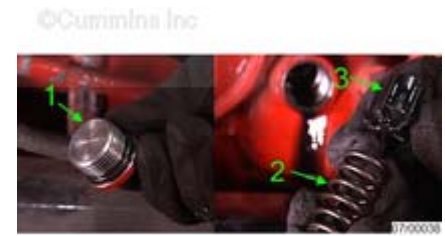
Use 17mm Allen® wrench or hex socket to loosen the lubricating oil filter bypass valve plug.

Remove retaining plug (1), spring (2), and plunger (3) from lubricating oil cooler housing.

Spring (2) and plunger (3) **must** be discarded.

Using a clean lint free cloth, clean retaining plug.

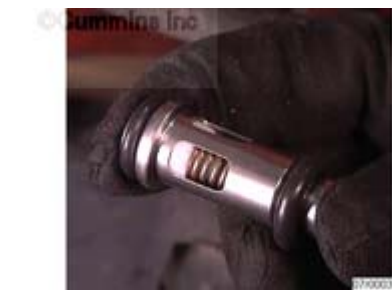
Inspect new lubricating oil filter bypass valve to verify two o-rings are correctly installed as shown.

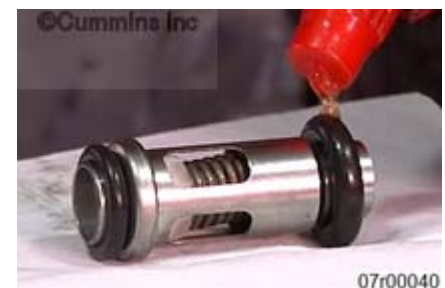
Lubricate the lubricating oil filter bypass valve with clean engine oil.

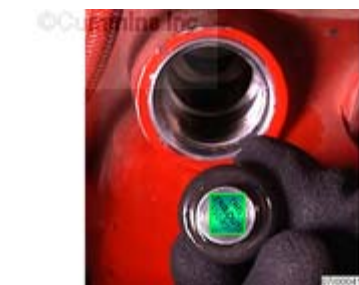
Insert lubricating oil filter bypass valve into lubricating oil cooler housing. Marking stating "THIS END OUT" **must** be visible.

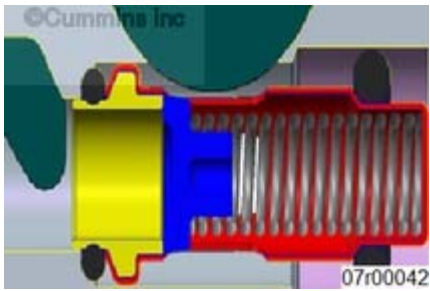
<p>Fully seat lubricating oil filter bypass valve in lubricating oil cooler housing. Verify o-rings are in proper location.</p>

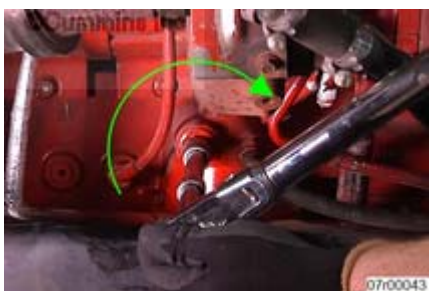
<p>Install retaining plug into lubricating oil cooler housing.</p> <p>Tighten retaining plug.</p> <p>Torque Value: 45 n.m [[33] ft-lb]</p>

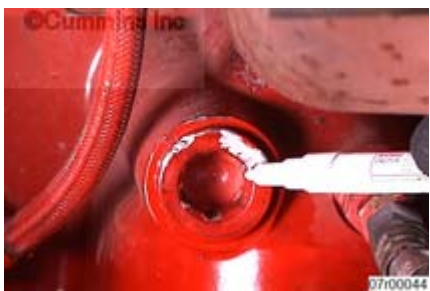
<p>If installing new lubricating oil filter bypass valve for the first time, clearly mark entire face of retaining plug using a high quality paint marker that is highly visible (such as yellow or white). Liberally apply paint marking.</p>

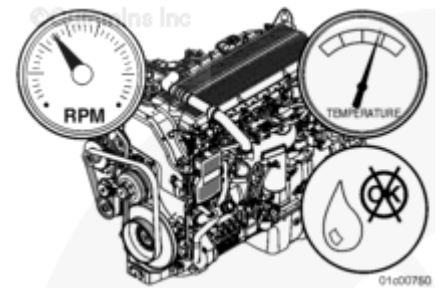
If leak persists remove plug and inspect plug o-ring and plug for damage.
