# Technical Service Bulletin

## 66 Paint flakes off radiator grille or license plate holder

66 15 45 2038652/3 January 21, 2015. Supersedes Technical Service Bulletin Group 66 number 14-43 dated October 17, 2014 for reasons listed below.

Model(s)	Year	VIN Range	Vehicle-Specific Equipment
A4, A5, Q5	2013 - 2015	All	Not Applicable

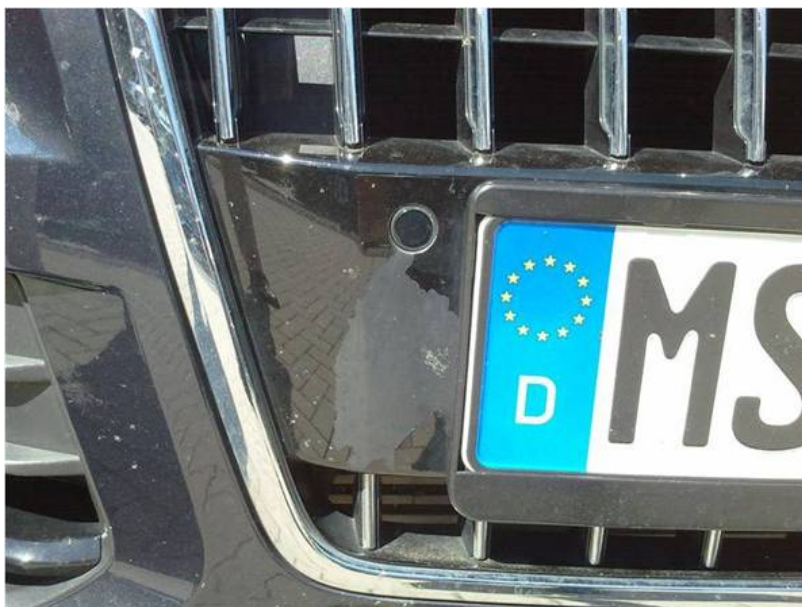
The paint is flaking off of the radiator grille or front license plate holder (Figure 1).

Figure 1. Example of flaked-off paint.

The surfaces of these components were too smooth (due to high-gloss polishing tools), which led to weak adhesion of the paint during production. Only components with color index T94 are affected.

Replace the components according to the instructions in Elsa at *Repair Manual >> Body >> Body Exterior >> 66 Exterior Equipment >> Radiator Grille/Front Trim*.
