Technical Service Bulletin

87 Air conditioning does not cool and/or compressor is noisy

87 15 60 2038023/2 March 20, 2015. Supersedes Technical Service Bulletin Group 87 number 14-56 dated September 12, 2014 for reasons listed below.

Model(s)	Year	VIN Range	Vehicle-Specific Equipment
A3, A3 cabriolet	2015	All	Not Applicable

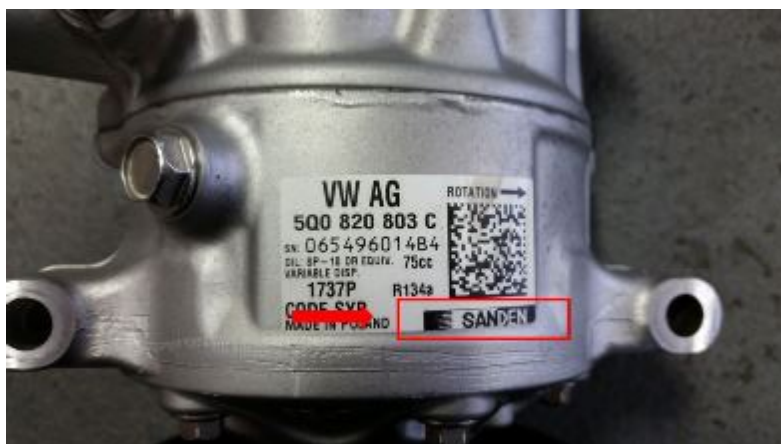
The originally installed compressor on the MY 2015 A3 is manufactured by Sanden (Figure 1). The replacement compressor is manufactured by Denso (Figure 2).

Figure 1: Sanden compressor identification tag.

When replacing the original Sanden compressor with a Denso compressor, be aware that while the refrigerant volume is the same regardless of the compressor installed, the PAG oil type and volume is not. Sanden and Denso compressors have specific PAG oils that must be used. The original PAG oil that will be in the refrigerant circuit must be flushed out completely with the air conditioning service station with flushing equipment, as specified in the Elsa Repair Manual.

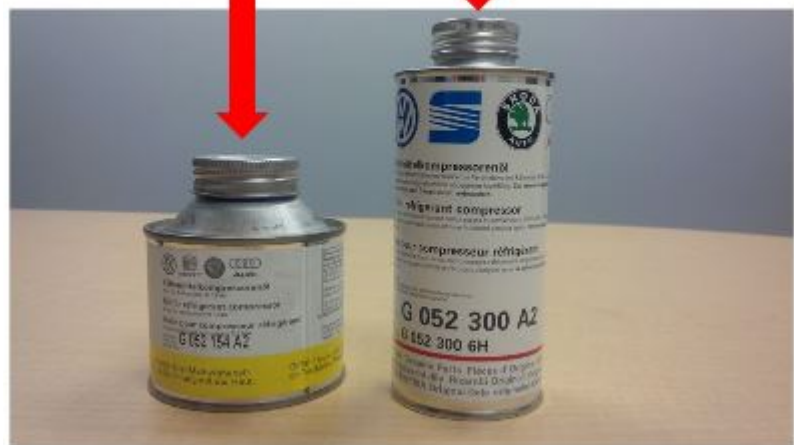
Sanden PAG oil G 052 154 A2

Denso PAG oil G 052 300 A2

Figure 3: Compressor manufacturer specific PAG oils.

The replacement compressor will come with the specified type of PAG oil for the compressor (Figure 3). The amount of PAG oil supplied with the replacement compressor may not be the exact amount required to replenish the refrigerant circuit. Drain and measure the PAG oil in the replacement compressor to determine the required amount. If the amount needs to be adjusted, do so using the correct type of PAG oil specified in ETKA. Refer to Elsa for the correct oil capacity for the compressor being installed.

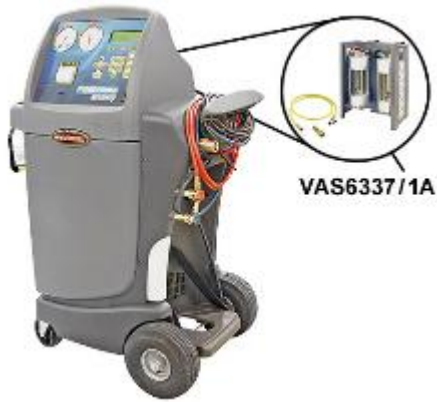
<p data-bbox="375 850 678 882">Robinair A/C Service Unit</p>	1
VAS 6337/1A

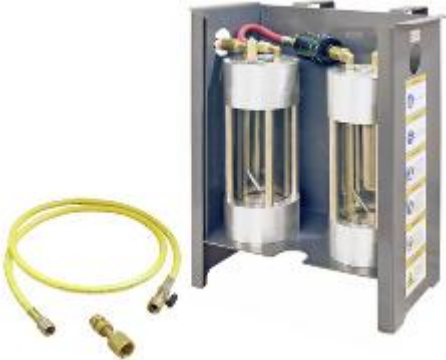
<p data-bbox="375 1327 695 1358">Air Conditioning Flush Tool</p>	1
VAS 6338/3	  <p data-bbox="375 1711 711 1743">Refrigerant Circuit Adapter 3</p>	1
