Technical Service Bulletin

74 Front seat backrest cover damaged

74 15 21 2036572/3 April 7, 2015. Supersedes Technical Service Bulletin Group 74 number 14-19 dated May 9, 2014 for reasons listed below.

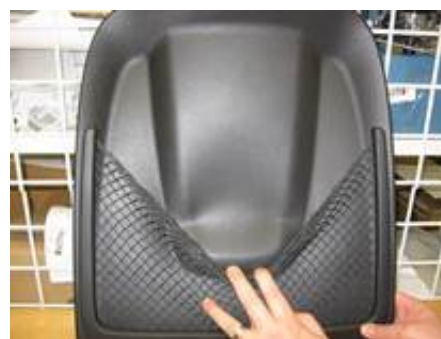
- The panel on the back of the front seat is warped or dented (Figure 1).
- The headrest on the rear seatback may also be damaged.

Figure 1. Damaged front seatback panel.

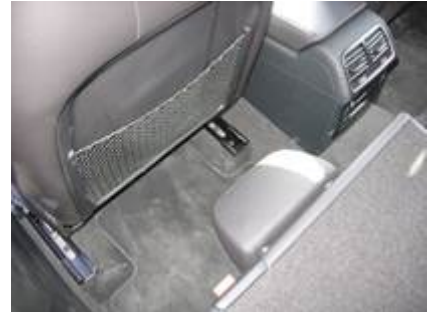
The damaged is caused when the headrest of the rear seat backrest comes in contact with the back of the front seat.

This occurs when the rear seat is folded down with the headrests installed (Figure 2), and the front seat is moved back far enough to make contact with the rear seat headrest (Figure 3).

Figure 2: *Folded-down rear seat backrest with headrest installed.*

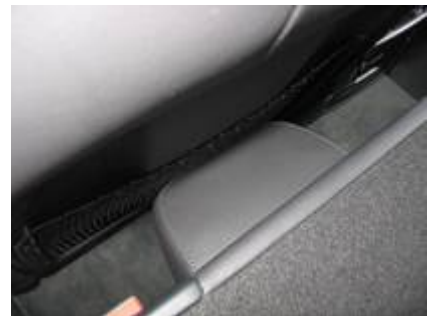
Figure 3: *Front seat moved back far enough to make contact with rear seat headrest.*

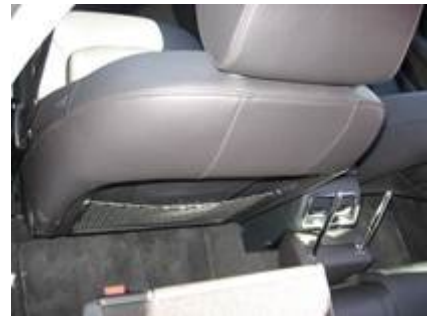
Figure 4: Rear seat backrest folded down with headrest removed.

- When the rear seat seatbacks are folded down, the rear seat headrests must be removed to accommodate the front seats (Figure 4).
- With the rear seat headrests removed, there is adequate clearance to accommodate the front seats even if they are adjusted as far back as possible (Figure 5).
- When the rear seats are folded back up and locked, the headrests must be reinstalled. The procedure for removal and reinstallation of the rear seat back headrests can be found in the Owner's Manual.

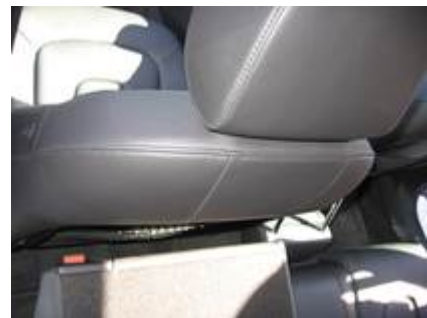
Figure 5: Front seat adjusted as far back as possible.
