Technical Service Bulletin

87 Unpleasant odor from heating and ventilation system

87 15 63 2010146/12 May 18, 2015. Supersedes Technical Service Bulletin Group 87 number 14-54 dated August 28, 2014 for reasons listed below.

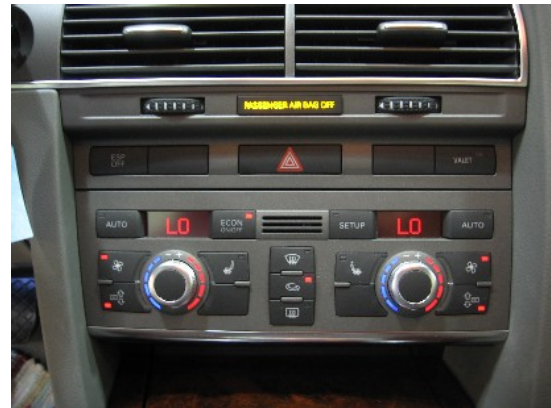
Figure 1. Climate control settings.

1. If the vehicle is equipped with an in-cabin pollen filter (such as in the A3, A6, and Q7), remove the pollen filter element and reinstall its cover before proceeding.
2. Start the engine.
3. Adjust the following climate control settings (Figure 1):
 - Set the temperature to its lowest setting.
 - Set the fan speed to its lowest setting.
 - Set the airflow direction to the dash vents only.
 - Activate recirculation and ECON modes.
4. Thoroughly shake a 100ml bottle of treatment and empty it into the filling chamber (Figure 2).

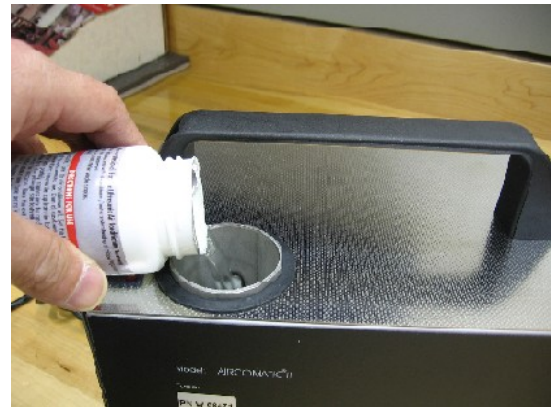
Figure 2. Pouring the treatment into the filling chamber.

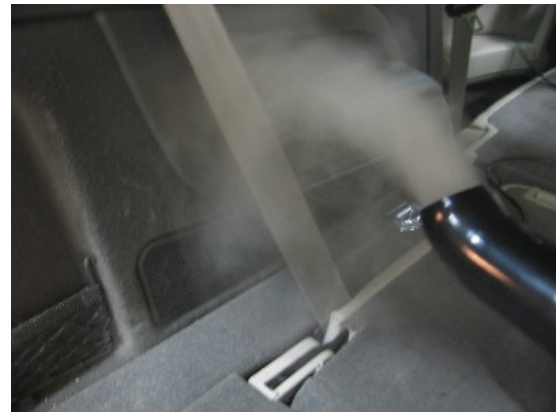
Figure 5. Correct positioning of the outlet tube on a Q7.

10. If the vehicle is equipped with a four zone climate control system with 2 evaporators (such as Q7 and A8), repeat the procedure for the rear A/C unit before proceeding. Use the same A/C settings listed above. Position the outlet tube toward the fresh air inlet vent for the rear unit. The configuration of the Q7 is shown in the illustration (Figure 5).
