Technical Service Bulletin

66 License plate mounting bracket threaded inserts stripped

66 15 49 2030471/4 March 24, 2015. Supersedes Technical Service Bulletin Group 66 number 15-46 dated February 19, 2015 for reasons listed below.

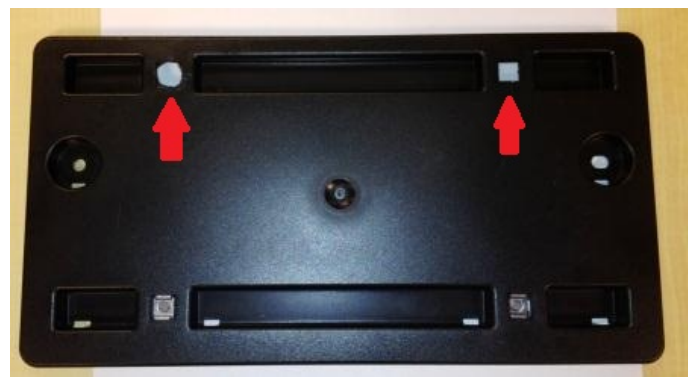
Figure 1. Damaged screw inserts

Damaged warranty parts have been returned to Audi of America with evidence of excessive torque used when installing the screw and/or excessive screw length (Figure 1).

The appropriate screw length is dependent upon the cumulative thickness of the license plate plus any decorative frame placed over the license plate.

Recommended screw length:

- License plate without decorative frame: M6 x 8 mm
- License plate WITH 2 mm thick decorative frame: M6 x 10 mm

Tip: Manually install the license plate screws using a handheld screwdriver. If the screw bottoms out, remove this screw and select a shorter screw instead of applying excessive torque. Otherwise, damage may occur to the license plate bracket screw inserts. In the event the license plate bracket screw inserts are damaged but the openings for the inserts in the license plate bracket are not, the license plate bracket screw inserts are available as a replacement part (WHT 003 200).
