Technical Service Bulletin

37 Oil appears to be leaking from transmission pan gasket

37 15 55 2039650/1 February 5, 2015.

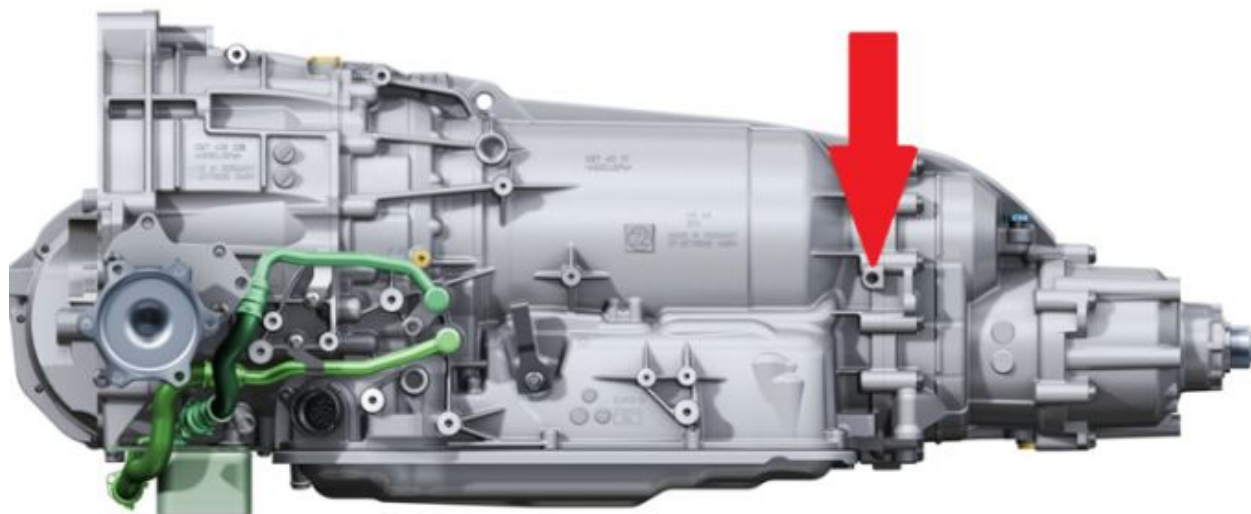
Figure 1. Location of double seal weep hole.

Be sure to check the weep hole of the double seal between the transmission and center differential, which is located on the driver's side of the vehicle (Figure 1).

1. Remove all oil residue from the transmission.
2. Confirm the exact location of the leak by applying oil leak tracing powder to the suspected areas of the leak, including the sides. Do not use oil dyes in any Audi transmission.

3. If the transmission oil pan gasket **is not** the source of the leak, open a TAC case and contact TAC for further instructions. Be sure to include clear photographs of the leak with the TAC case.
