Service Action

Code: 17F2

**Subject: 2013 MY Audi S6, S7, A8 and S8 with 4.0L Engine
Oil Filter Bypass Valve**

February 03, 2015

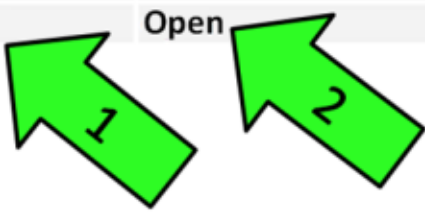
EXAMPLE

- ⇐ Ensure that the Status is “Open”
<arrow 2>
- ⇐ Note the Applicable Criteria ID
<arrow 1> for use in determining the correct work to be done and corresponding parts associated

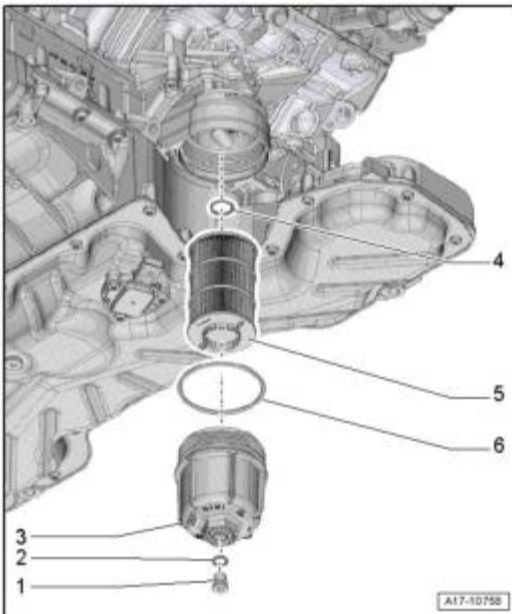
- Remove the front noise insulation.
 - ⇐ Place used oil collection unit under the oil filter housing <3>.
 - ⇐ Remove the drain plug <1> and drain engine oil.

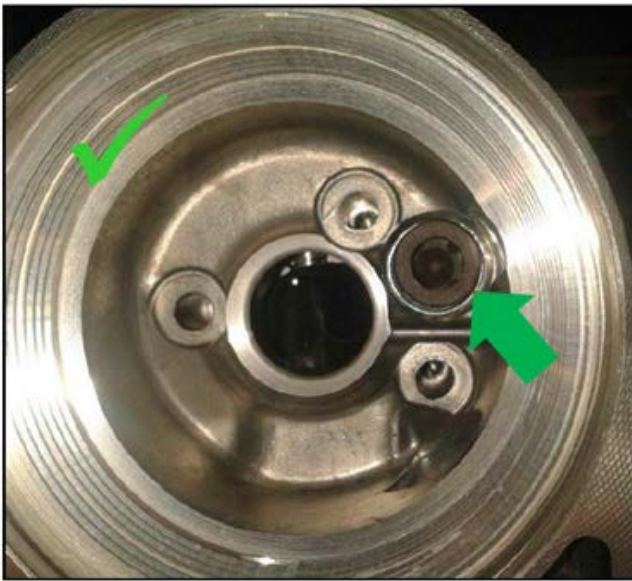
Installed Correctly

- Inspect oil filter bypass valve:
⇐ **Installed Correctly:** The black plastic <arrow> is present in the oil filter chamber.
Continue to Section E

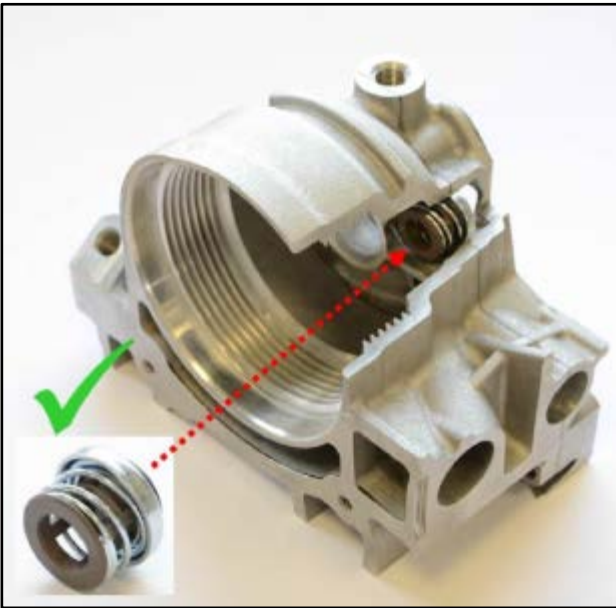
Cutaway showing the correct installation

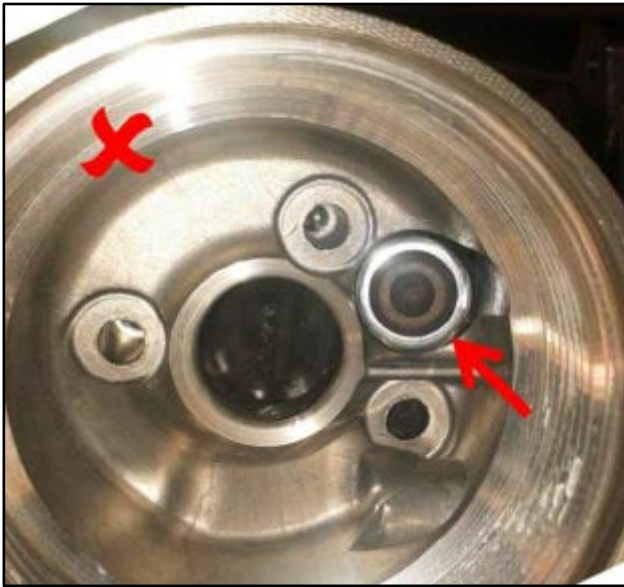
Installed Incorrectly

⇐ **Installed Incorrectly:** The silver metal collar <arrow> is visible in the oil filter chamber.
Continue to Section C

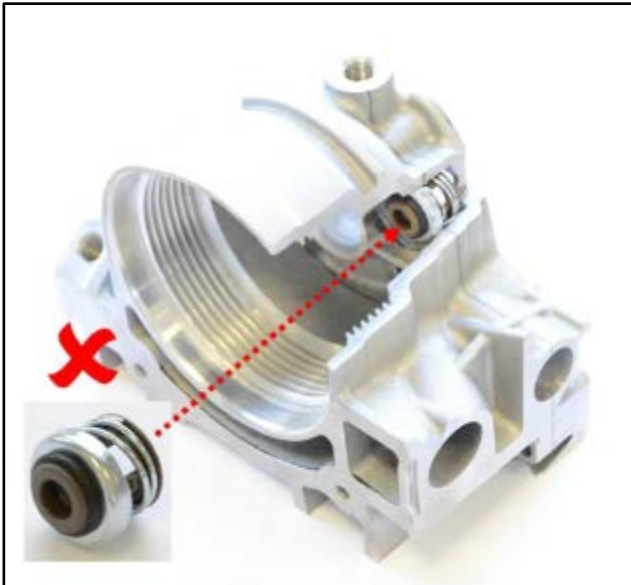
Cutaway showing incorrect installation

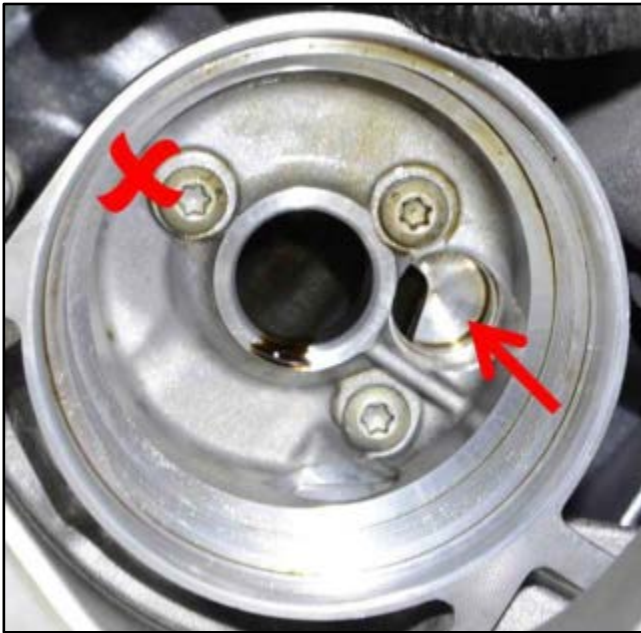
Valve Missing

⇐ **Valve Not Installed:** Valve is not present in the oil filter chamber <arrow>. **Continue to Section D**
