Technical Service Bulletin

87 Unpleasant odor from heating and ventilation system

87 15 64 2010146/13 June 24, 2015. Supersedes Technical Service Bulletin Group 87 number 15-63 dated May 18, 2015 for reasons listed below.

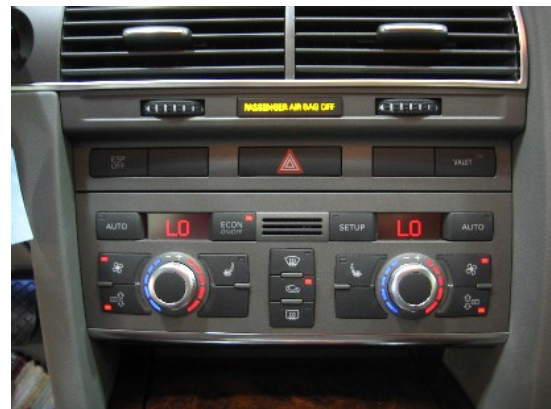
Figure 1. Climate control settings.

1. If the vehicle is equipped with an in-cabin pollen filter (such as in the A3, A6, and Q7), remove the pollen filter element and reinstall its cover before proceeding.
2. Start the engine.
3. Adjust the following climate control settings (Figure 1):
 - Set the temperature to its lowest setting.
 - Set the fan speed to its lowest setting.
 - Set the airflow direction to the dash vents only.
 - Activate recirculation and ECON modes.
4. Thoroughly shake a 100ml bottle of treatment and empty it into the filling chamber (Figure 2).

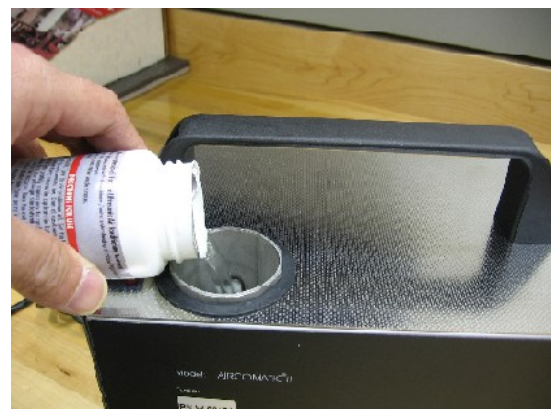
Figure 2. Pouring the treatment into the filling chamber.

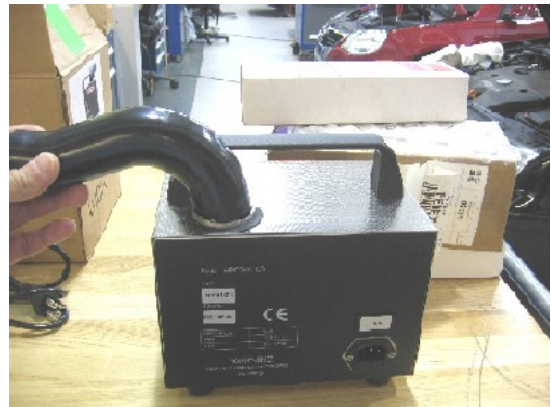
Figure 3. The connected outlet tube.

5. Connect the outlet tube (Figure 3).

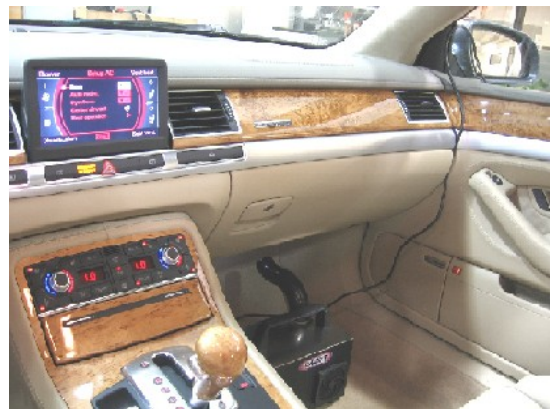
Figure 4. Window is slightly open so that the cord can pass through.

6. Place the cleaning unit into the passenger side footwell, ensuring that the unit is as level as possible.
7. Connect the unit power cord, and route it through one of the windows, which should be slightly open (Figure 4). All other windows and the sunroof should be completely closed.

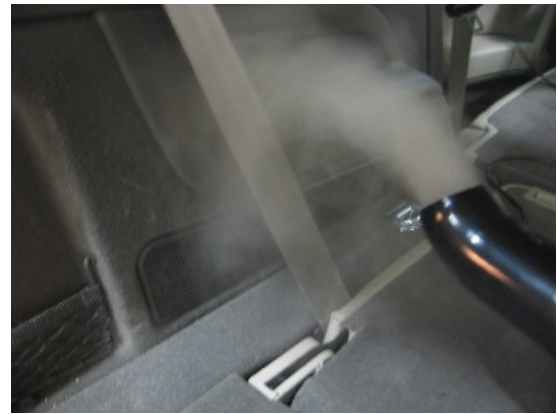
Figure 5. Correct positioning of the outlet tube on a Q7.

10. If the vehicle is equipped with a four zone climate control system with 2 evaporators (such as Q7 and A8), repeat the procedure for the rear A/C unit before proceeding. Use the same A/C settings listed above. Position the outlet tube toward the fresh air inlet vent for the rear unit. The configuration of the Q7 is shown in the illustration (Figure 5).
