# Technical Service Bulletin

## 91 Generation III radio: Loose or broken control knobs

91 15 89 2017425/5 June 3, 2015. Supersedes Technical Service Bulletin Group 91 number 14-30 dated April 7, 2014 for reasons listed below.

Model(s)	Year	VIN Range	Vehicle-Specific Equipment
A4, A5, A5 Cabriolet, Q5	2010 - 2016	All	CAN Radio

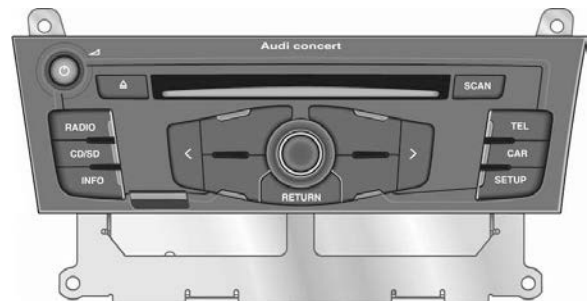
Figure 1. A generation III radio.

On generation III Concert and Symphony radios (Figure 1), the control knob or volume knob is broken or loose.

Knobs may be damaged by outside influence.

The knobs can be replaced individually and are available as accessories.

Part Number	Part Description	Quantity
8T0059528	Control knob replacement kit	1*

\* This part number is a kit that contains one volume knob and one control knob.
