# Tech Tips

TT 50-12-01

2011-2015 Jetta Sedan- Water Leak into Front Passenger  
Compartment

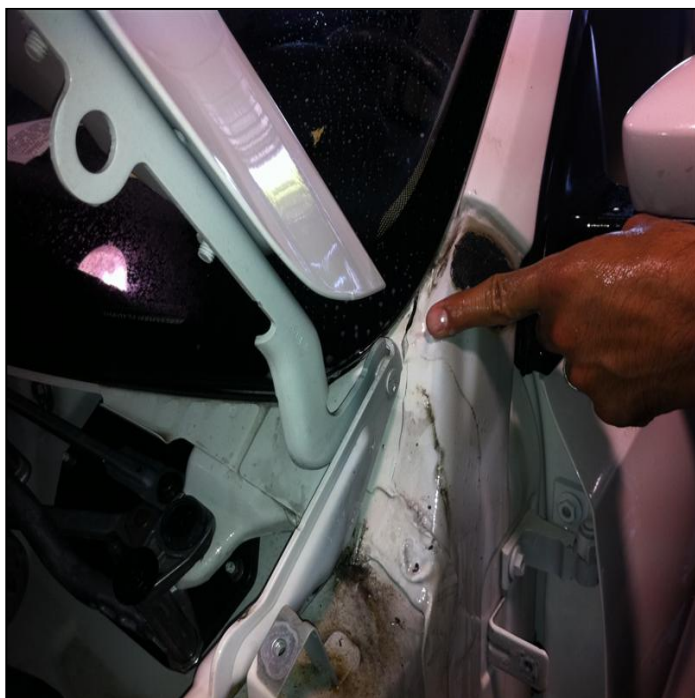
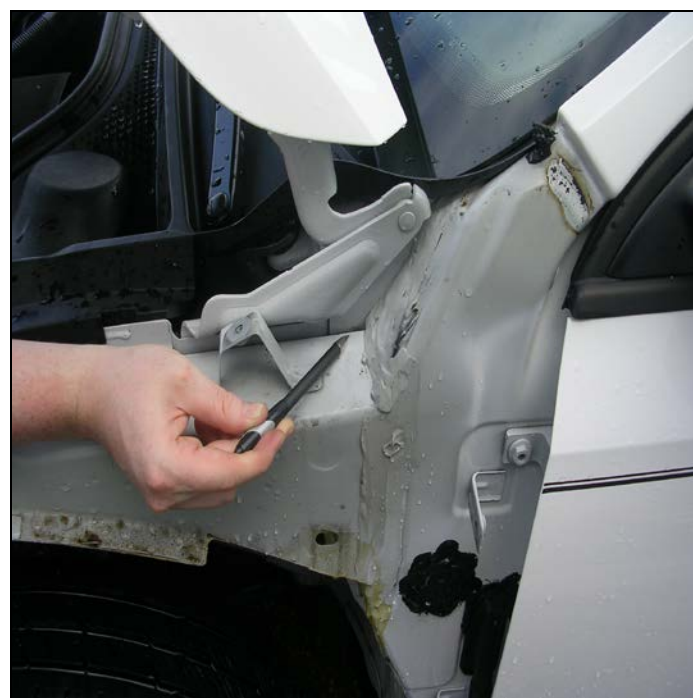
A concern of water leak into the front passenger compartment may be caused by a seam sealer skip or hole in the area around hood hinge or behind front fender.

Isolate leak location by switching HVAC blower on high, with all doors and windows closed, and then spraying soapy water, or a foaming cleaner, over seam sealer. If bubbles are observed at any point during this test, repair leak at location of bubbles using an appropriate seam sealer.
