# Tech Tips

TT 60-07-01

2007-2015 EOS - Water Leak From the "A" Pillar Area

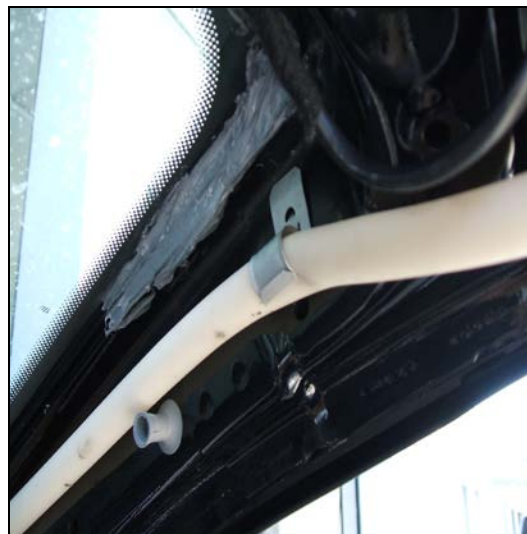
Figure 2

2) For concerns with water leaks from the "A" pillar side and/or dome lamp area –

- Check at the sunroof drain hose clip location.
- An improperly clipped or pinched hose may reduce the water flow causing the water to backup and overflow into the vehicle (see figure 2).
