Tech Tips

TT 64-14-04

2012-2015 Beetle/Beetle Convertible Front Window Contacts Rear Window Glass, Window Misaligned

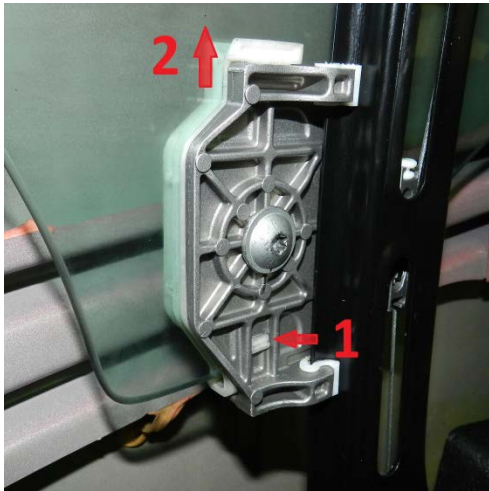
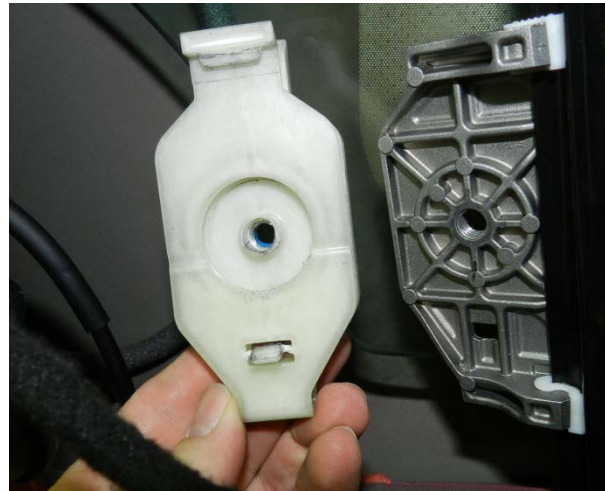
Fig. 4

Remove the bolt for the regulator clamp then remove the plastic clamp from the elevator and window glass by releasing the clip toward the bottom of the clamp then sliding the clamp up. (See Figs. 4 and 5)

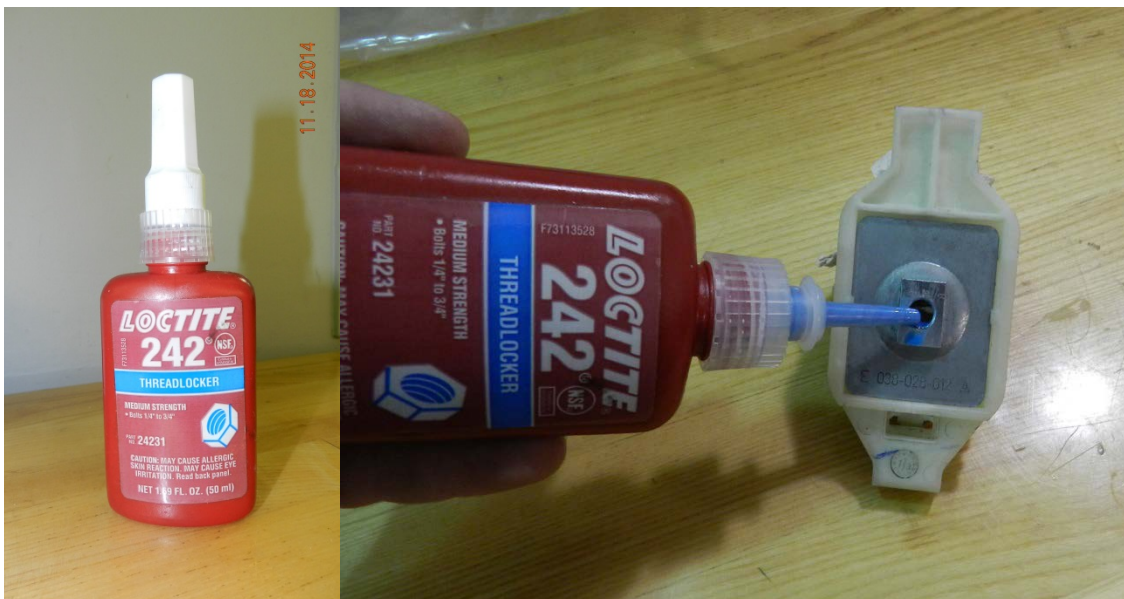
Fig. 5

Apply a few drops of Loctite brand 242 medium strength thread locking compound (blue) to the threaded insert in the plastic regulator clamp. (See Fig. 5)

Thread locking compound should not be solely applied to the clamp bolt as the effectiveness may be reduced. Apply directly to the threads on the back of the regulator clamp.

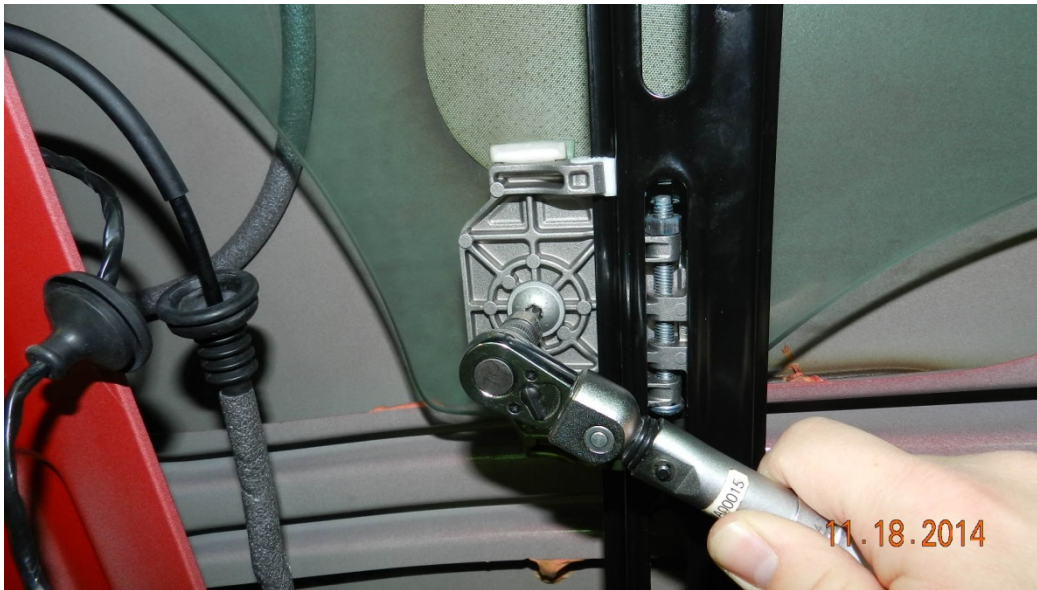
Fig. 6

Once the window glass is properly adjusted, torque both the front and rear regulator clamp bolts to **7 Nm** using torque wrench 1783 (VAG1783). (See Fig. 6)

Check for proper function of the window with the door open and closed before reassembling.
