### TT 64-15-01

#### 2012-2015 Passat – Rattle when Closing Front Door

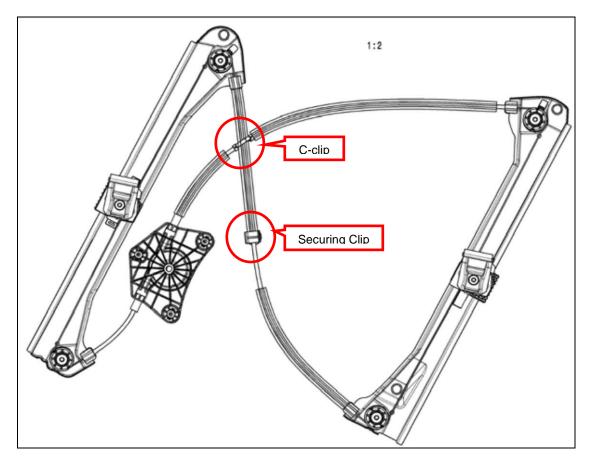
Figure 1: Location of regulator cable securing clip and c-clip.

For issues of a rattle noise when closing the front door(s), inspect the window regulator cables to ensure the securing clip and the cable c-clip are properly attached. If c-clip is missing it may have fallen inside the door. If c-clip can't be found, or will not stay attached to the cables, crisscross 2 zip-ties as shown in figure 3 to secure the cables. Also inspect that the door wiring harness is properly secured with the 6 retaining clips.

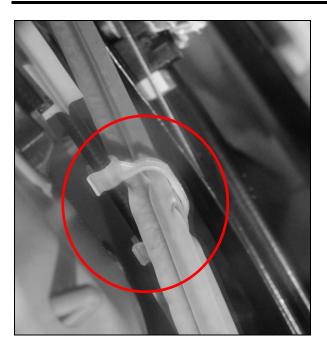
Figure 2: Proper installation of regulator cable c-clip.

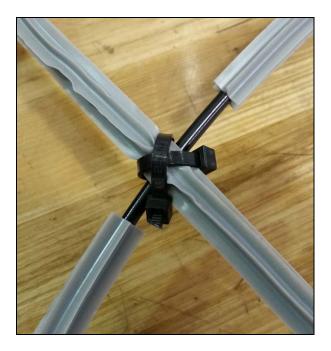
Figure 3: Crisscross 2 zip-ties to secure regulator cables if c-clip is missing. Do not overtighten zip-ties.

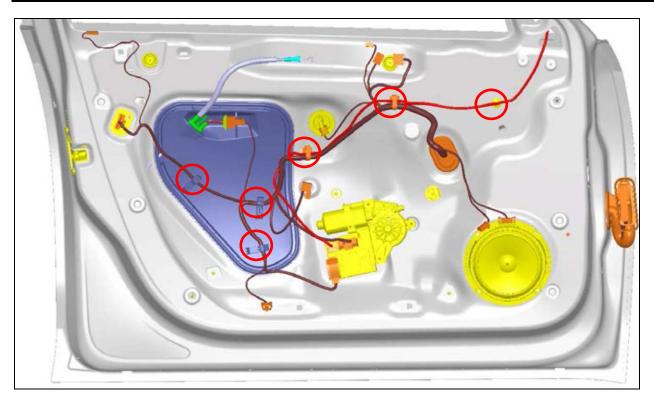
Figure 4: Location of door wiring harness retaining clips (red circles).
